The Migration to Higher Thrust Engines and the Effect on Control Speeds

Steve Nelson
Boeing Flight Operations Engineering

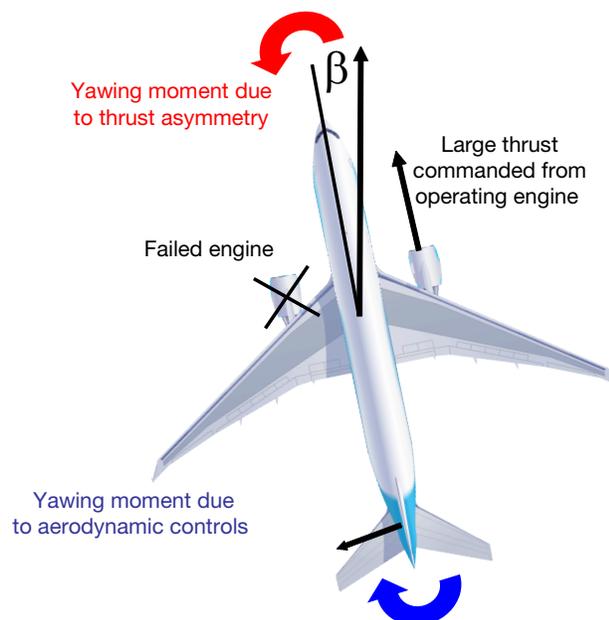
For the 777 airplane the growth in engine thrust levels has increased since the original PW4074 engine. This original engine was rated at 74000 pounds of thrust and was envisioned to grow to around 95000 pounds of thrust. The 777-200LR has a current offering of a 115000 pound thrust engine. With this engine growth the vertical tail and rudder size has remained the same. This has resulted in reduced margins between the normal operating speed and the in-air minimum control speed

There is a speed below which there is a loss of directional control. This speed is defined by the inability to reliably maintain desired bank angle and/or heading at a given asymmetric thrust. This speed is always lower than the certified minimum control speed (V_{MCA}/V_{MCL}).

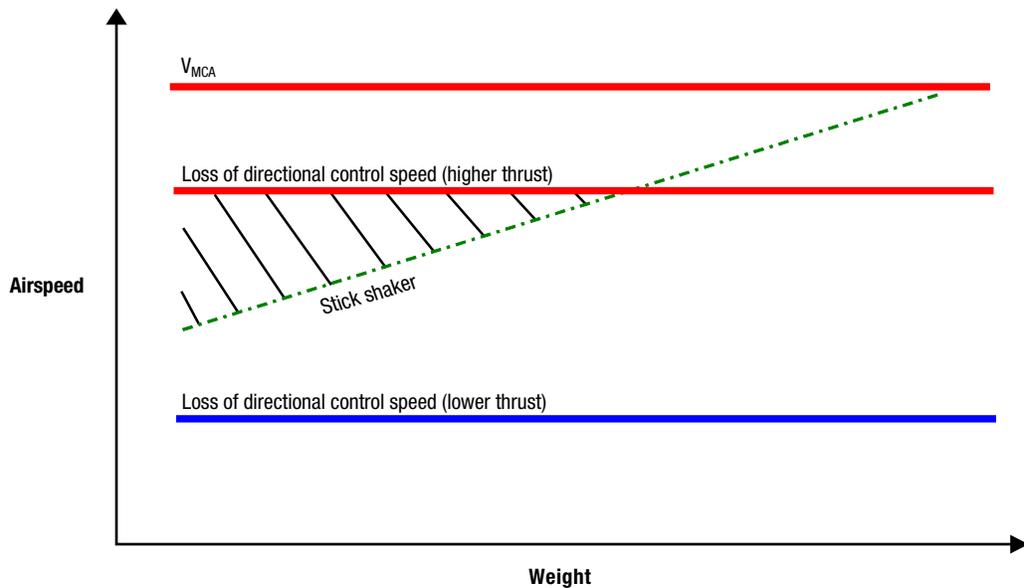
One push of TO/GA button provides adequate thrust for most situations, and provides substantial speed margin to loss of directional control speed in the event of an engine failure. Two pushes of TO/GA button provides full G/A thrust, reducing margin to loss of control speed in the event of an engine failure.

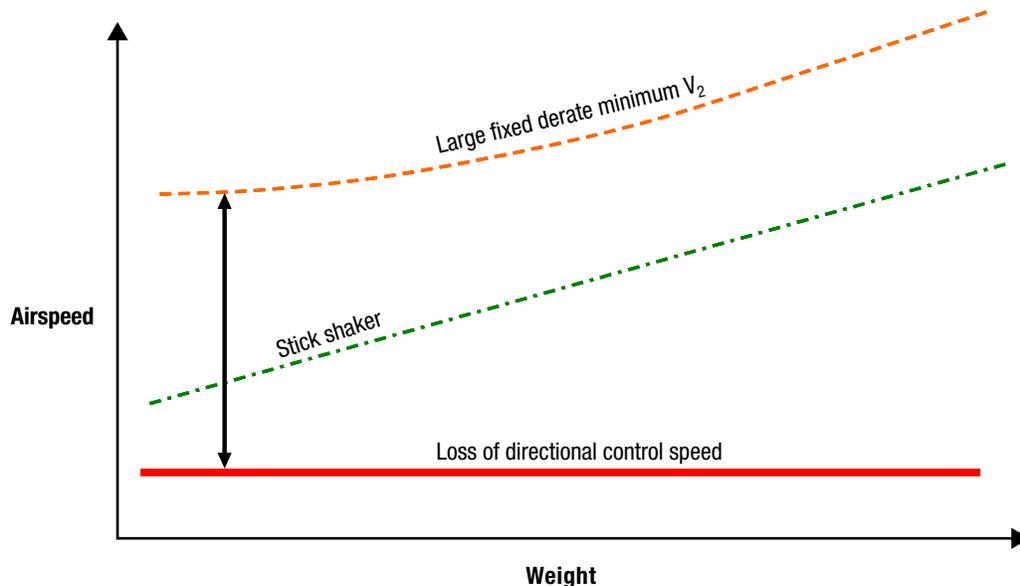
Not following Boeing procedures and advancing thrust reduces the margin to loss of directional control speed.

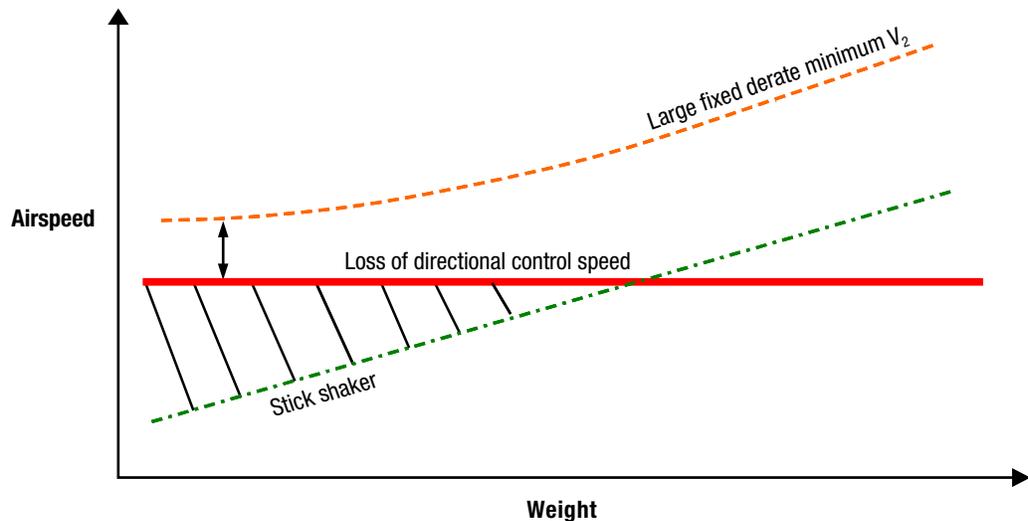
A V_2 floor is one of the technical solutions that we are looking at. The V_2 floor would maintain the larger speed margin to the loss of directional control speed that is found on the lower thrust engines.

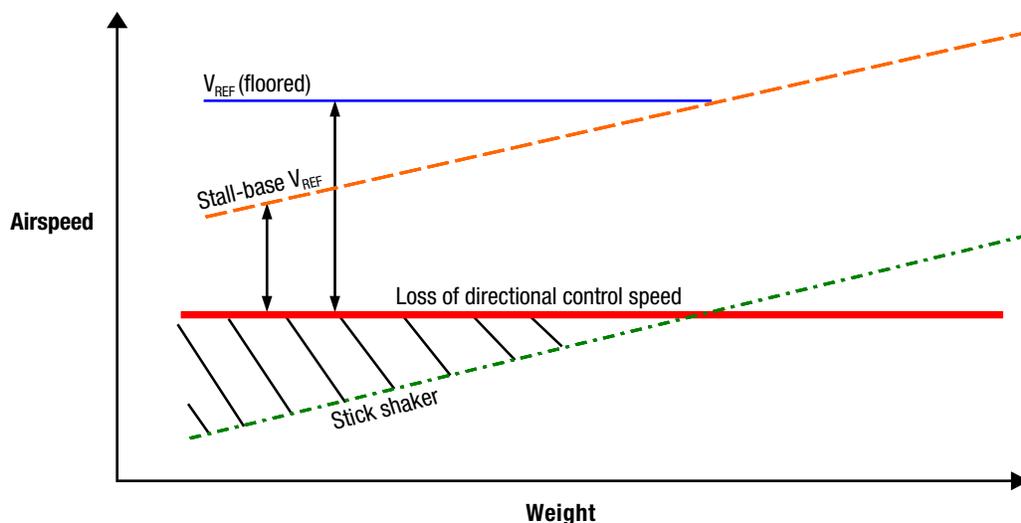
One push of TO/GA button provides adequate thrust for most situations, and provides substantial speed margin to loss of directional control speed in the event of an engine failure.

Two pushes of TO/GA button provides full G/A thrust, reducing margin to loss of control speed in the event of an engine failure.

The 777-200LR maintains an excellent margin to loss of control speed due to a V_{REF} speed floor.

Boeing is currently evaluating speed margins for the 777-200ER at light weights to match 777-200LR methodology.
