Final Report

EgyptAir Boeing 777-200 aircraft cockpit fire

AT Cairo Airport

Registration SU-GBP

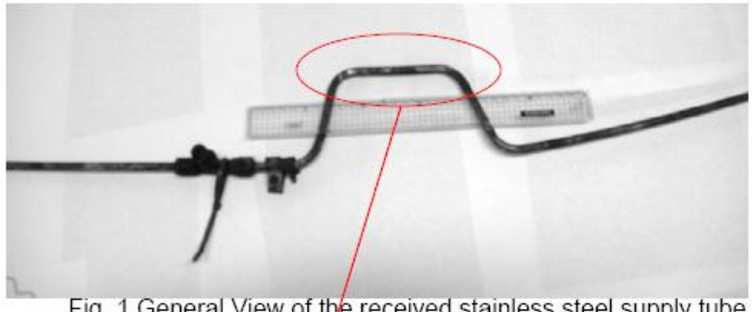
Fig. 1 General View of the received stainless steel supply tube

The tube surface was covered by fire products, and some areas have rough surface. The molten metal is basically aluminum alloy, resulted from the fire.

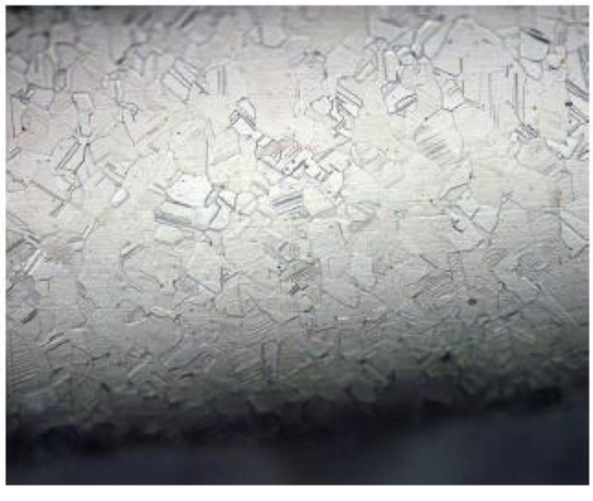
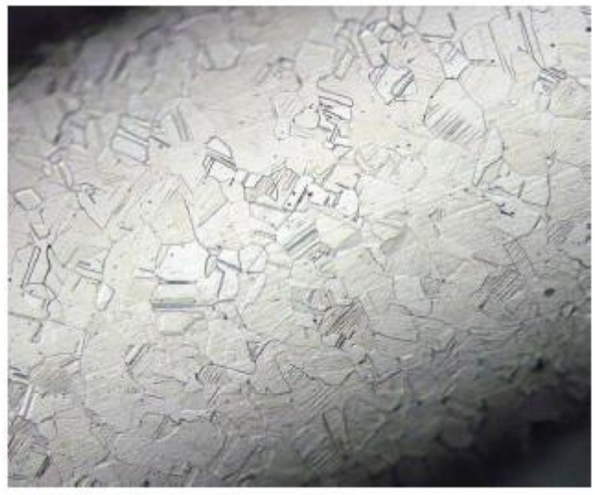
Microstructure of the investigated stainless steel spring, 200X

The stainless steel spring surface was covered by fire products with some spot rusted area (red color). No direct evidence of a short circuit was fund found, but most of the wiring near the supply tubing and portions of the tubing were missing, with evidence of melting on the remaining portions.

According to CMRDI view, most plausible cause for the observed melting of the stainless steel spring assembly is an oxygen fuel flame caused by high attained temperatures

The microstructure is normal for this type of stainless steel with normal grain size and without any precipitates.

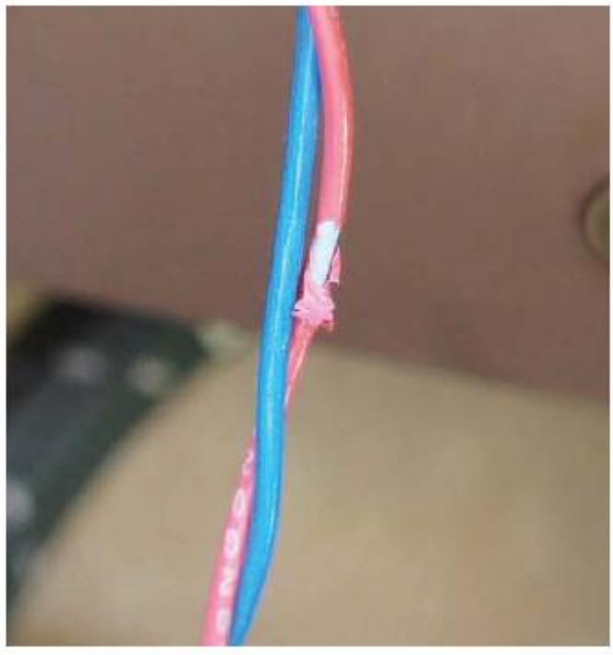
On one of the 777-200 aircraft, the outer layer of wiring insulation was found damaged, although the inner layer was intact and the conductor was not exposed.

Damaged first officer oxygen light plate 5 volt AC wiring on a different 777-200 airplane

It was later determined that approximately 380 early 777 aircraft (including the accident) had been produced without sleeving on this wire run. Although the missing clamp was found on a number of 777-200 aircraft, the reason for the missing clamps could not be determined as the clamps have been part of the original design of the 777 aircraft. Boeing determined that it was appropriate to install sleeving on these wires and released a Service Bulletin (777-33-0042, dated 9 January 2012) recommending that 777 operators inspect and if necessary repair the captain's and first officer's oxygen light plate wiring.

1. Released Service Bulletin 777-33-0042, dated 9 January 2012, recommending that 777 operators inspect and if necessary repair the captain's and first officer's oxygen light plate wiring.

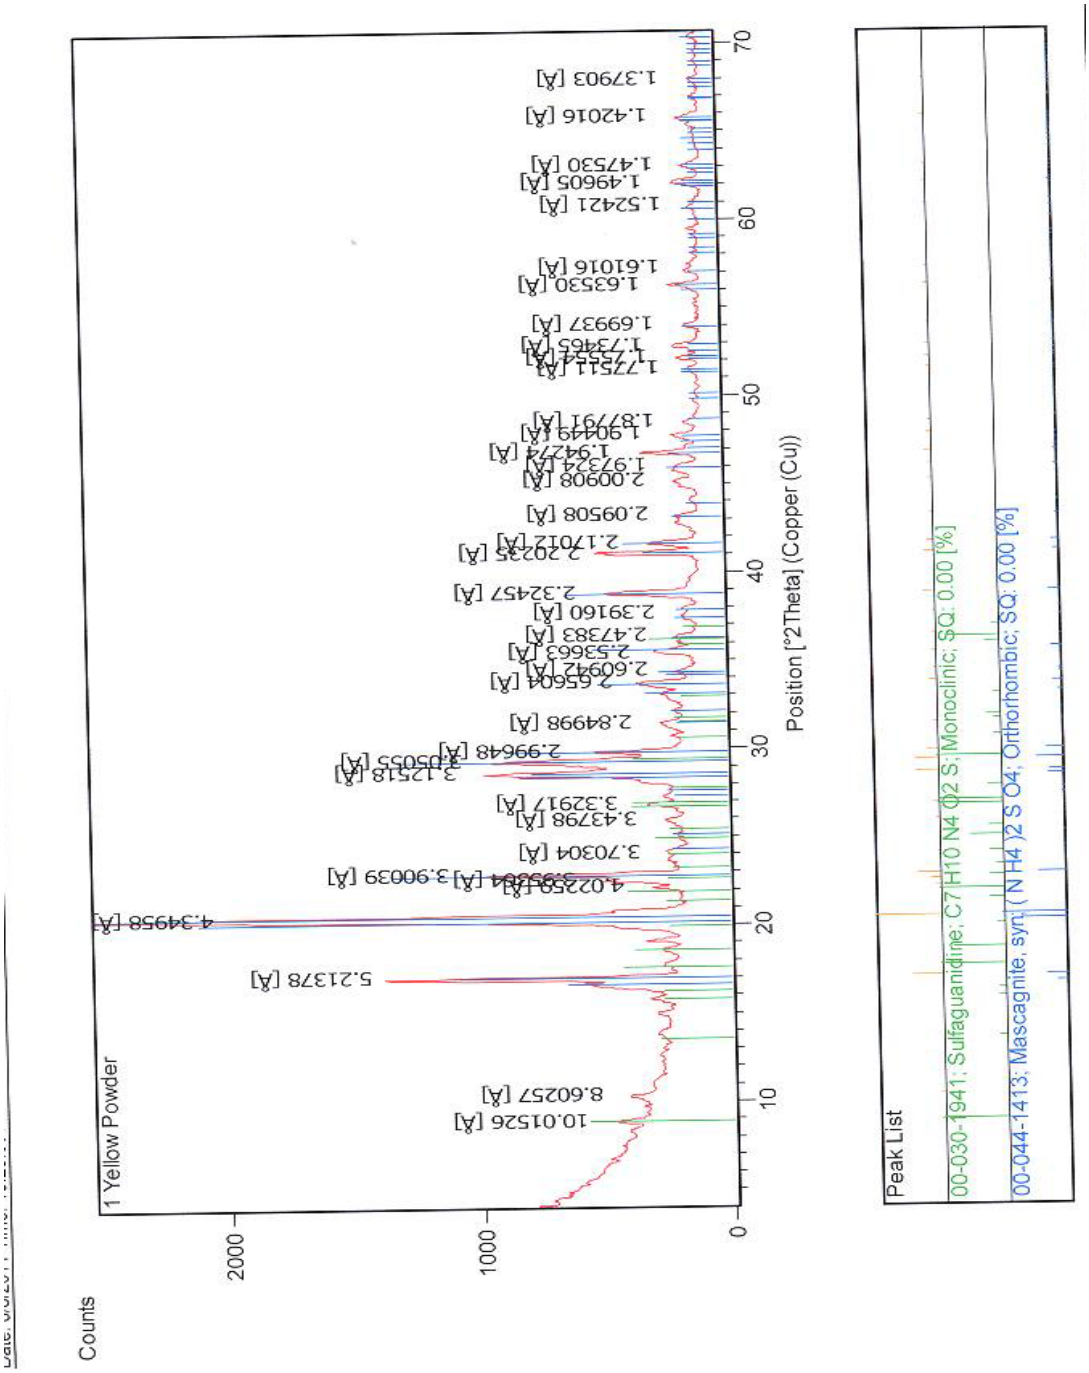
Sample No.1: Yellow Powder (Flight Deck R.H.S. SU-GBP)

The test results showed that the yellow powder is mainly consists from Sulfaguanidine $C_7H_{10}N_4O_2S$ and Mascagnite $(NH_4)_2SO_4$.

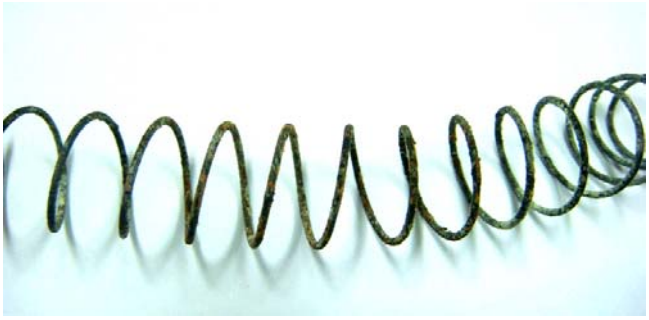
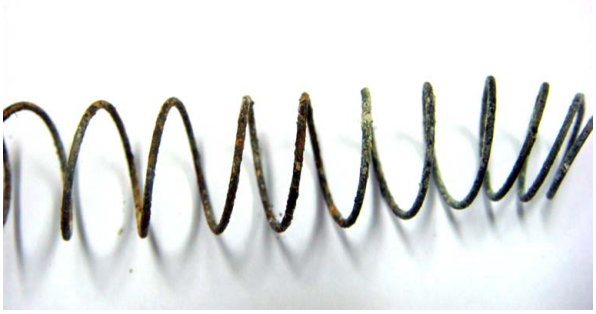
The stainless steel spring surface is covered by fire products with some spot rusted area (red color). No direct evidence of a short circuit was fund, but most of the wiring near the supply tubing and portions of the tubing were missing.

The only way to cause melting of the stainless steel spring assembly is an oxygen-fuel flame because temperatures that are attained in ordinary fires are not sufficient to melt stainless steel. The source of oxygen to allow for this melting would have had to be located closely to the melted stainless steel spring assembly; thus, the source of oxygen was the flexible oxygen hose connected to that particular spring assembly.

It is supposed that the stainless steel spring had been subjected to high energy level, which heated the internal spring until it became an ignition energy source, causing the flexible oxygen hose to ignite and sustain a fire. The time to failure, may took few seconds depending on the amount of energy supplied to the internal spring.

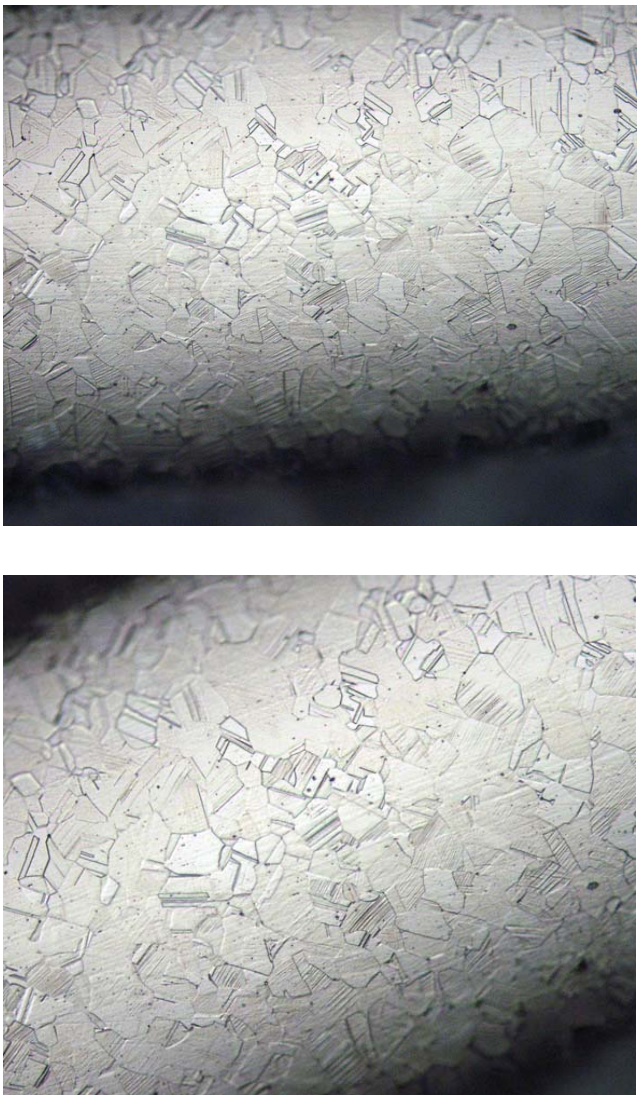
Microstructure of the investigated stainless steel spring, 200X

This could be approved from the metallurgical microstructure of stainless steel wire, investigated at different places. The microstructure is normal for this type of stainless steel with normal grain size and without any precipitates, as shown in the following figure. If the heating of the stainless steel spring took long time the microstructure will be coarser and different type of precipitates will be observed on the grain boundaries, which is not our case.

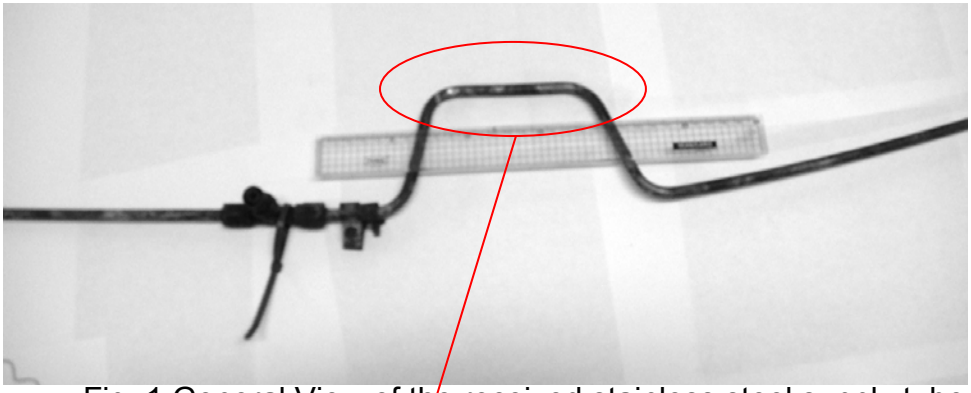
Fig. 1 General View of the received stainless steel supply tube

The tube surface was covered by fire products, as shown in Fig.2, and some areas have rough surface. The deposited molten metal shown in Fig.2, was send to chemical analysis. The molten metal is basically aluminum alloy, resulted from the fire.

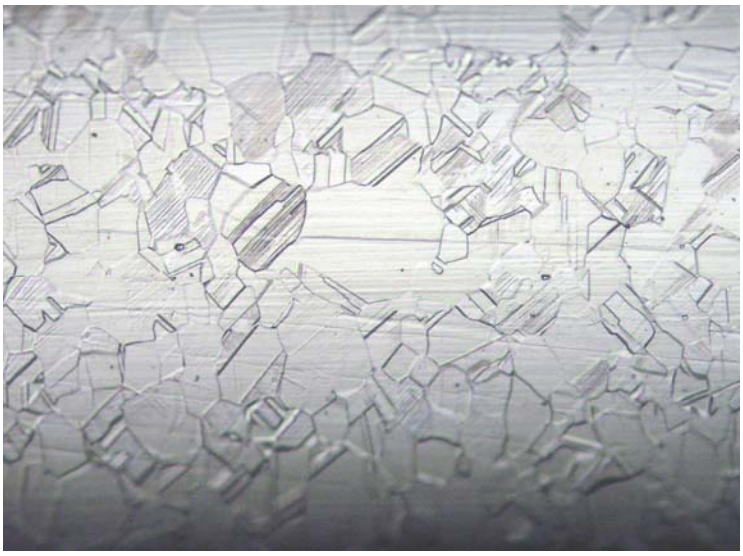
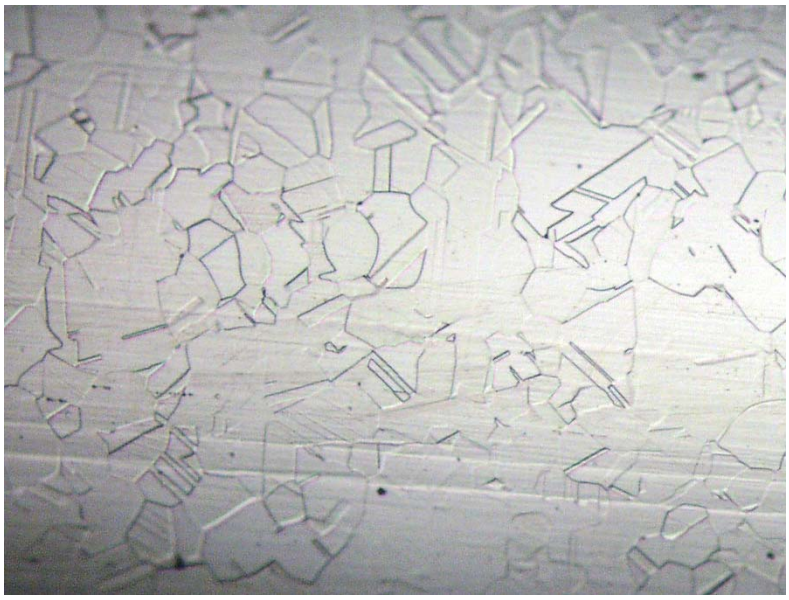
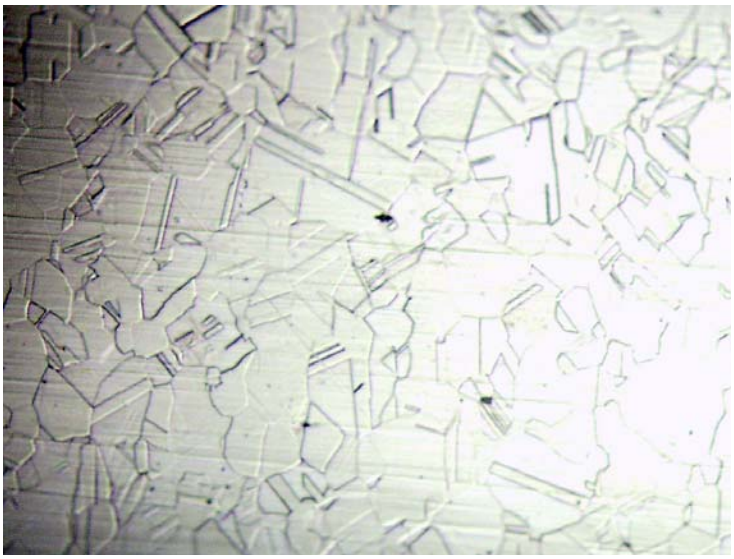
Microstructure of the investigated stainless steel spring, 200X

The only way to cause melting of the stainless steel spring assembly is an oxygen-fuel flame because temperatures that are attained in ordinary fires are not sufficient to melt stainless steel. The source of oxygen to allow for this melting would have had to be located closely to the melted stainless steel spring assembly; thus, the source of oxygen was the flexible oxygen hose connected to that particular spring assembly.

It is supposed that the stainless steel spring had been subjected to high energy level, which heated the internal spring until it became an ignition energy source, causing the flexible oxygen hose to ignite and sustain a fire. The time to failure, may took few seconds depending on the amount of energy supplied to the internal spring.
This could be approved from the metallurgical microstructure of stainless steel wire, investigated at different places. The microstructure is normal for this type of stainless steel with normal grain size and without any precipitates, as shown in the following figures. If the heating of the stainless steel spring took long time the microstructure will be coarser and different type of precipitates will be observed on the grain boundaries, which is not our case.
