Aircraft Accident Investigation Report  
KNKT/07.06/07.02.35

**NATIONAL  
TRANSPORTATION  
SAFETY  
COMMITTEE**

**BOEING 737-497**

**7 MARCH 2007**

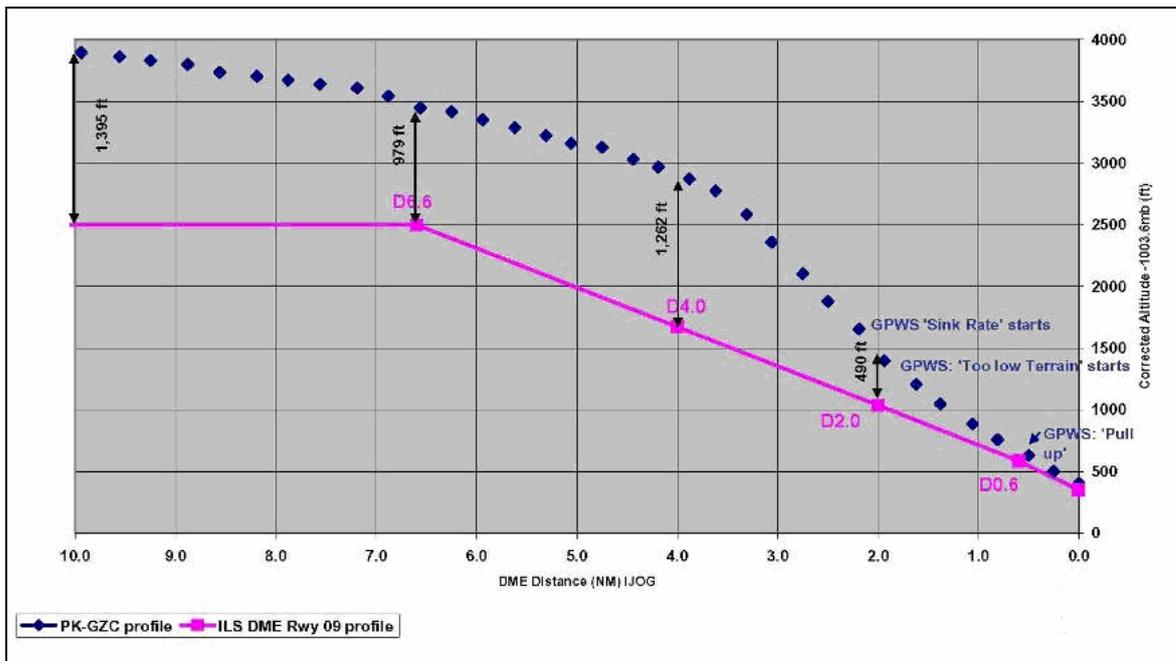
**Figure 8: Comparison of PK-GZC and ILS DME approach profiles for Yogyakarta runway 09 approach**

The chart (Figure 8), prepared by the Australian Transport Safety Bureau, was derived from the Jeppesen Instrument Landing System (ILS) chart for runway 09 at Yogyakarta, and recorded data taken from the SSFDR for the accident flight. During the approach, GA200 was above the ILS approach profile (glideslope). The runway touchdown zone for the ILS approach was between 150 and 620 meters from the runway 09 threshold. The aircraft touched down about 860 meters from the threshold.

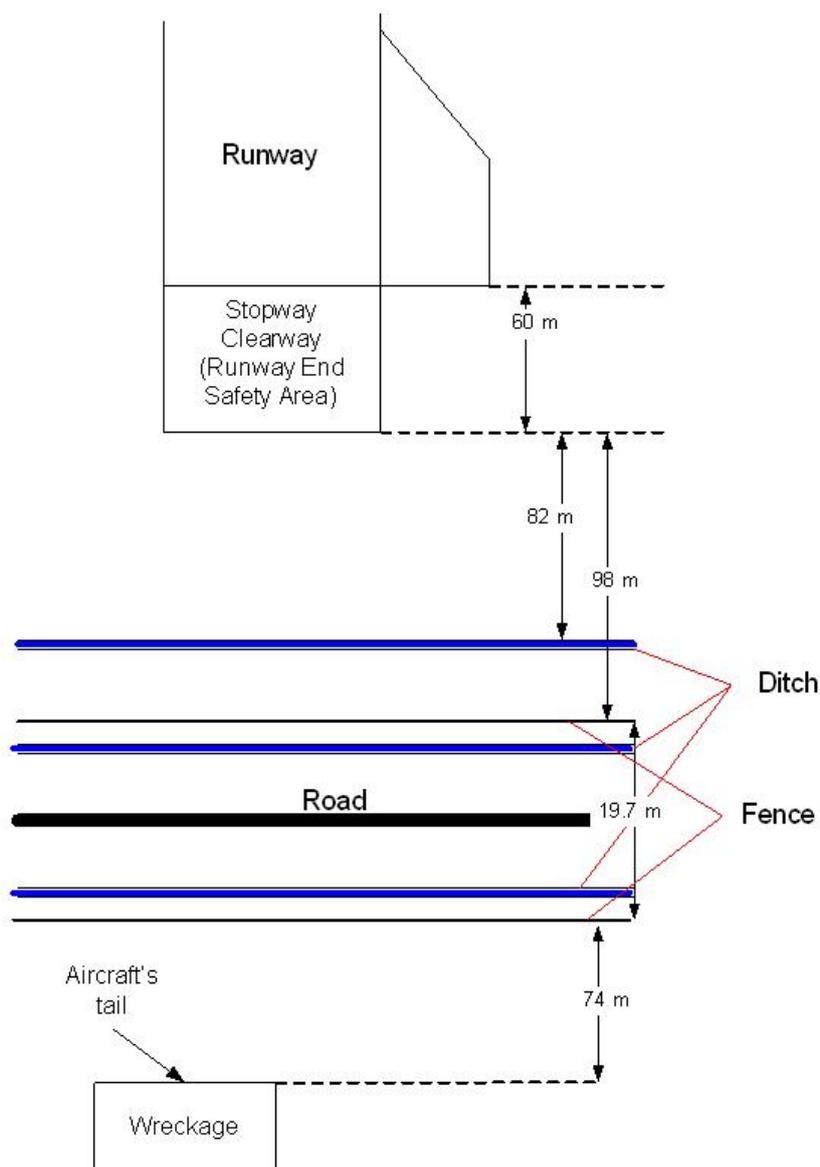
Figure 12: Dimensions from runway 09 departure threshold to tail of aircraft

Paragraph 3.5.3 recommends that for a Category 3 airport such as Yogyakarta, a RESA should, as far as practicable, extend from the end of a runway strip to a distance of at least 240 meters.

Figure 12 shows distances between the runway and the accident site, and significant obstructions.

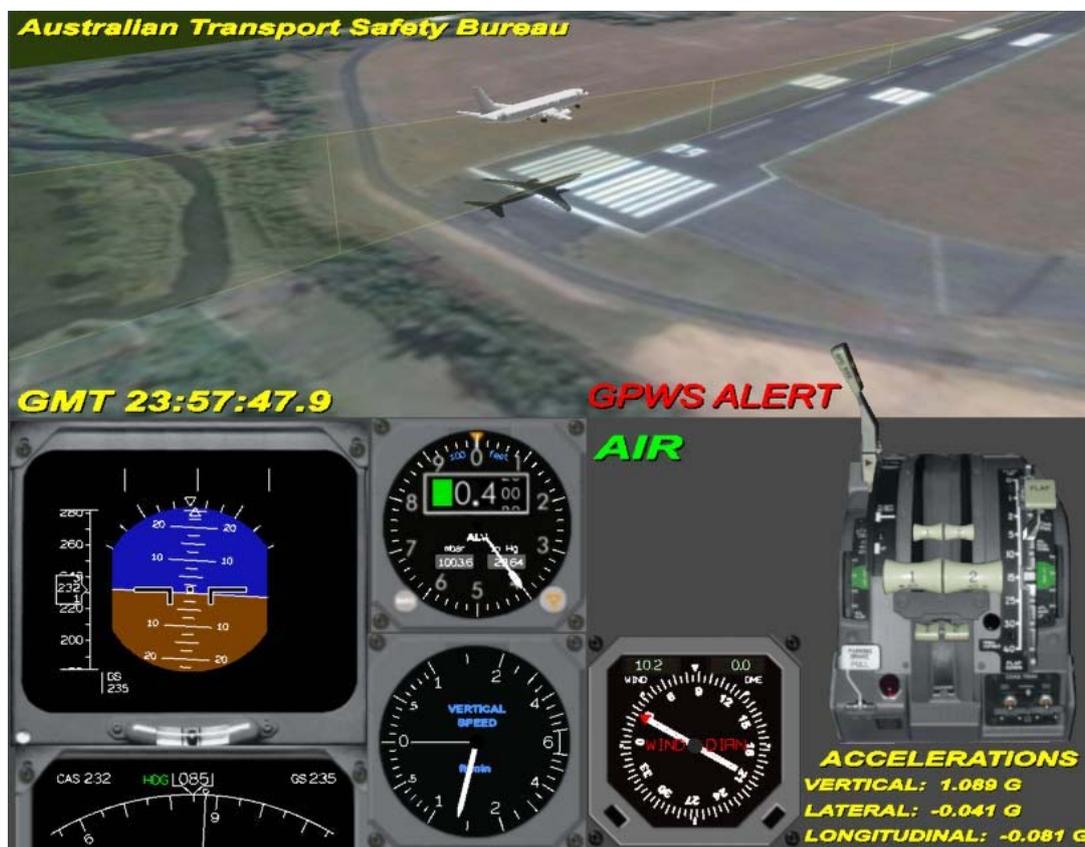
Figure 14: Picture taken from the SSFDR animation

- The copilot called ‘Wah Capt, go around Capt’.
- 23:57:47 Seven seconds before touchdown, the rate of descent was 1,400 feet per minute and decreasing. The aircraft crossed the runway 09 threshold (Figure 14) 89 feet above the ground (704 feet pressure altitude), at an airspeed of 234 knots (groundspeed of 236 knots).

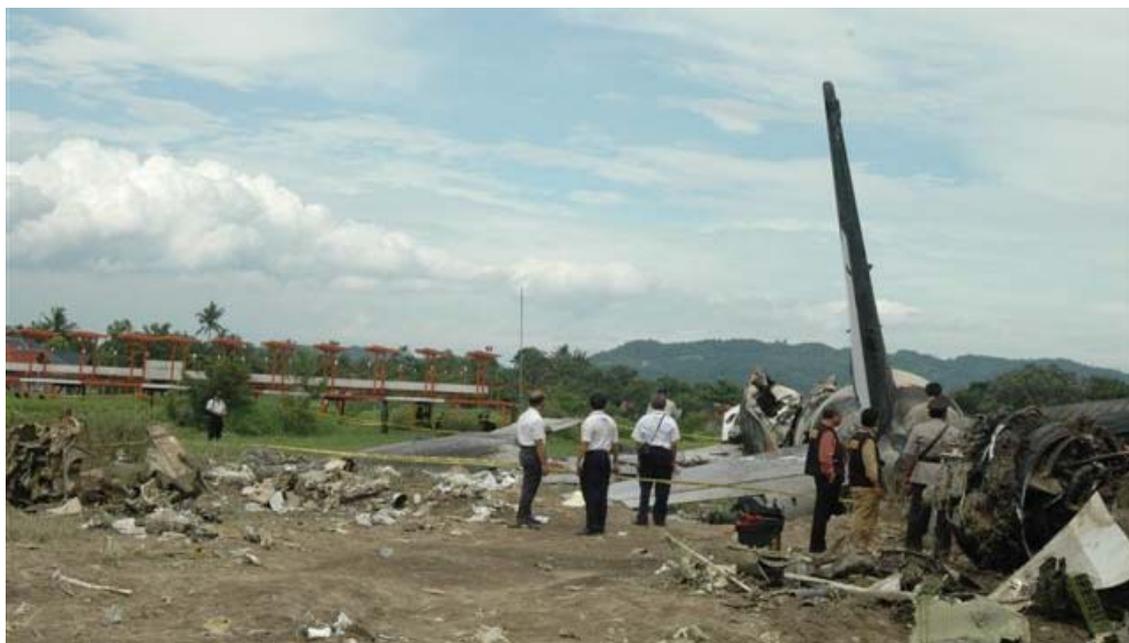
**Figure 16: Runway approach lights adjacent to the accident site**

The accident site was located in a rice field about 252 meters beyond the departure end of Yogyakarta Adi Sucipto runway 09. It was an open field with airport approach lighting infrastructure. The aircraft stopped adjacent to the runway approach lights, and to the right of the runway extended centerline. The approach lights were not damaged (Figure 16).

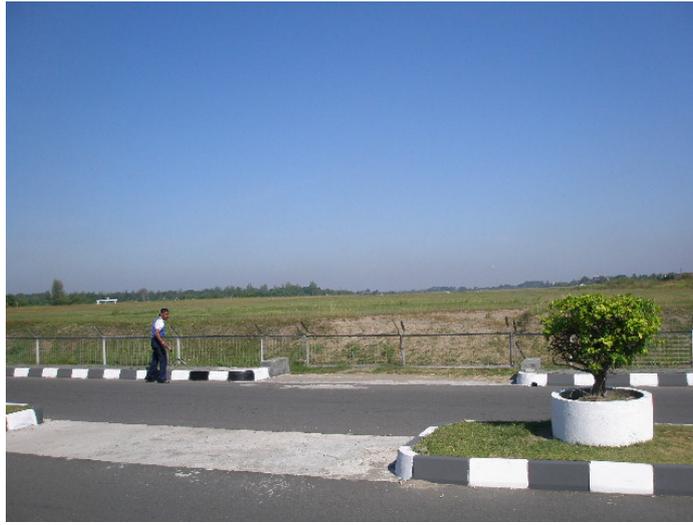
**Figure 22: Access road from runway across urban road. View towards the runway**

Since the accident on 7 March 2007, the Yogyakarta airport operator constructed an access road between the airport perimeter and the rice field where the accident occurred. The road is along the flight path of arriving and departing aircraft using the Yogyakarta runway and crosses an urban road. It covers two ditches and passes through a median strip on the road (Figure 22 and Figure 23).

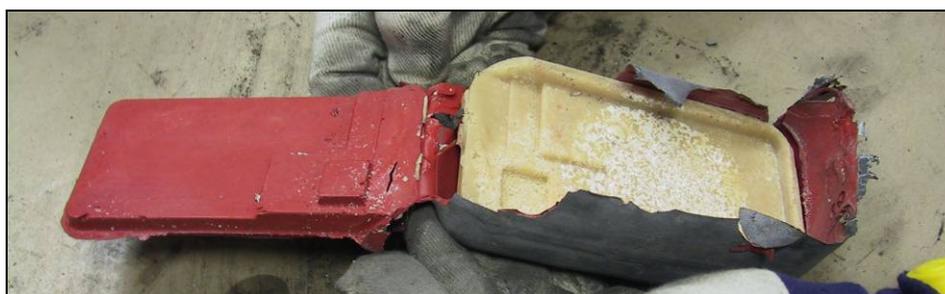
**Figure 3: Memory board from PK-GZC SSFDR**

The memory board was carefully removed from the CSMU on 09 March 2007 (Figure 3).

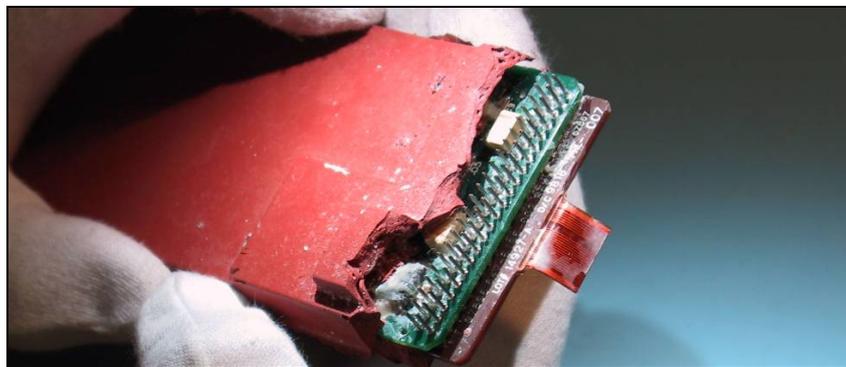
**Figure 5: Connector pins and cable prior to download**

The memory board connector pins were cleaned and the flex cable replaced (Figure 4 and Figure 5)

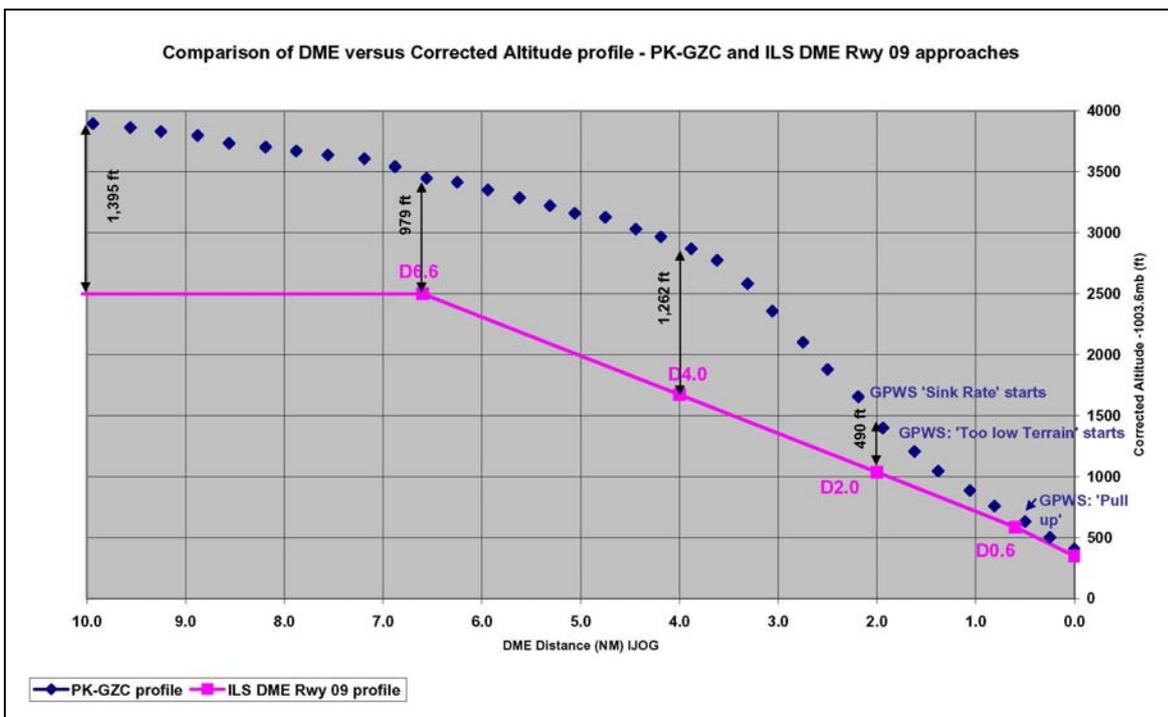
**Figure 7: Yogyakarta runway 09 approach showing DME vs corrected altitude profile of PK-GZC and ILS DME approach plates**

At the intermediate fix (IF) 10.1 DME IJOG (3.5 DME JOG) PK-GZC corrected altitude was 3,927 feet. The aircraft passed the final approach point (FAP), 6.6 DME IJOG, passing JOG VOR, approximately 950 feet above the approach plate altitude (2,500 feet) to commence the 3 degree glideslope. At D4.0 IJOG, PK-GZC was at 2,935 feet, 1,262 feet above the glideslope (1,673 feet). At D2.0 IJOG, PK-GZC was at 1,527 feet, 490 feet above the glideslope (1,037 feet). PK-GZC attained the glideslope at approximately 0.5 DME IJOG.

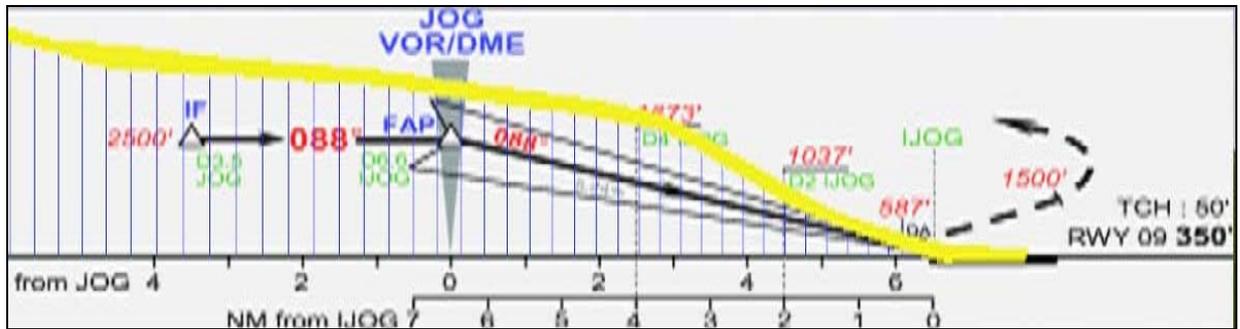
**Figure 8:** Screenshot of the animated PK-GZC flight path (blue) over the Garuda Yogyakarta approach plate (elevation view)

The approach flight path was derived using the groundspeed, drift angle, heading and corrected altitude. An elevation profile view of the flight path was overlaid on the Garuda JOG approach plate using Insight animation (Figure 8). The PK-GZC approach profile was considerably higher than the 3 degree glideslope approach profile.

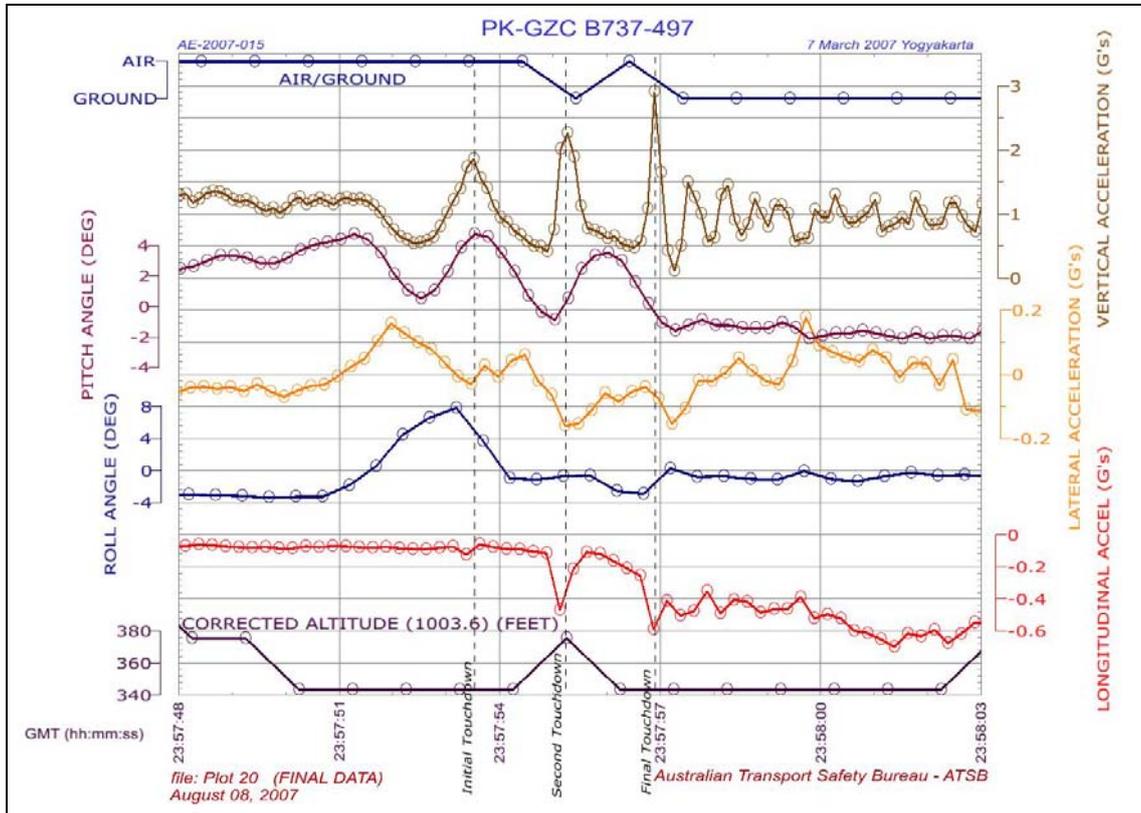
**Figure 10: Graphical representation of 15-second touchdown period**

The final touchdown time was considered to be coincident with the +2.91 g vertical acceleration peak at 23:57:57. At this time the aircraft pitch angle was recorded as 3.5 degrees and decreased to -1.1 degree over the following second. This was considered to be the time when the nose wheel of the aircraft separated and the nose gear commenced contact with the runway surface (nose wheel separation section 2.9). The physical evidence/damage, attributed to the landing of PK-GZC, was noted during the inspection of Yogyakarta runway 09 on 10 March 2007. The nose landing gear scrape mark commenced at chainage marking 222 (1,100m from runway 09 threshold).

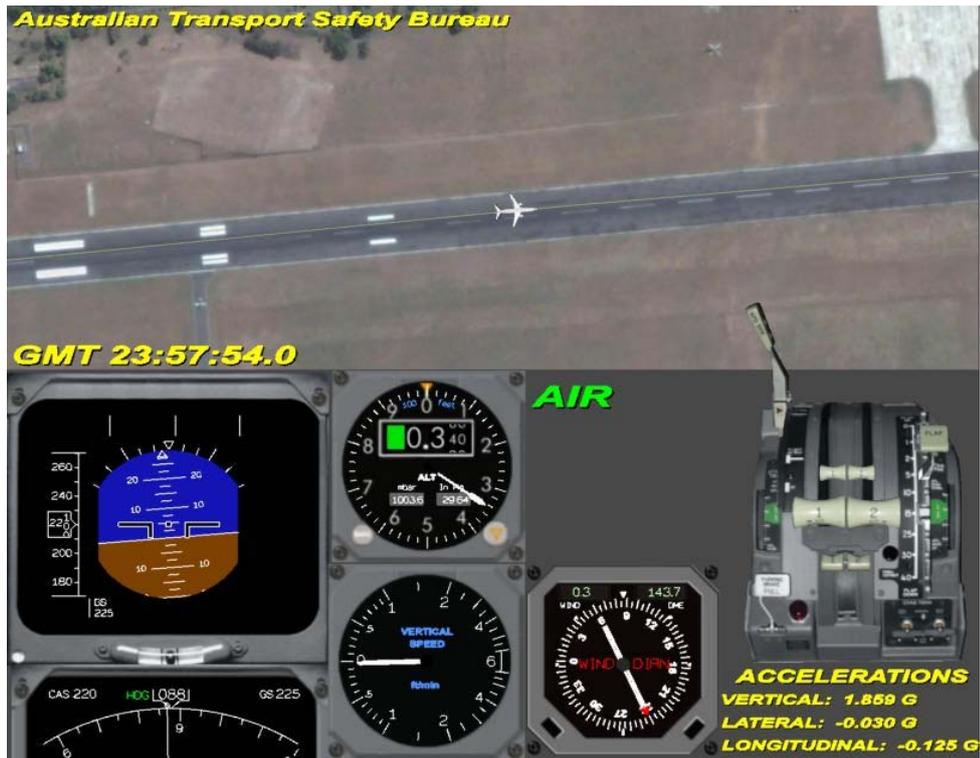
**Figure 11: Initial touchdown location (+1.86G)**

The initial vertical acceleration peak of 1.86g although not resulting in a GROUND activation, was consistent with a sudden roll direction change of eight degrees over two samples (Figure 12). The vertical acceleration spike corresponding with a roll rate greater than 8 degrees/second and direction change indicated that a touchdown had occurred at this time.

The initial touchdown was further along the runway than the touchdown zone for runway 09. The animation touchdown locations matched both the calculated touchdown points and physical evidence observed on the runway considered to be associated with PK-GZC accident landing.

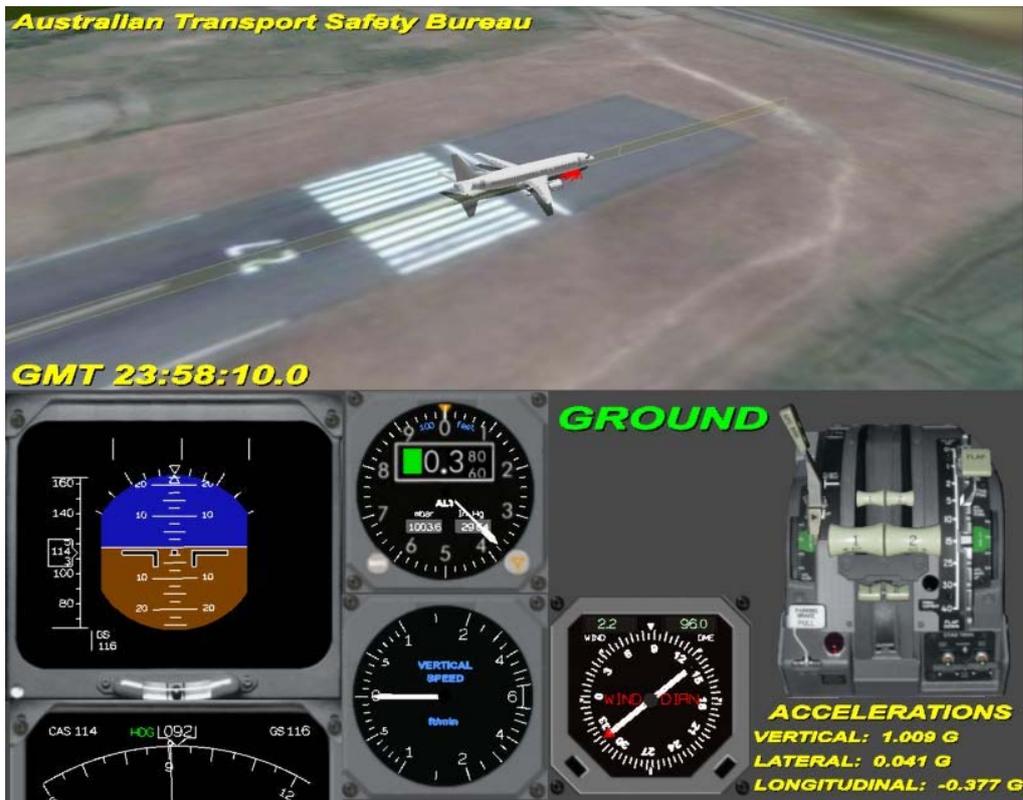
**Figure 16: Flight path animation of aircraft passing over runway 27 threshold line**

The flight path animation indicated that the aircraft passed the threshold line marking of runway 27 at 23:58:10 (Figure 16). Table 4 gives a distance of approximately 2,220 meters to this point which equates closely to the published runway length of 2,200 m between threshold marks. Jeppesen Chart relating to Yogyakarta, JOG ADI SUTJIPTO<sup>24</sup>, shows a stopway distance of 60 meters on the far end of runway 09 giving a total distance from the 09 threshold to the end of the stopway of 2260 meters.

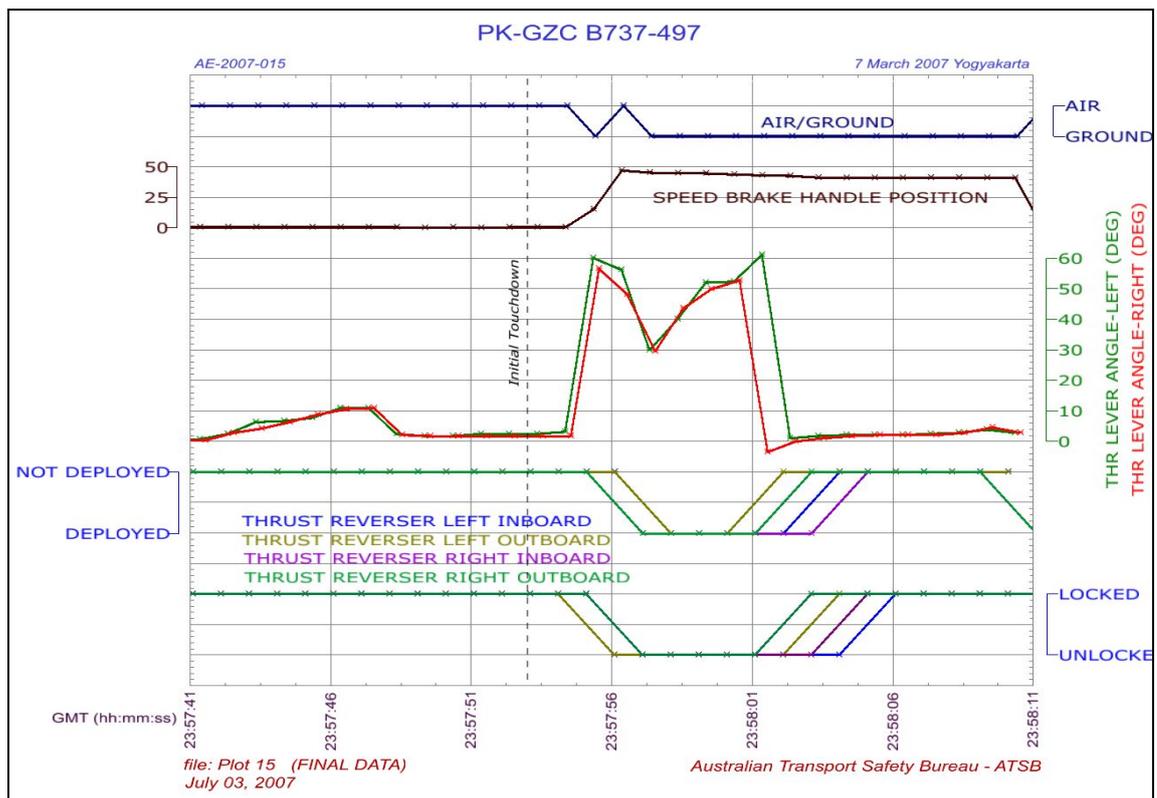
The recorded flight data indicated that only the right thrust reverser was used on the previous two landings. Further examination found that only the right thrust reverser had been used for the previous 27 sectors. This indicated that the left thrust reverser was unserviceable for a considerable number of flights immediately prior to the accident flight.

However the recorded data showed that both engines’ thrust reversers were deployed at 23:57:58, 4 seconds after the touchdown. They were stowed at 23:58:05 approximately seven seconds prior to the aircraft departing the paved runway.
