Final Report by the Aircraft Accident Investigation Bureau

concerning the serious incident

to the Gulfstream IV aircraft, A6-HHH

on 15 August 2003

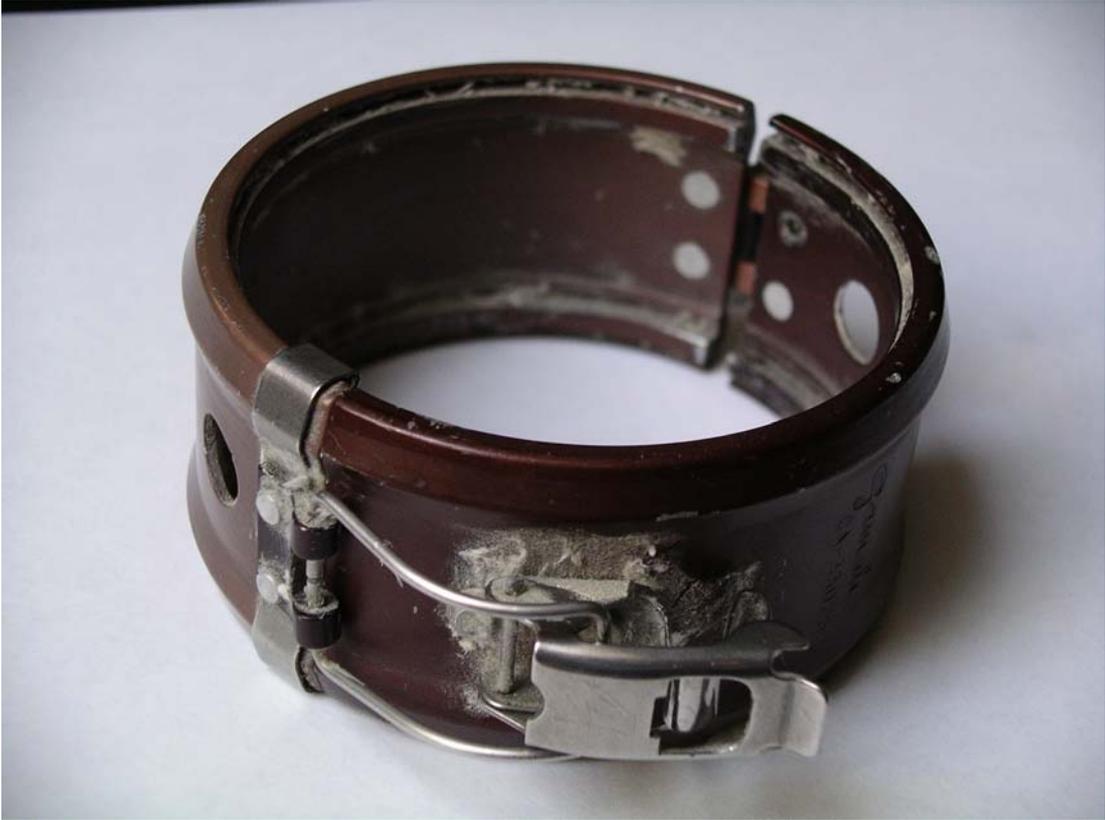
Picture 3

- As a result of this clamp breaking, the two sections of the wing anti-ice duct, which carry hot bleed air from the left engine compressor to the leading edge of the left wing, became separated (Picture 3).

The rise in cabin floor temperature is attributable to the failure of a clamp. The hot air escaping from the wing anti-ice duct caused local heating of the passenger cabin floor above.
