TECHNICAL REPORT

A-035/1998

Accident of aircraft Fairchild SA-227-AC "Metro III", registration number EC-FXD, in the municipal area of El Prat de Llobregat (Barcelona), on 28th July, 1998
(Issue 2)

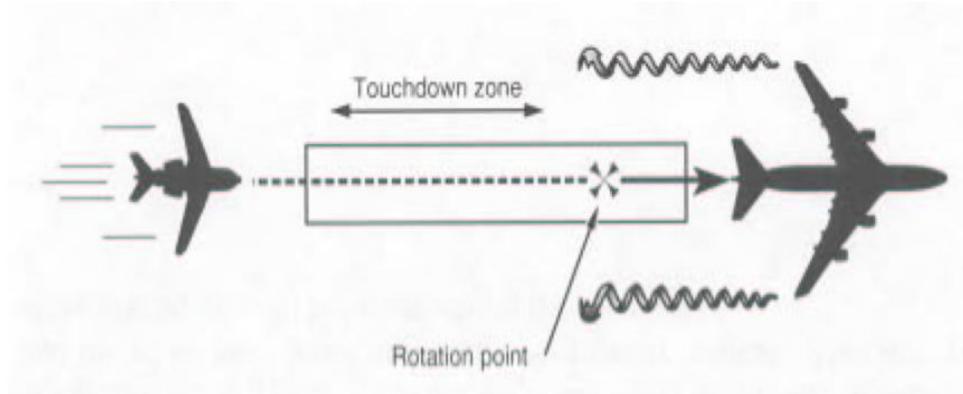
Figure 1.17.3.1 Landing zone to avoid the wake of the aircraft the takes off before

The rule that crews of light aircraft apply in practice to avoid being affected by the wake of a heavy departing aircraft, is to land well before the rotation point of the heavy aircraft (see Figure 1.17.3.1, copied from the FAA Advisory Circular 90-23F).
