Engine-intake Icing Sets Stage for Ditching of Shorts 360 During Cargo Flight

Snow likely entered unprotected engine air intakes when the twin-turboprop airplane was parked overnight facing into strong surface winds. Intake-airflow disruption resulting from the crew's selection of the intake anti-icing vanes during departure caused nearly simultaneous flameouts of both engines.

[FSF editorial note: This article, except where specifically noted, is based on the U.K. Air Accidents Investigation Branch report no. 2/2003 (EW/C2001/2/6): *Shorts SD3-60, G-BNMT, near Edinburgh Airport on 27 February 2001*. The 91-page report contains illustrations and appendixes.]

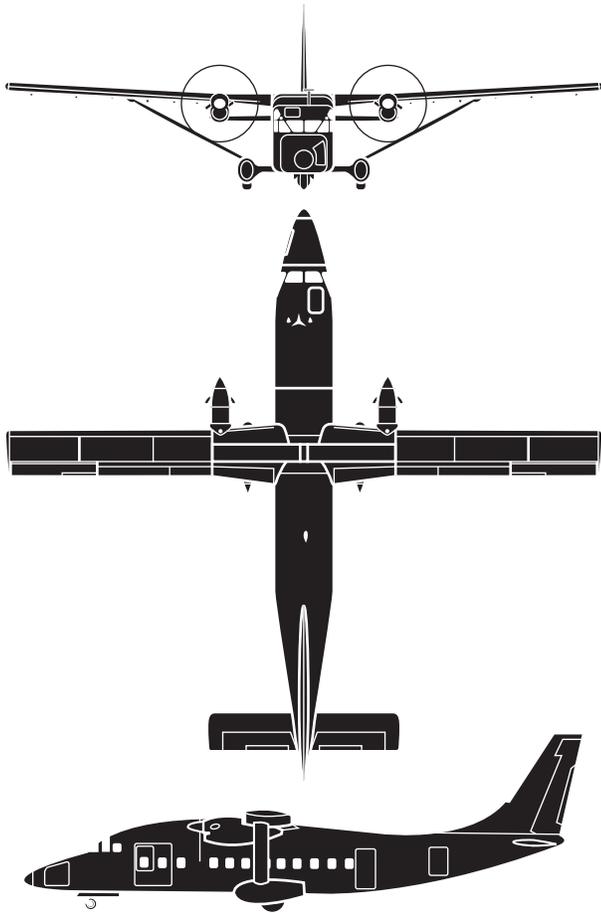
The Short Brothers SD3-60 (Shorts 360) is an unpressurized twin-turboprop short-range commuter/regional transport derived from the SD3-30 (Shorts 330), which first flew in 1973. The 330's twin vertical fins were replaced with a swept single vertical tail, the fuselage was lengthened 0.9 meter (3.0 feet) to accommodate six more passengers, and more powerful engines were installed. The 360 first flew in 1981, and deliveries began in 1982.
