Final Accident Report

Accident involving Sudan Airways Airbus 310

Registration ST-ATN

At Khartoum Airport

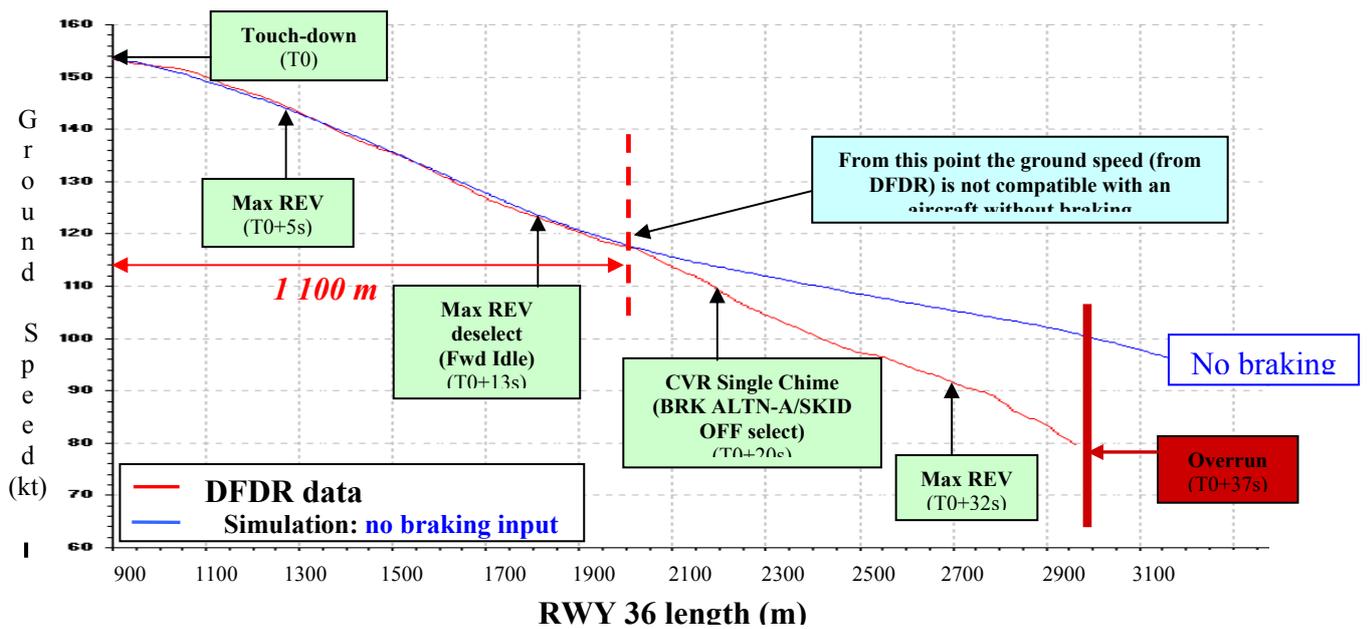
The blue curve was determined by simulation:

- For a rollout without braking inputs (runway braking friction coefficient, μ , not applicable),
- With thrust reverser 2 (RH) selected 5 seconds after touch-down and stowed 1800 meters after runway threshold (as for the event)

During the first 1 100 meters, the actual rollout matches with aircraft slowing down without braking.

After the first 1 100 meters, the actual rollout diverges from rollout without braking, which indicates that braking was effective

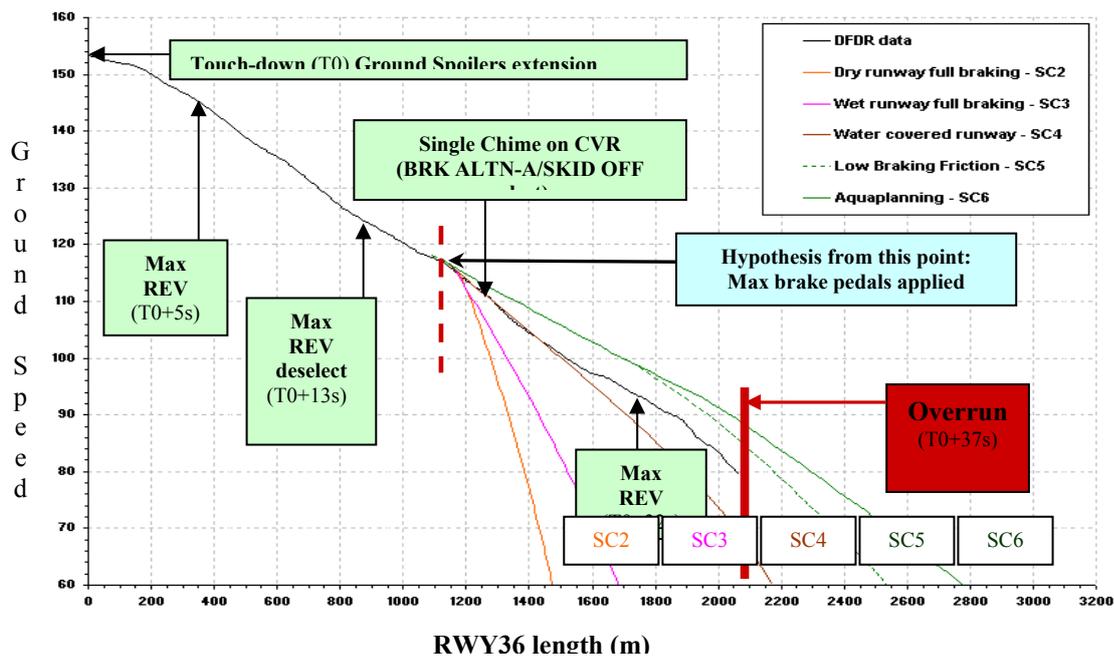
The **actual curve** (in black) is positioned between the **brown curve** (“water covered runway”) and the **dotted green** one (“low braking friction”).

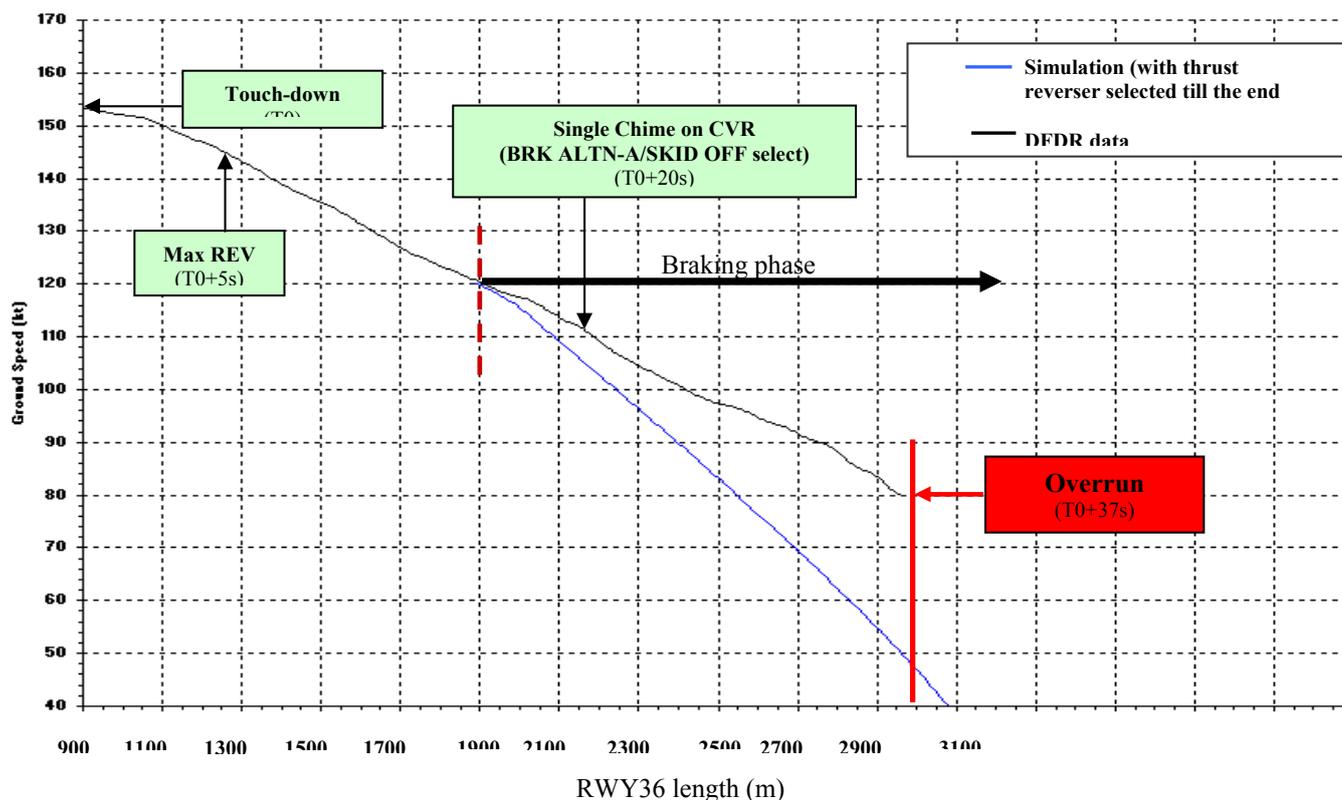
1.19.1.5 Breaking performance simulation n°3 (with one thrust reverser and full braking input)

- With full braking input (max pedals) applied 2 000 meters after runway threshold.
- With thrust reverser kept selected till the end.

- With $\mu=0.1$, corresponding to a runway with low braking friction coefficient.

In that case, the aircraft would have overrun the runway at about 48kt instead of 76kt.

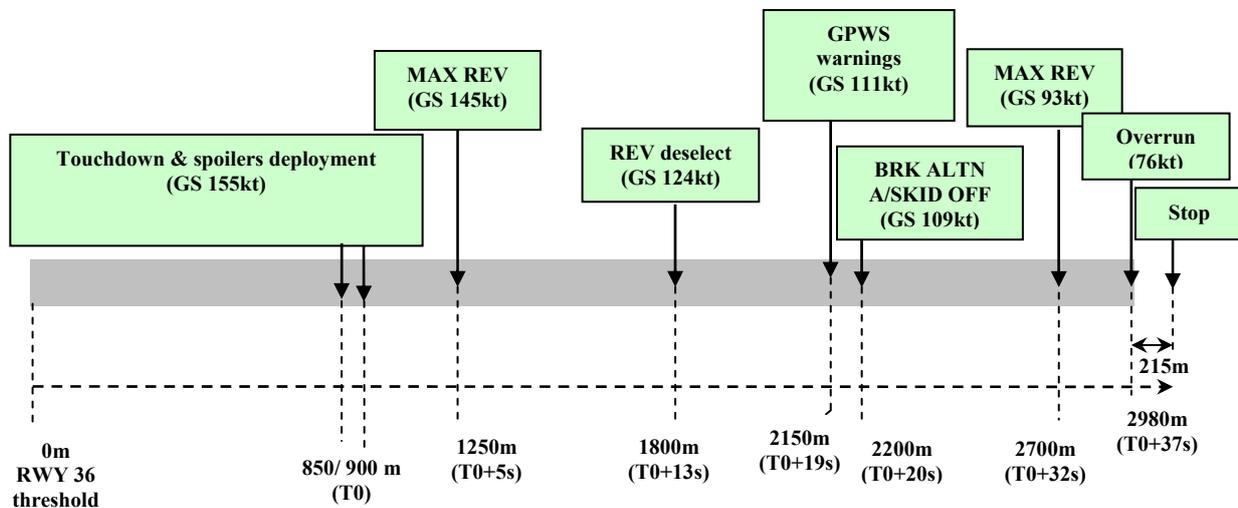
2.1. *Sequence of events*

According to the recorders analysis, the sequence of event was the following:

The captain was flying the aircraft. He complied with the control clearances and performed a stabilized approach. The CVR reading showed a good coordination between the Captain and the co-pilot.
