**Hard landing, inappropriate stopover maintenance procedure,
take-off with a substantially damaged aeroplane**

Aircraft	Airbus A330-211 registered F-GZCB
Date and time	13 April 2011 at 18 h 25 ⁽¹⁾
Operator	Air France
Place	Caracas-Maiquetía Simón Bolívar Airport (Venezuela)
Type of flight	Scheduled international public transport of passengers
Persons on board	Captain (PF), copilot (PNF), copilot (relief), 10 cabin crew, 202 passengers
Consequences and damage	Aeroplane substantially damaged

This is a courtesy translation by the BEA of the Final Report on the Safety Investigation. As accurate as the translation may be, the original text in French is the work of reference.

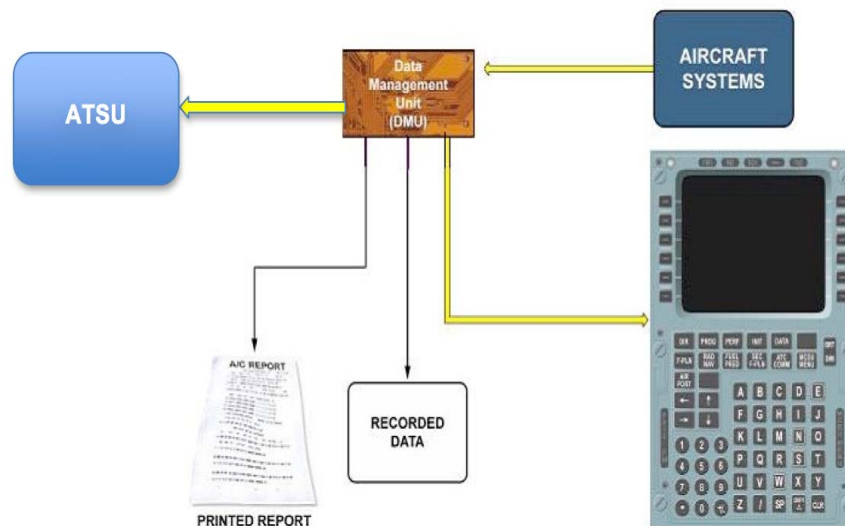
On 13 April, no R15 report relating to the hard landing had been received by the MCC. The last R15 found via the MCDU was dated 21 March 2011. An R15, generated by the DMU on 13 April, at 18 h 55 min 26 had been sent on 14 April at 21 h 14 min 02, or the day after the Paris - Caracas flight, at the beginning of the breakdown action. It is likely that the R15 associated with the last flight was not available at the time of the technicians’ operations.

Two malfunctions occurred during these flights:

- The DMU did not issue a R15 report immediately after the hard landing, yet the conditions to generate it were met;
- No R15 report associated with the last flight was available on the page of the ACMS menu of the MCDU.
