**SERIOUS INCIDENT**

<b>Aircraft Type and Registration:</b>	Airbus A330-343, G-VKSS
<b>No &amp; Type of Engines:</b>	2 Rolls-Royce RB211 Trent 772B-60 turbofan engines
<b>Year of Manufacture:</b>	2011 (Serial no: 1201)
<b>Date &amp; Time (UTC):</b>	19 January 2013 at 2333 hrs
<b>Location:</b>	On departure from Orlando International Airport, USA
<b>Type of Flight:</b>	Commercial Air Transport (Passenger)
<b>Persons on Board:</b>	Crew - 14                      Passengers - 311
<b>Injuries:</b>	Crew - None                      Passengers - None
<b>Nature of Damage:</b>	Damage to both engines, leading edges and radome
<b>Commander's Licence:</b>	Airline Transport Pilot's Licence
<b>Commander's Age:</b>	48 years
<b>Commander's Flying Experience:</b>	13,850 hours (of which 128 were on type) Last 90 days - 135 hours Last 28 days - 75 hours
<b>Information Source:</b>	AAIB Field Investigation

**Synopsis**

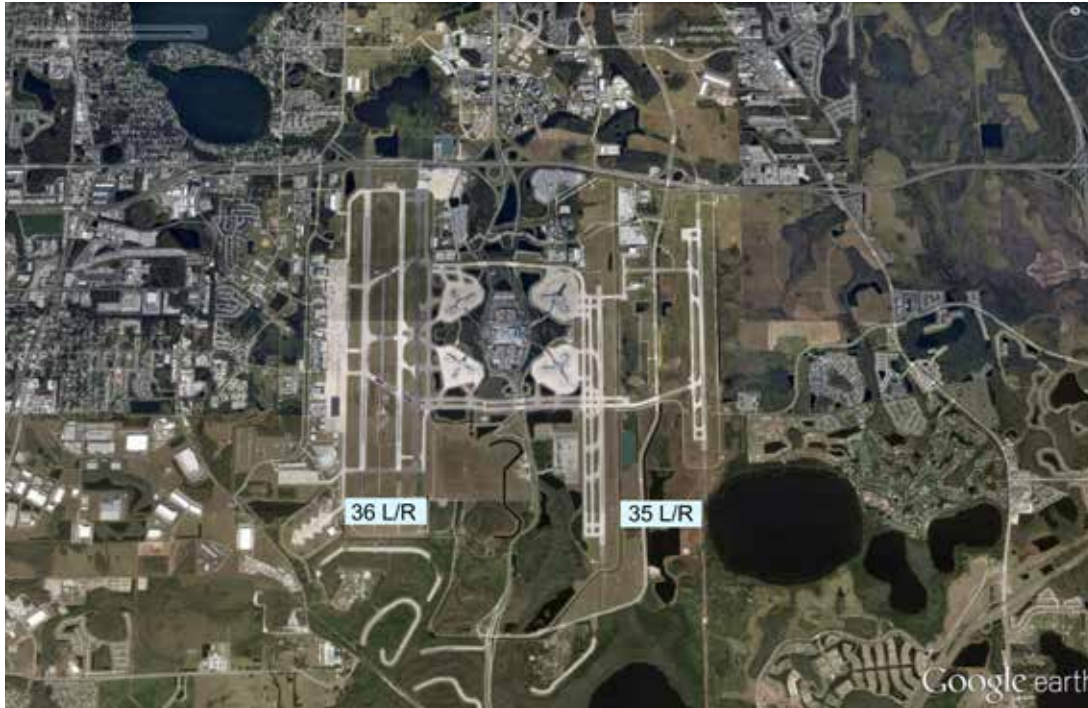
**Figure 1**

During 2011 there were 317,020 aircraft movements. 115 aircraft were struck by birds of which arriving aircraft accounted for 72% of the strikes. The majority of strikes (44%) occurred on Runway 17L/35R, 22% on Runway 17R/35L, 22% on Runway 18L/36R and 12% on 18R/36L. Approximately 66% occurred on the eastern airport complex which is considerably less developed than the western complex (Figure 1).

Orlando International Airport
