ATSB TRANSPORT SAFETY REPORT
Aviation Occurrence Investigation
AO-2009-027
Final

In-flight fire
427 km south-west of Guam
10 June 2009
Airbus A330-202
VH-EBF

In-flight fire – 427 km south-west of Guam – 10 June 2009 – Airbus A330-202 – VH-EBF

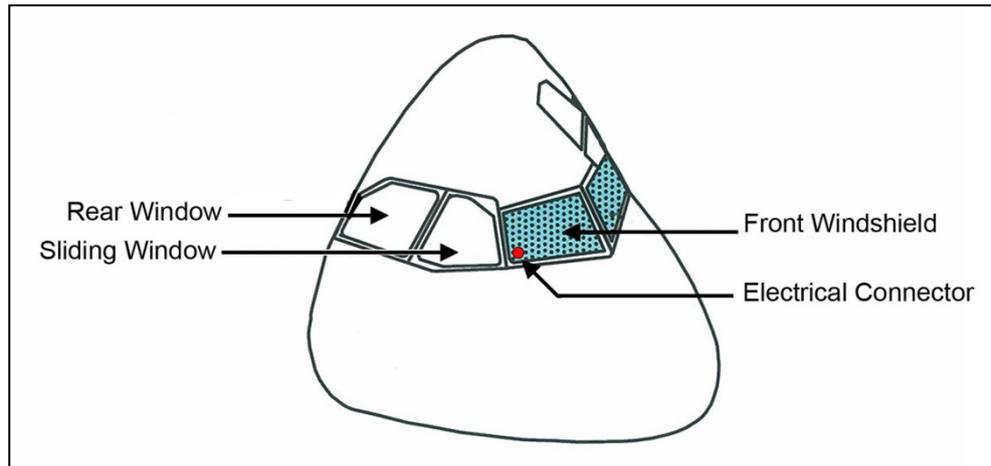
Figure 2: A330 window configuration

The aircraft's cockpit was equipped with two forward windshields, two fixed windows and two sliding windows (Figure 2). The aircraft's windshield anti-icing and defogging system was designed to enable clear visibility in icing or fogging conditions. Window heating was automatically activated upon first start-up of the aircraft's engines (left or right) and stopped at the last engine shutdown. The crew could also control the operation of the window heat by using a pushbutton switch⁶ to override the automatic operation of the system and apply continuous full heating.
