SERIOUS INCIDENT

Aircraft Type and Registration:	Airbus A340-313, G-VAIR
No & Type of Engines:	4 CFM56-5C4 turbofan engines
Year of Manufacture:	1997
Date & Time (UTC):	27 April 2008 at 0218 hrs
Location:	Nairobi Airport, Kenya
Type of Flight:	Commercial Air Transport (Passenger)
Persons on Board:	Crew - 14 Passengers - 108
Injuries:	Crew - None Passengers - None
Nature of Damage:	Minor scratches to left aft lower fuselage
Commander's Licence:	Airline Transport Pilot's Licence
Commander's Age:	49 years
Commander's Flying Experience:	14,250 hours (of which 9,667 were on type) Last 90 days - 108 hours Last 28 days - 41 hours
Information Source:	AAIB Field Investigation

Synopsis

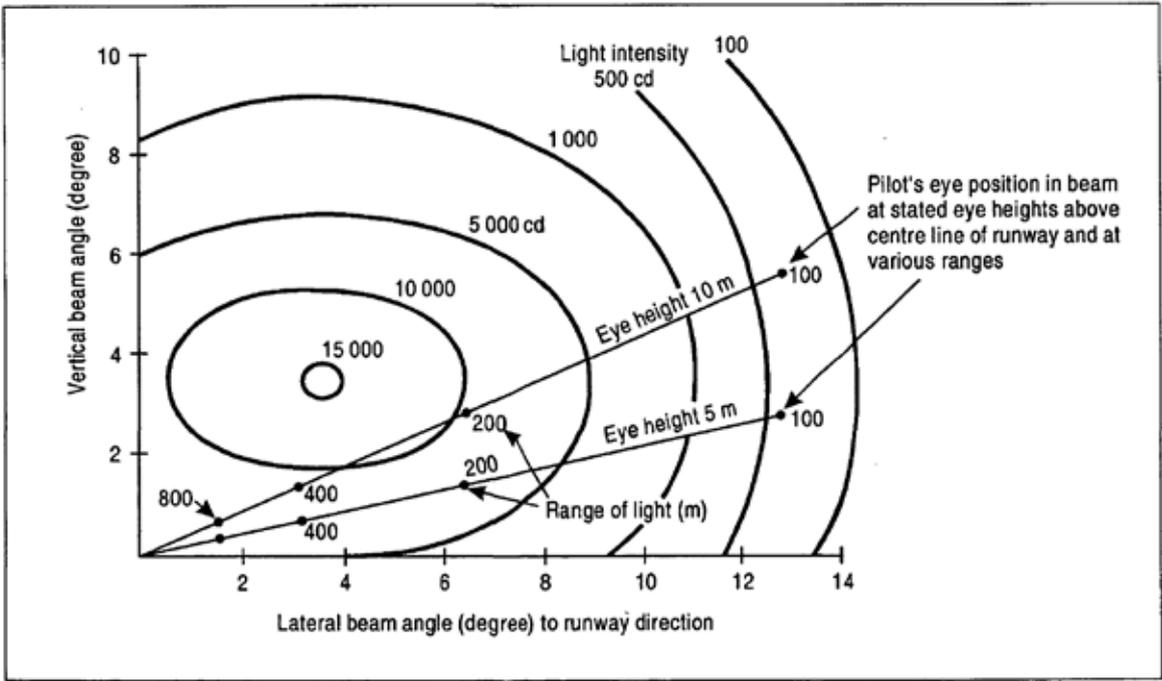
Figure 9

ICAO Annex 14 specifies characteristics of each type of runway light in terms of isocandela diagrams (Figure 9 refers) which define the required beam shape and intensity. Annex 14 also specifies required colour and setting angles of the emitted light and maintenance performance levels for individual fittings and overall serviceability of a lighting system. Any individual light fitting is deemed unserviceable when the light intensity is less than 50% of specification.

Isocandela diagram for a runway edge light taken from ICAO Manual of Runway Visual Range Observing and Reporting Practices, Third Edition 2005. (Doc 9328 AN/908)
