NATIONAL TRANSPORTATION SAFETY BOARD

Interim Factual Report

NTSB Case Number: DCA13IA037
Location: Boston, Massachusetts
Date: January 7, 2013
Aircraft/Operator: Boeing 787-8, JA829J, Japan Airlines

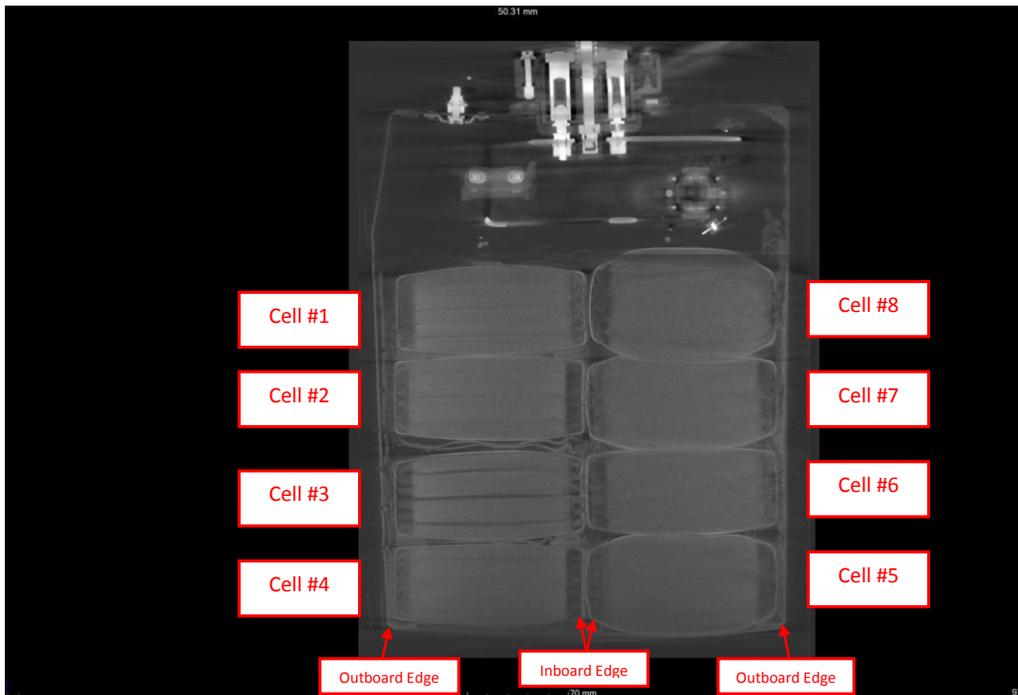
Figure 15. Cross-sectional view of the auxiliary power unit battery.

The CT scans for the main battery showed no anomalies outside the cells. The CT scans for the APU battery showed that (1) several cells were distorted and had an expanded or contracted profile, (2) several current collectors inside the cells were separated, (3) some current collector fingers were out of their designed alignment,³⁶ and (4) a breach of the battery case corresponded with a breach of the cell wall in cell 5. A CT scan of the APU battery is shown in figure 15.
