In-Flight Inferno

BY MARK LACAGNINA

This article is based on the English translation of Republic of Korea Aircraft and Railway Accident Investigation Board Aircraft Accident Report ARAIB/AAR1105, “Crash Into the Sea After an In-Flight Fire, Asiana Airlines, Boeing 747-400F, HL7604, International Waters 130 km West of Jeju International Airport, 28 July 2011.” The report is available at <araib.go.kr>.

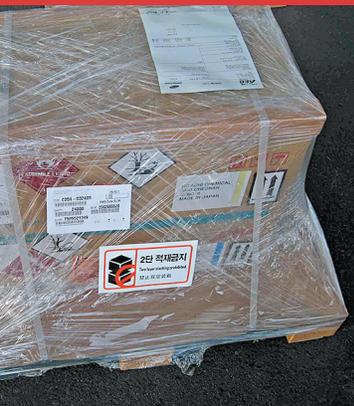
Areas of the main cargo deck near the dangerous-goods pallets had "shattered into many pieces due to dangerous goods' explosive energy," the report said. Residues of the flammable liquids and paint were found on the upper surface of the right wing, and small electronic devices packaged among the cargo were found embedded in composite wing structures.

The energy that caused this "was generated by fire-induced explosion of flammable materials and lithium-ion batteries," the report said. "The ARAIB assumes that a fire likely broke out first on or near the pallets containing the dangerous goods, but physical evidence of the cause of the fire was not found."
