Investigation Report

Type of Occurrence:	Serious incident
Date:	19 December 2010
Location:	Köln/Bonn
Aircraft:	Airplane
Manufacturer / Model:	Airbus / A319-132
Injuries to Persons:	Two persons with minor injuries
Damage:	None
Other Damage:	None
Information Source:	Investigation by BFU
State File Number:	BFU 5X018-10

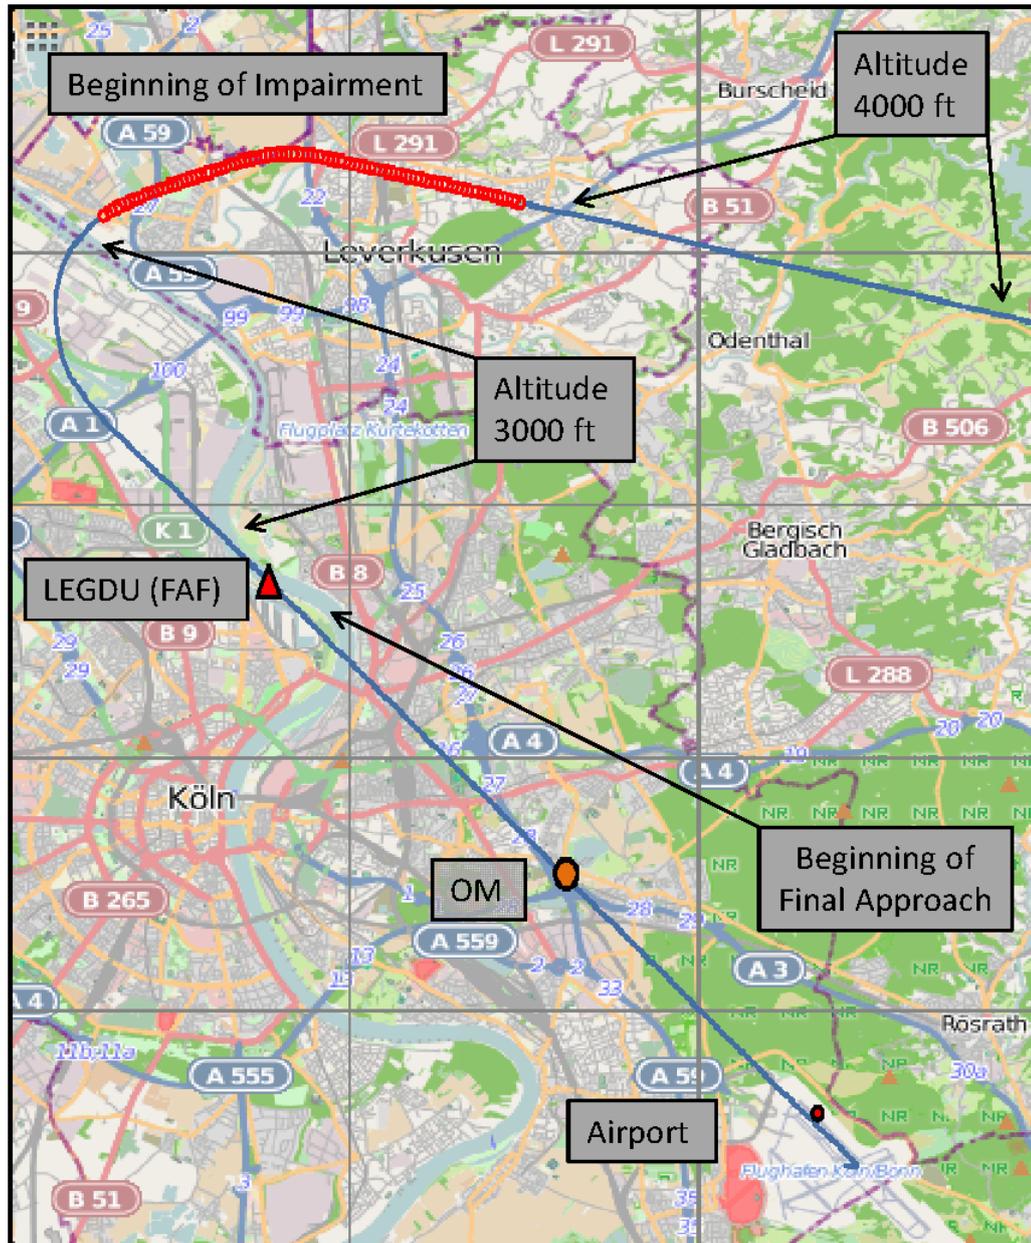
Image 1: Flight path

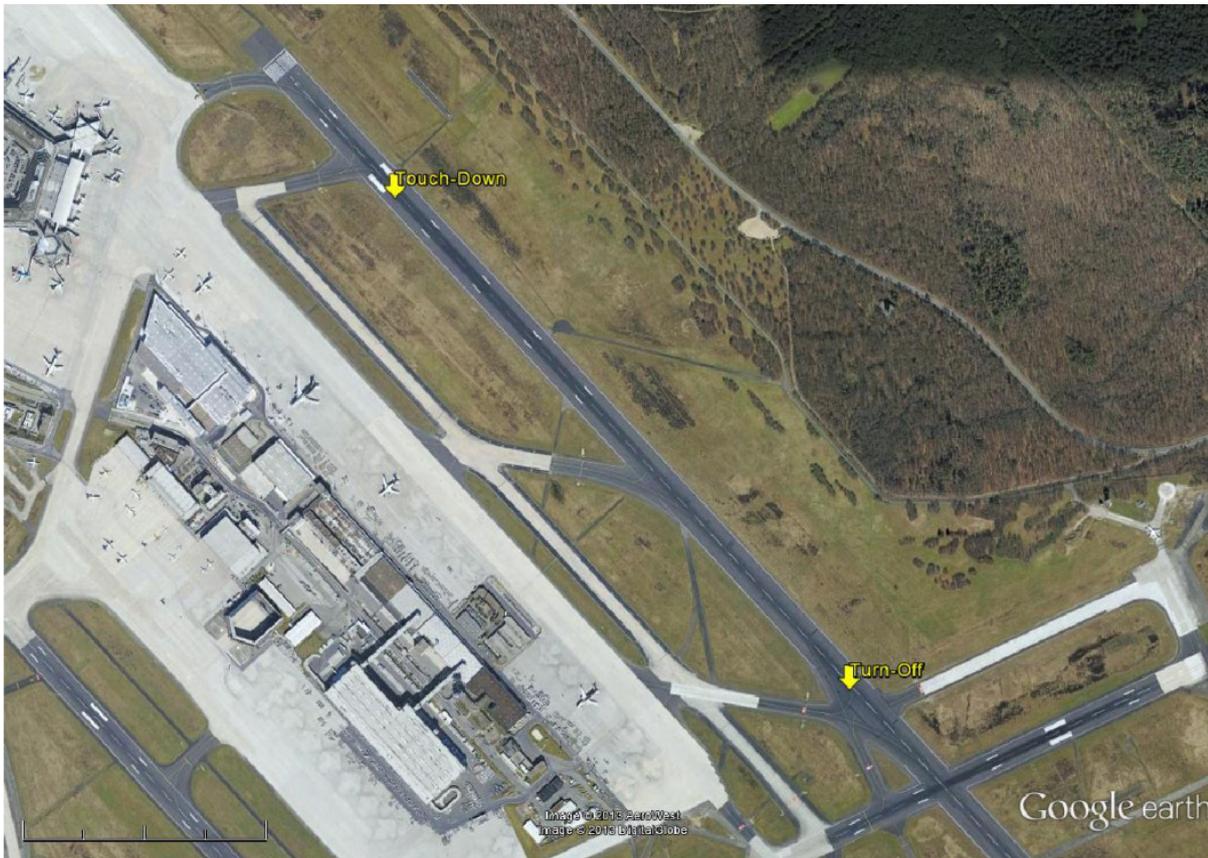
The airplane touched down at 2134 hrs with a ground speed of 135 kt, about 365 m (1,200 ft) behind the threshold and used autobrake. According to the PIC at a speed of about 40 kt he began to brake manually. Forty seconds after touch-down, after about 1,300 m, the aircraft left runway 14L with a ground speed of about 10 kt and entered taxiway A3.

Image 2: Touch-down and turn-off point of the airplane based on the QAR data

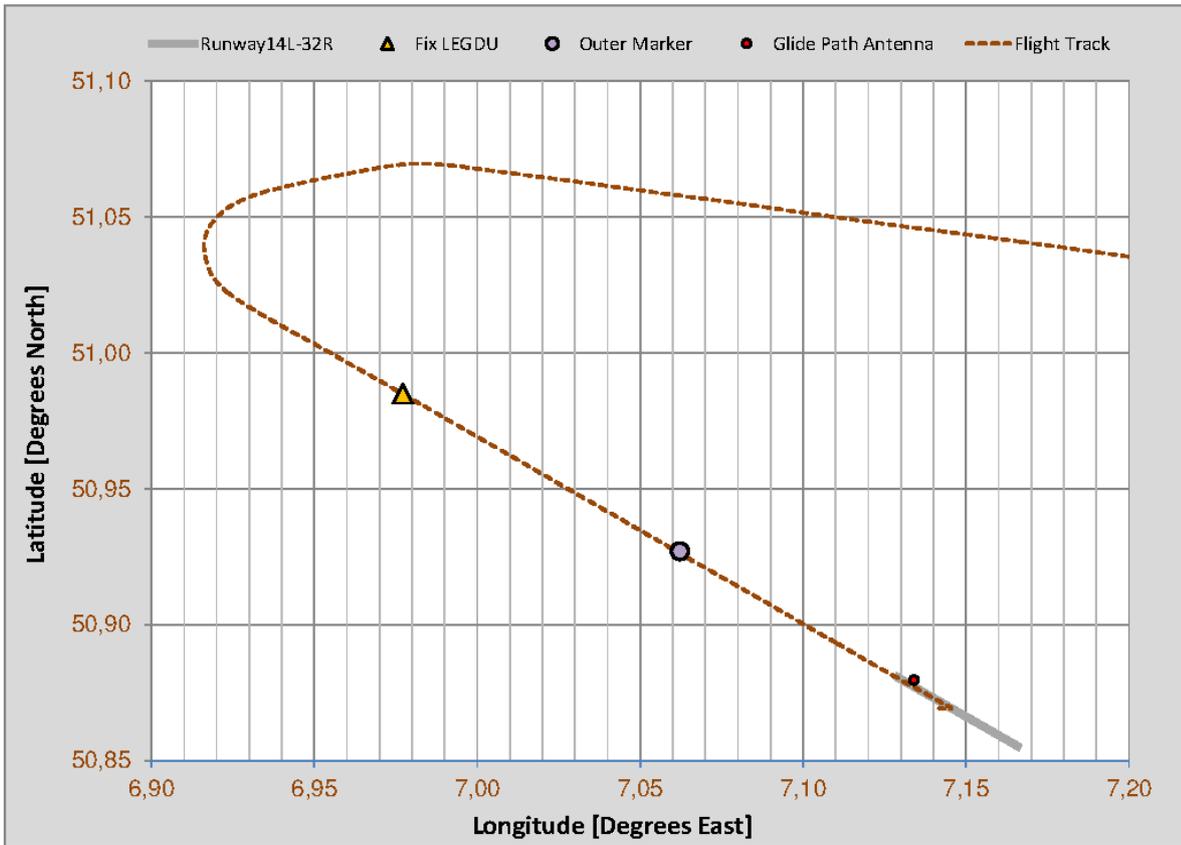
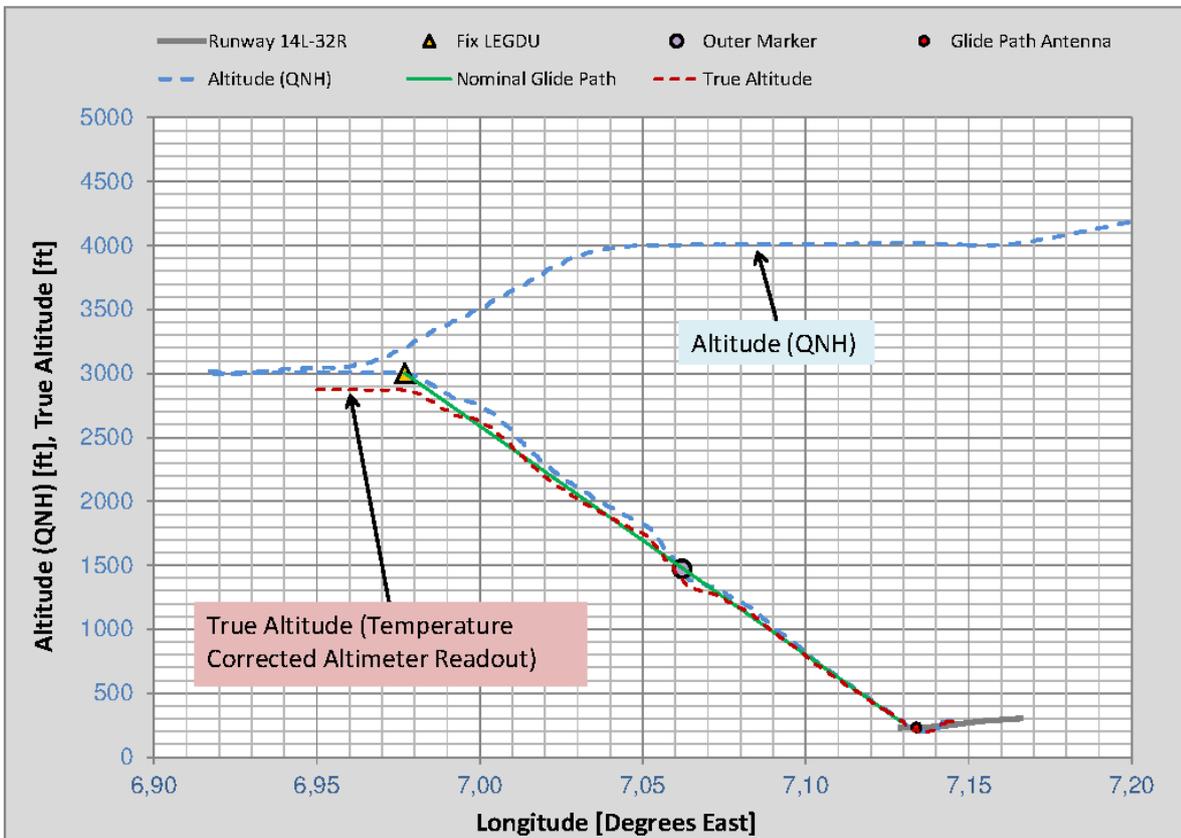
Image 3: Reconstructed flight path

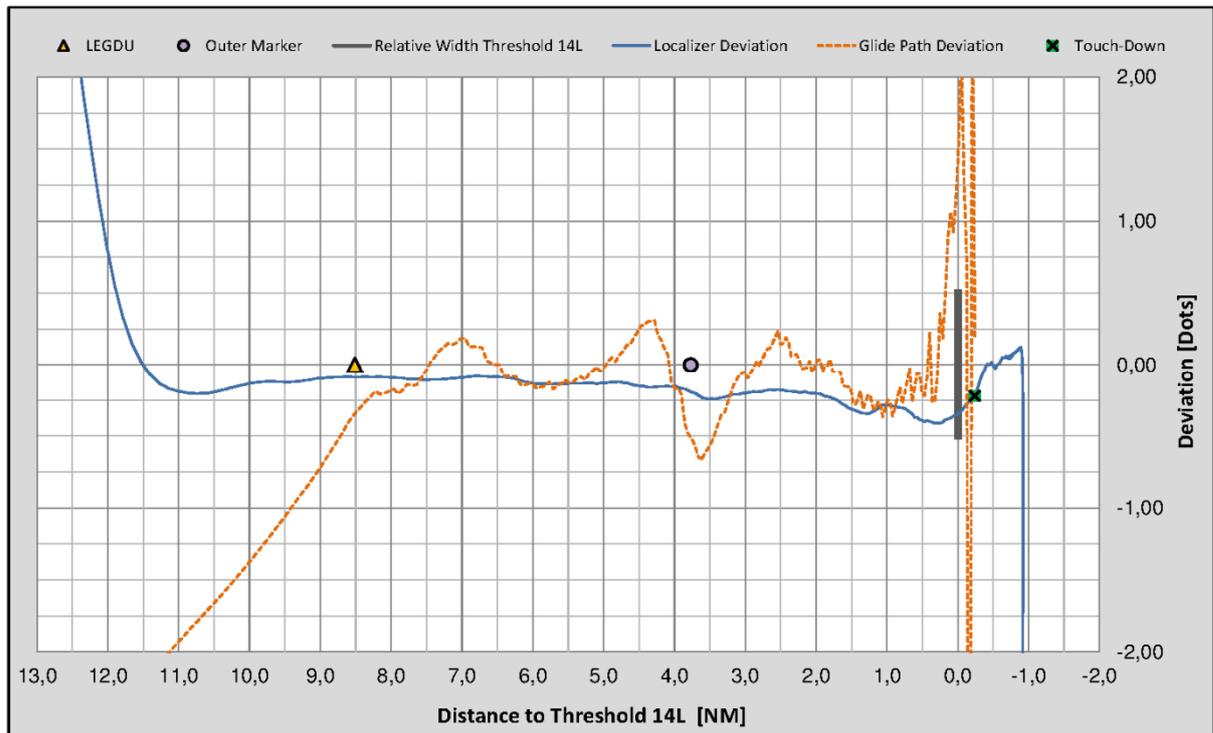
During the entire approach the runway heading did not show any abnormalities. The glidepath did not show any instability. The determined short-term deviations from the glidepath by about 8 - 7 NM and 5 - 3.5 NM prior to touch-down were very likely due to the change in configuration (flaps, landing gear) and speed.

Image 10: Deviation from the runway heading and the glidepath

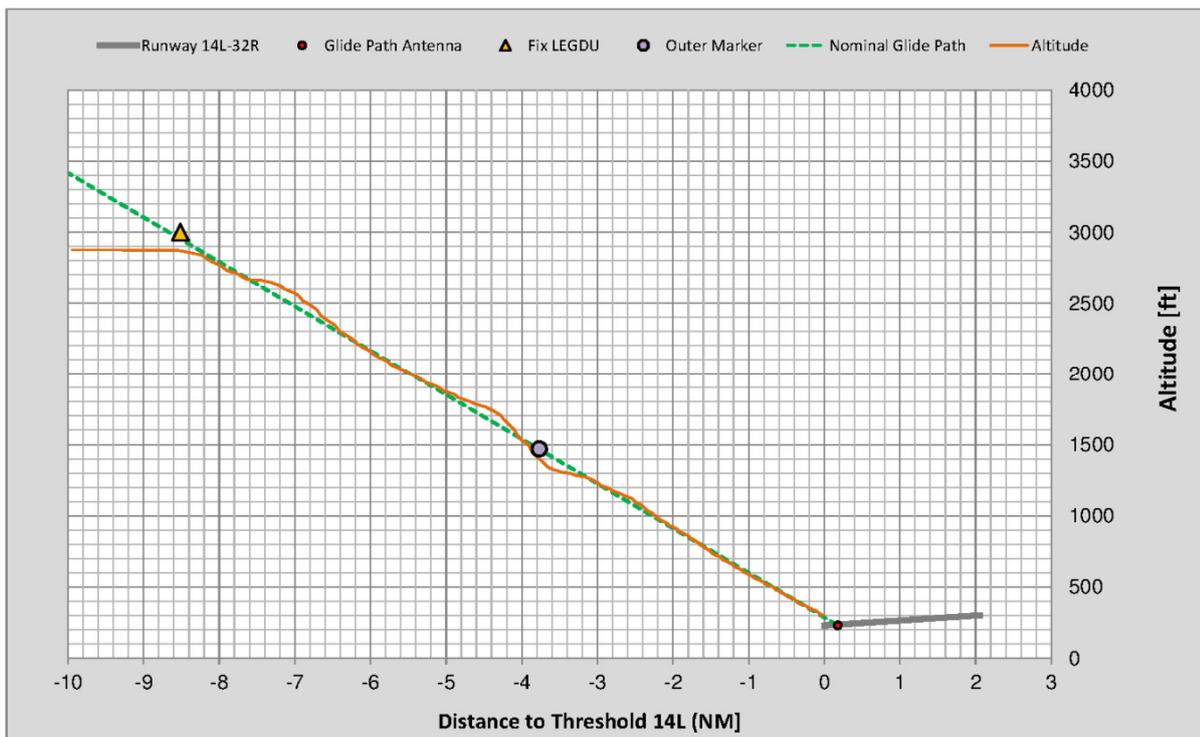
An assessment if the indicated airspeed met the criteria for a stabilised approach (+10 kt, -5 kt) while passing 1,000 ft was only possible to a limited extent.

Because the touchdown occurred in the normal area of the runway and the fact that the airplane could leave the runway after about 1,600 m indicated that the speed during short final and touch-down was adequate.

Image 11: Approach as vertical profile
