## ***Report RL 2008:01e***

**Aircraft incident to SE-DSP in airspace  
south-west of Stockholm, AB county,  
Sweden, on 22 March 2007.**

Case L-04/07

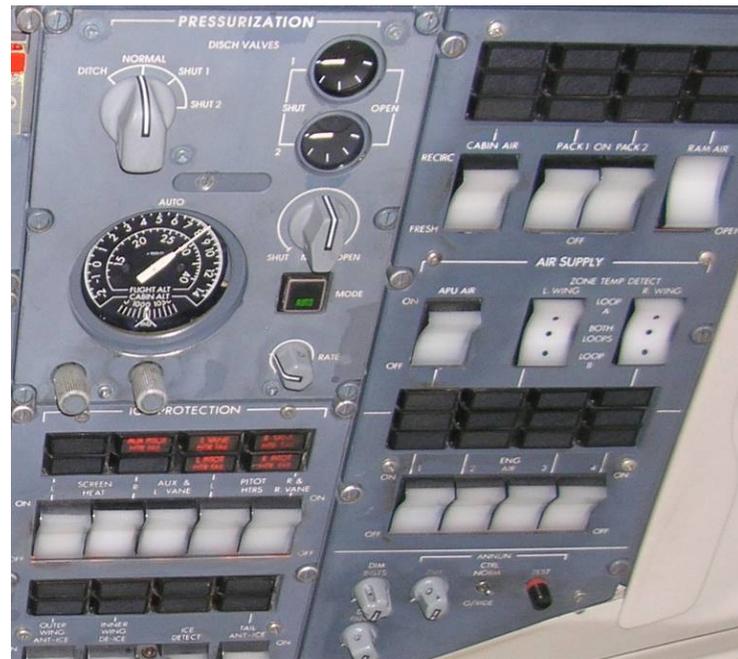
Fig. 1

The system is controlled by the pilots from two control panels located on the overhead panel the cockpit. From there the pilots can select the source

of the cabin air, activate the packs and set the desired cabin pressure and temperature. See fig. 1.

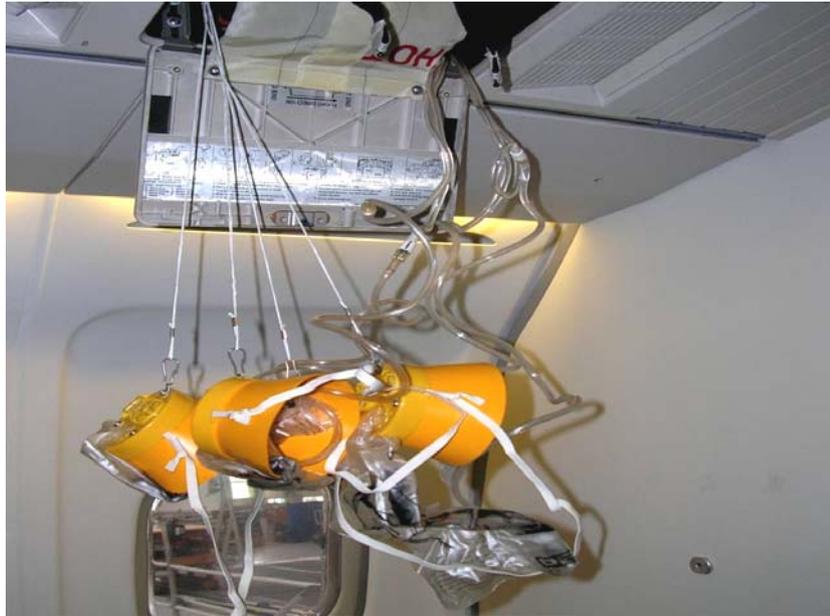
*Fig. 2*

This type of aircraft has an oxygen system that can provide passengers with oxygen if an abnormal loss of pressure occurs during flight. The system consists of individual oxygen masks that are stowed behind hatches in the ceiling panel above the passenger seats. If during flight the pressure in the cabin falls below that normally applicable at  $13\,250 \pm 250$  feet, the hatches should open automatically so that the oxygen masks drop down above the passenger seats. The system is controlled by a pressure sensor in the cabin (Aneroid Switch). The prescribed interval for functional checking of the sensor is 10 000 flights, which is equivalent to about five flying years with this company.

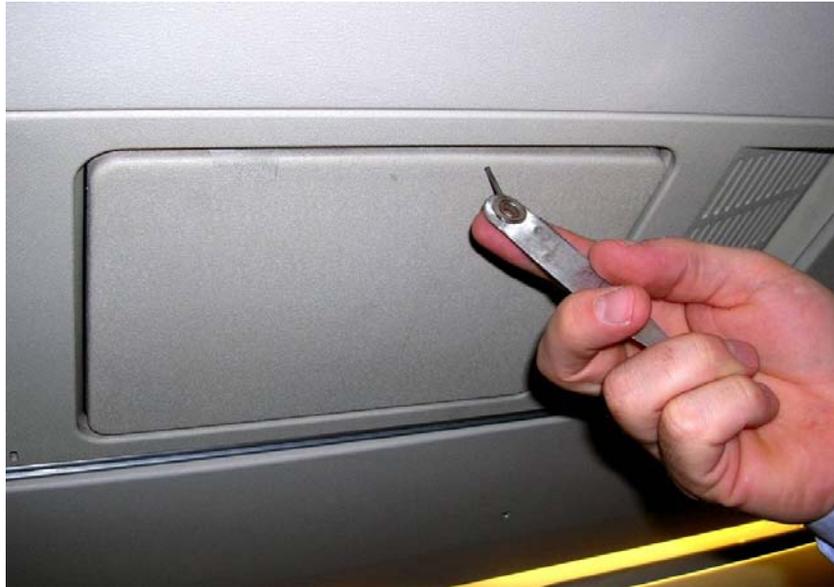
*Fig. 4*

The hatches can also be operated electrically by means of switches in the cockpit, or mechanically with the aid of a small tool (Oxygen Unit Key) that is inserted into a small hole on the outside of each hatch. There are three keys in the aircraft, located in the cabin under the cabin crew seats. The prescribed interval for functional checking of the latch mechanism is 24 months.
