COMISIÓN DE INVESTIGACIÓN DE ACCIDENTES E INCIDENTES DE AVIACIÓN CIVIL

TECHNICAL REPORT

**Accident occurred on 21 May 1998 to
Aircraft Airbus A-320-212 Registration G-UKLL
At Ibiza Airport, Balearic Islands**

A - 19/98

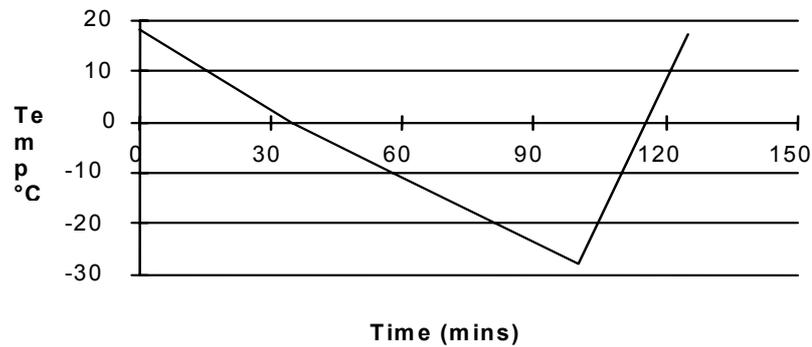
Temperature Profile

The initial test roughly followed the total air temperature profile for the accident flight, as derived from the FDR. Thus the valve was cooled at a near-constant rate to the lowest value of -28°C before being warmed up again to $+17^{\circ}\text{C}$, as shown below:

The BDDV function was tested after one hour, at which point the temperature was -11°C , with the hydraulic fluid temperature at -3°C . A satisfactory pressure output was obtained in response to brake pedal input. However, when the test was repeated after 1 hr 25 min elapsed time, with the test chamber and fluid temperatures at -20°C and -12°C respectively, no output was obtained, thus reproducing the failure condition. This condition persisted at the lowest temperature of -28°C . The ensuing warming-up process was intended to simulate the descent and landing on the accident flight. After reaching $+17^{\circ}\text{C}$ the fluid reservoir temperature was still at -16.8°C , although its temperature at the input to the BDDV was $+12.9^{\circ}\text{C}$. The left and right brake functions were tested in turn by applying the maximum input pressure of 12 bar, and maintaining it for one minute. No brake output pressure was obtained on either side. After waiting an additional minute, the tests were repeated, and it was found that normal operation had been restored.

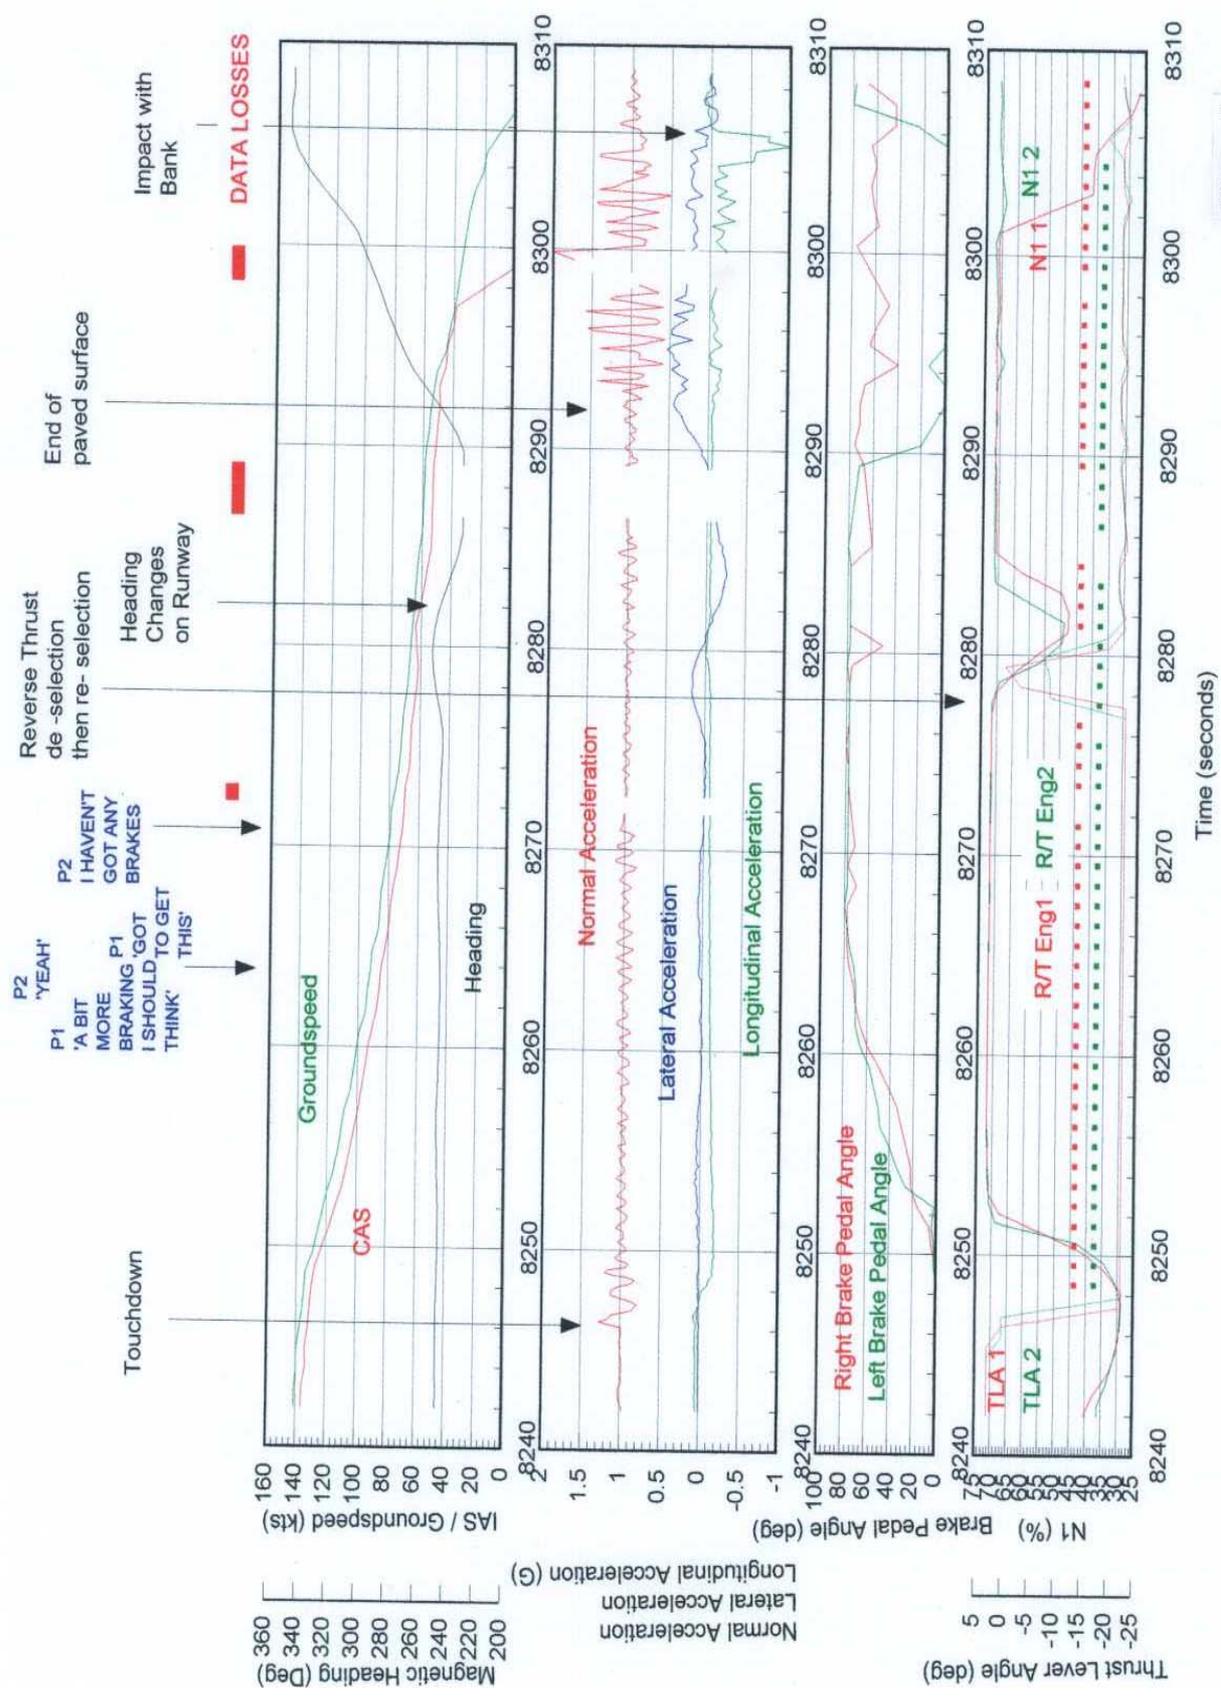
Appendix D Figure 1 shows the final minute of FDR data covering the approach and landing from 20 ft AGL to the end. Relevant comments from the CVR are included. The aircraft touched down at an airspeed of 132 kts CAS, at a distance calculated to be 2000m from the end of the paved surface. Figure 2 shows the calculated distance and Figure 3 shows the FDR data and relevant CVR comments plotted against the distance from touchdown.

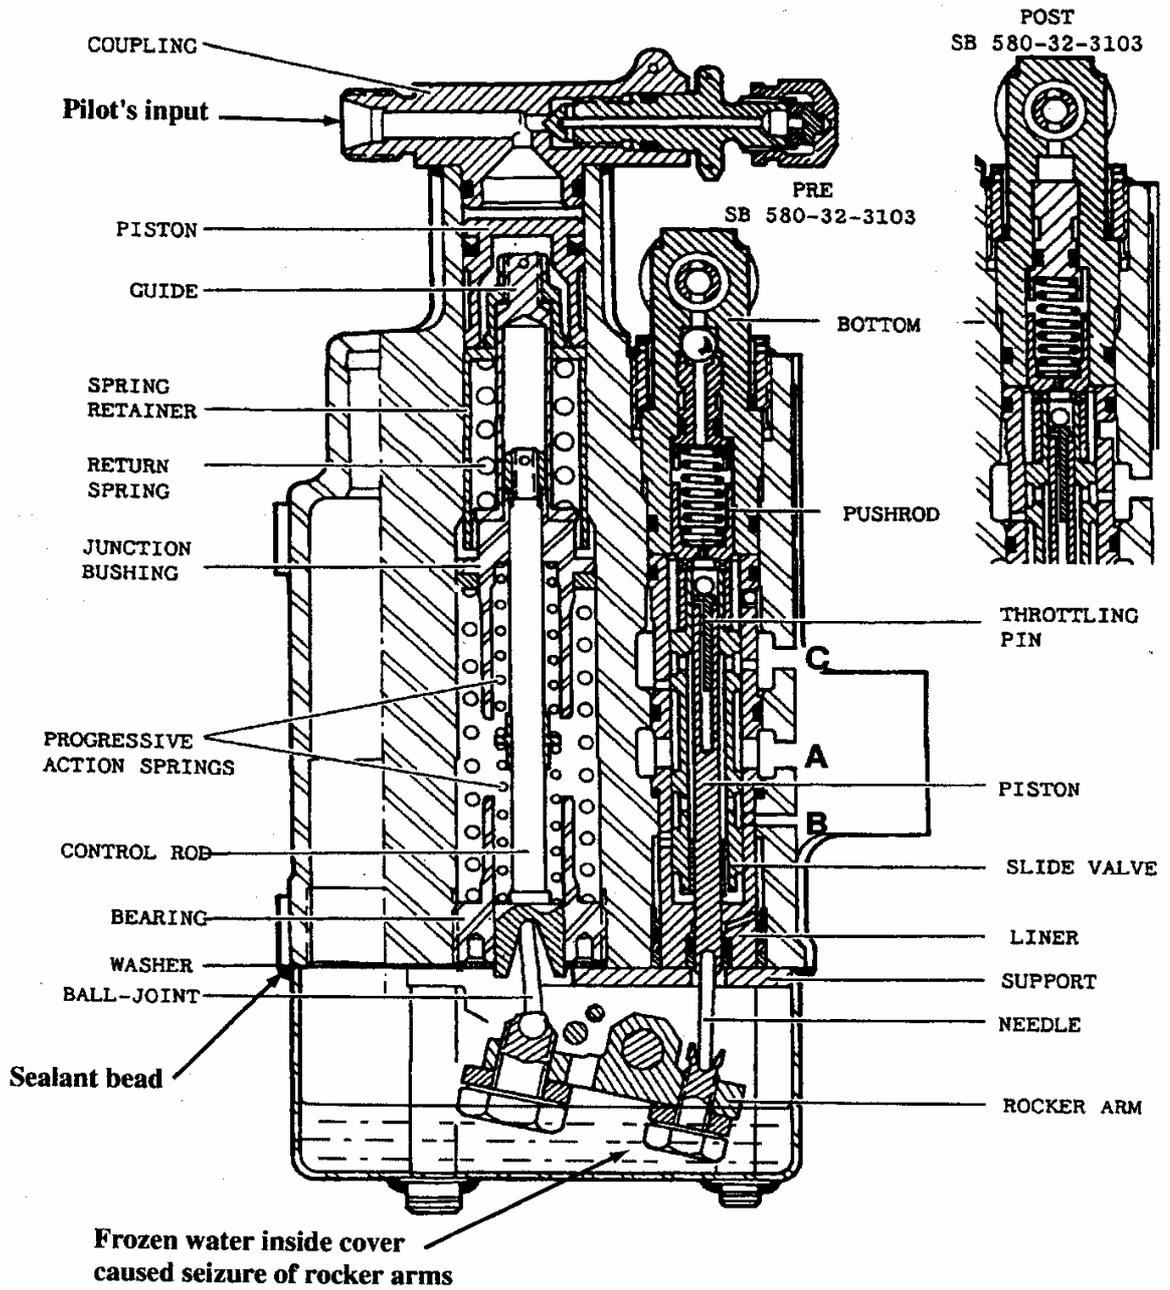
FIGURE 2 SECTION THROUGH BDDV
(Adapted from Messier-Bugatti diagram)

After the chamber had been force-warmed to ambient temperature, the BDDV was subjected to a further test to confirm that it was fully functional again, before being removed from the test rig. The cup-shaped cover at the base of the valve body was removed and found to contain a quantity of fluid. This consisted of 30 ml of dirty water and 3.5 ml of what appeared to be a mixture of hydraulic fluid and grease. This was later analysed by the Fuels and Lubricants laboratories at DERA, Pyestock, United Kingdom, along with the samples of hydraulic fluid taken from the BDDV prior to its installation in the environmental test rig.

The moving parts of the valve had been assembled with silicone grease and it was apparent that emulsification had occurred as result of contact with the water. However, there was no visible corrosion that may have impeded the operation of the valve. As a final check, the BDDV was reinstalled, with its cover, in the test chamber and cooled to

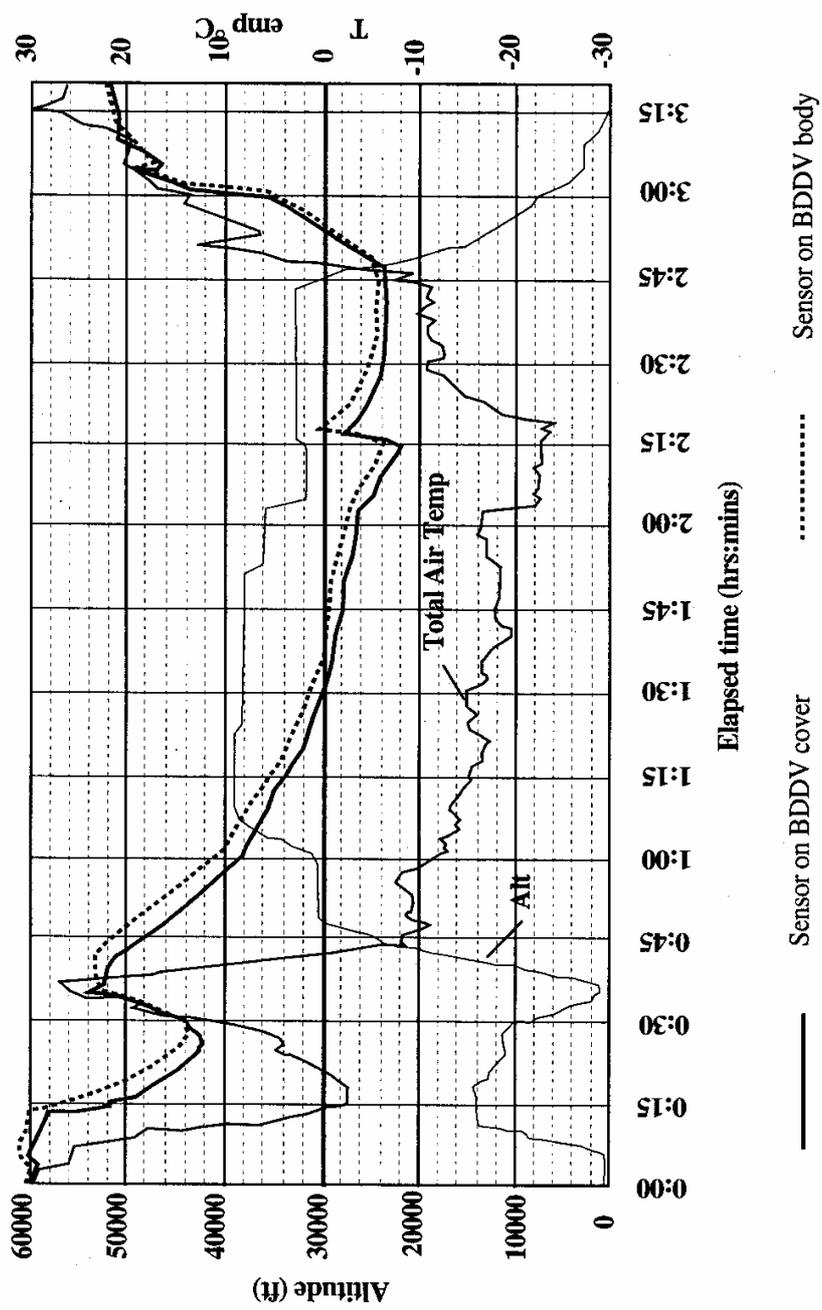
FIGURE 3. A320 BDDV TEMPERATURE MEASUREMENT TESTS

Airbus Industrie conducted a flight test on an A320 aircraft in which two temperature sensors were attached to the BDDV, one on the valve body and the other on the cover. A test flight was also conducted on an A300-600. Once again, two sensors were used, one being attached to the valve cover, but with the other measuring the ambient air temperature 10 cm from the valve. Plots of the two test flights are appended (Appendix E, Figures 3 and 4).
