**AVIATION INVESTIGATION REPORT
A05H0002**

RUNWAY OVERRUN AND FIRE

**AIR FRANCE
AIRBUS A340-313 F-GLZQ
TORONTO/LESTER B. PEARSON INTERNATIONAL
AIRPORT, ONTARIO
02 AUGUST 2005**

Report Number A05H0002

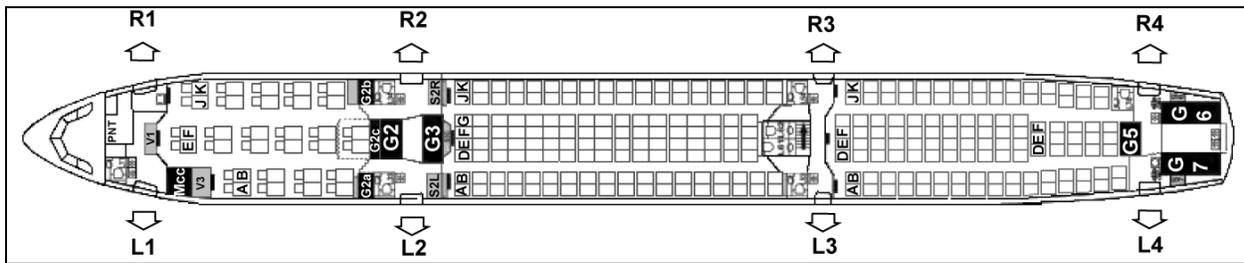
Figure 2. Aircraft cabin and exits

The aircraft has six cabin doors, three on the left side (L1, L2 and L4) and three on the right side (R1, R2, and R4), and two emergency exit doors (L3 and R3). The cabin doors are used as entrance and exit doors for the passengers and the crew. The aircraft cabin was equipped with eight cabin crew stations, one adjacent to each of the cabin doors/emergency exits. The cabin crew station at the L1 door included two cabin crew seats. From a seated position, cabin crews

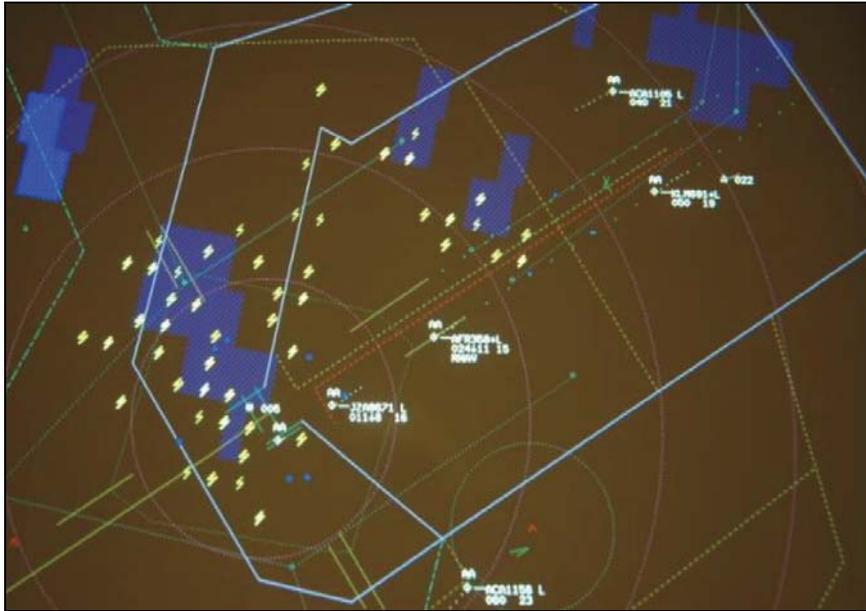
Figure 3. Weather intensity information displayed to the controller

Weather intensity information is highly stylized and is displayed⁹ to the controller as shown in Figure 3. Information on weather movement is not indicated on the display and any interpretation is based solely on the observations of the controller. As AFR358 is on final approach to land, an area of level 2 intensity is depicted on the upper left corner of the graphic. The remaining areas are level 1.
