TECHNICAL REPORT

A-070/2004

Accident of aircraft
BOEING B-737,
registration PH-BTC,
at Barcelona Airport
(Spain), on 28
November 2004

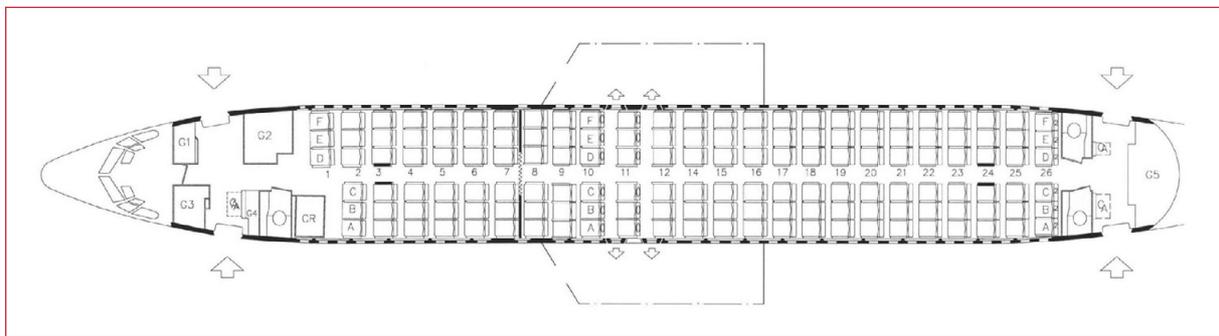
The aircraft has 4 overwing emergency exit hatches, and slides mounted on every door of the airplane. Doors are numbered 1L (forward left), O1L (overwing forward left), O2L (overwing rear left), 2L (rear left) and similarly for 1R, O1R, O2R and 2R.

A malfunction had been identified with deployment of the escape slide of the forward service door (1R). This was the subject of an informative letter («fleet team digest») issued by the manufacturer in December 2002. In some cases the slide became twisted (approximately 90 degrees) during deployment and subsequent inflation. This twisted slide condition rendered the slide and exit unusable for egress. The problem was traced to be probably caused by the escape slide being delayed inside the slide compartment. The manufacturer of the aircraft and the vendor were working on a solution at the time of the PH-BTC accident.

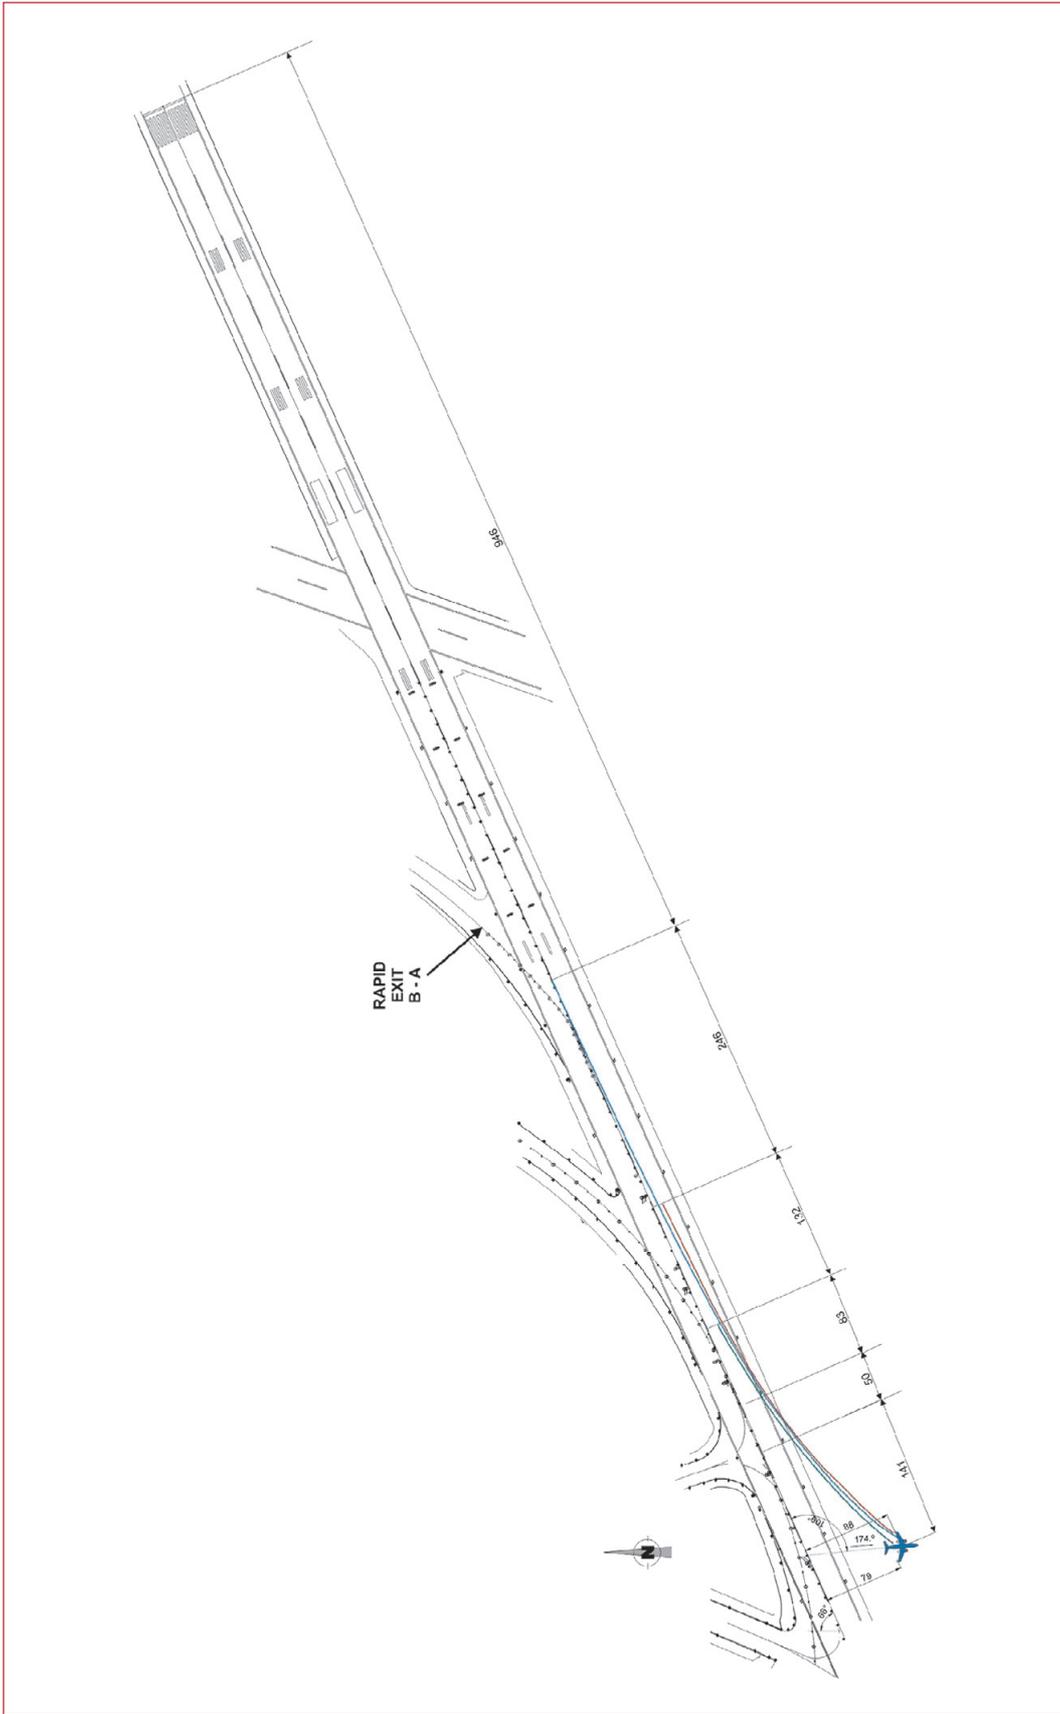
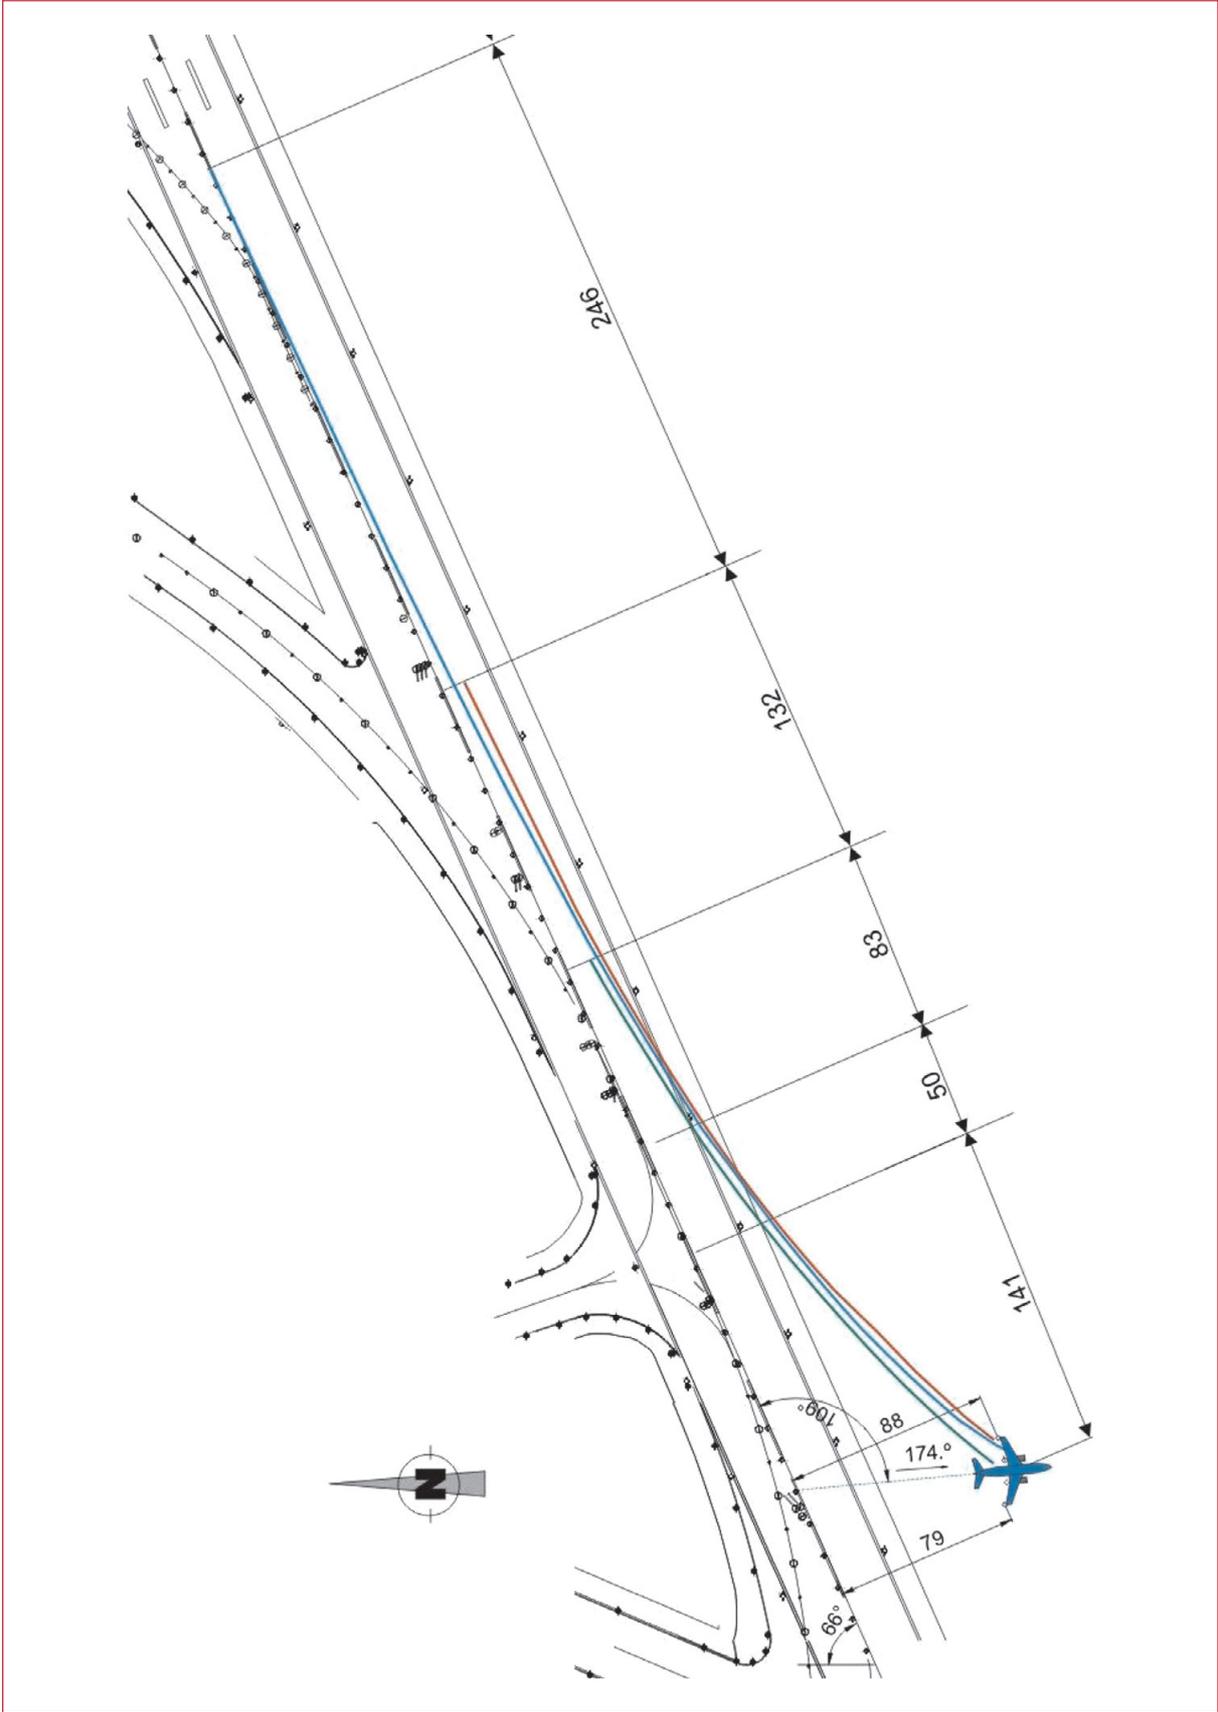
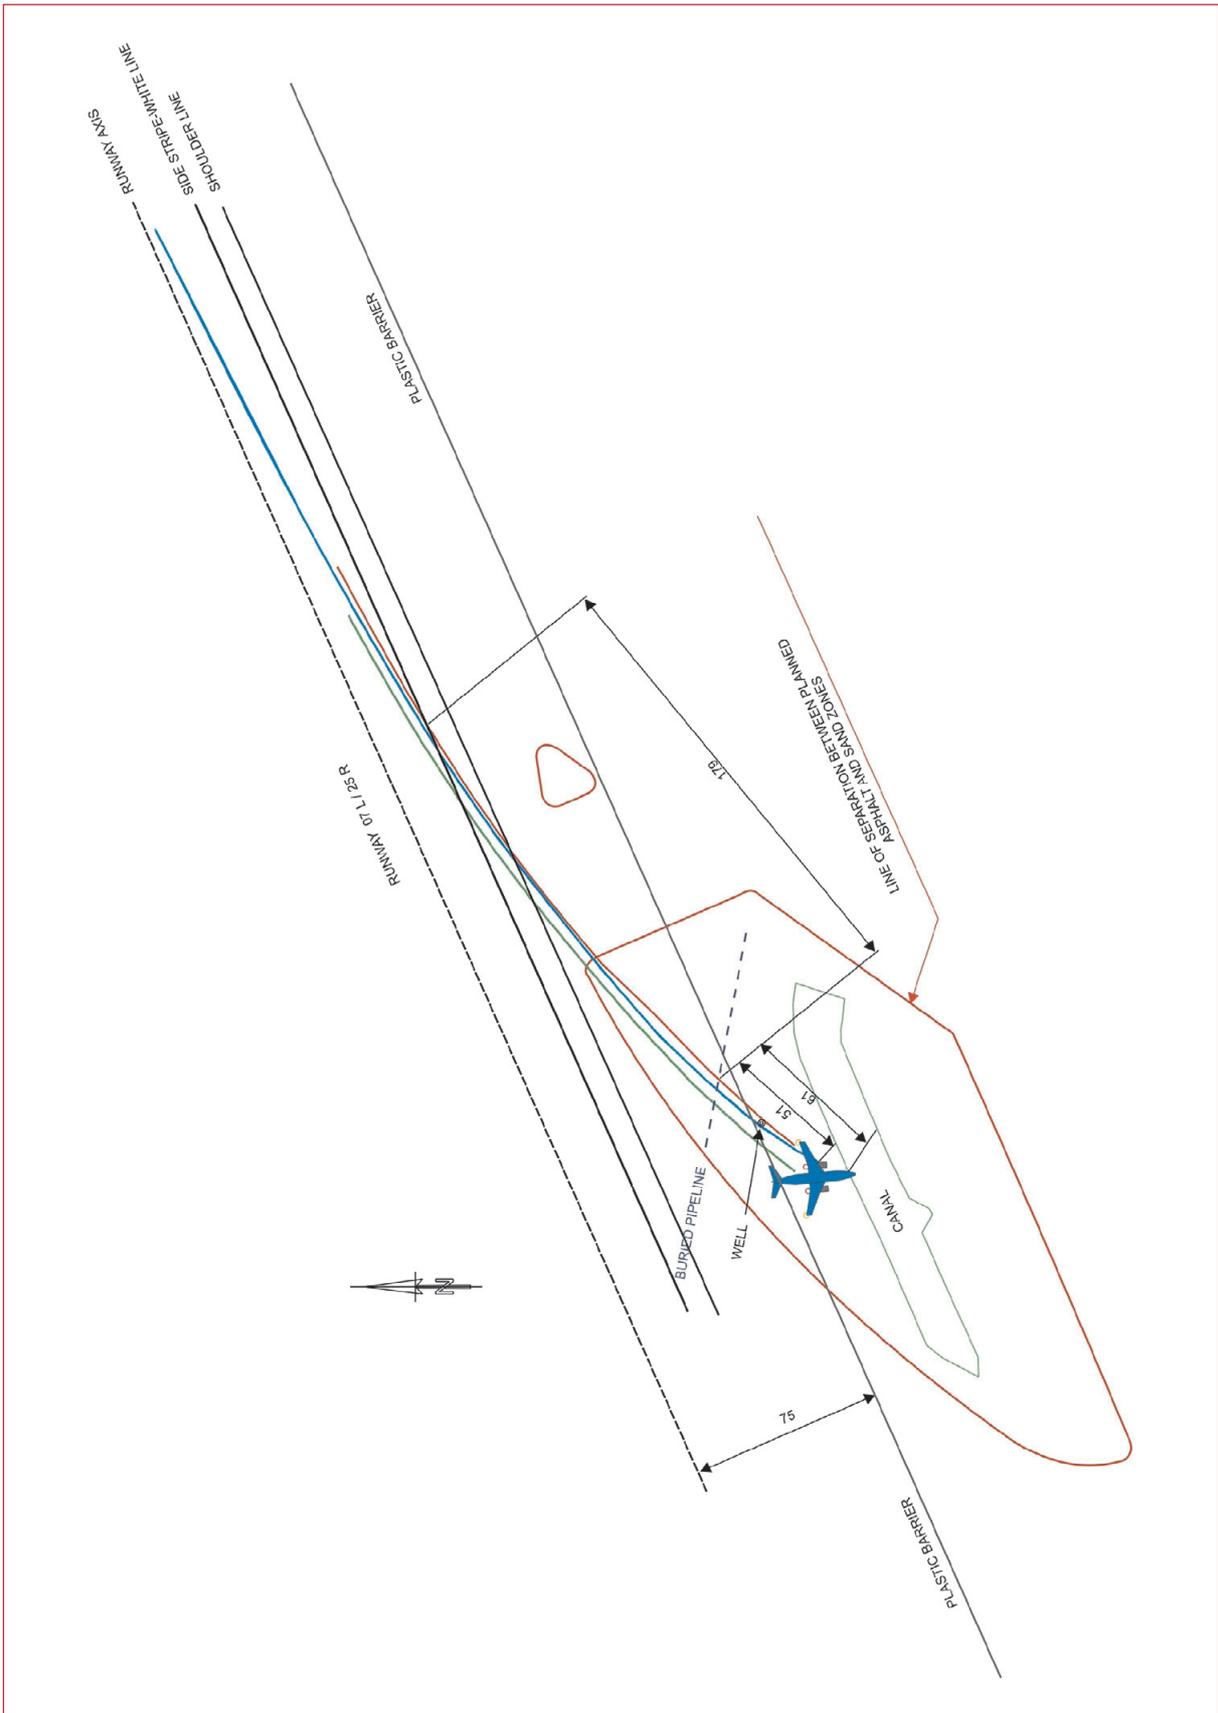
Drawing of the runway marks

The aircraft exited the surface of runway 25R and went through another paved area under construction of some 10 m in width after jumping a step of approximately 10 cm of height. After passing over a trench around 20 cm deep, it then entered an unprepared zone covered mostly by sand and the landing gear dragged through the unprepared surface. The aircraft crossed a plastic fence line and suffered some damage from iron bars that were supporting construction signaling nets. The NLG and the LH MLG hit a buried pipeline that probably made them collapse and detach, respectively (see white arrows in the attached Photo 1.12.1).
