**INCIDENT**

<b>Aircraft Type and Registration:</b>	Boeing 747-132, N481EV	
<b>No &amp; Type of Engines:</b>	4 Pratt & Whitney JT9D-7F Series turbofan engines	
<b>Category:</b>	1.1	
<b>Year of Manufacture:</b>	1970	
<b>Date &amp; Time (UTC):</b>	24 April 2004 at 1048 hrs	
<b>Location:</b>	Airborne near the Compton VOR beacon	
<b>Type of Flight:</b>	Public Transport (Cargo)	
<b>Persons on Board:</b>	Crew - 4	Passengers - None
<b>Injuries:</b>	Crew - None	Passengers - N/A
<b>Nature of Damage:</b>	None	
<b>Commander's Licence:</b>	Air Transport Pilot's Licence	
<b>Commander's Age:</b>	57 years	
<b>Commander's Flying Experience:</b>	About 16,000 hours (of which 4,000 were on type) Last 90 days - 116 hours Last 28 days - 53 hours	
<b>Information Source:</b>	AAIB Field Investigation

**Synopsis**

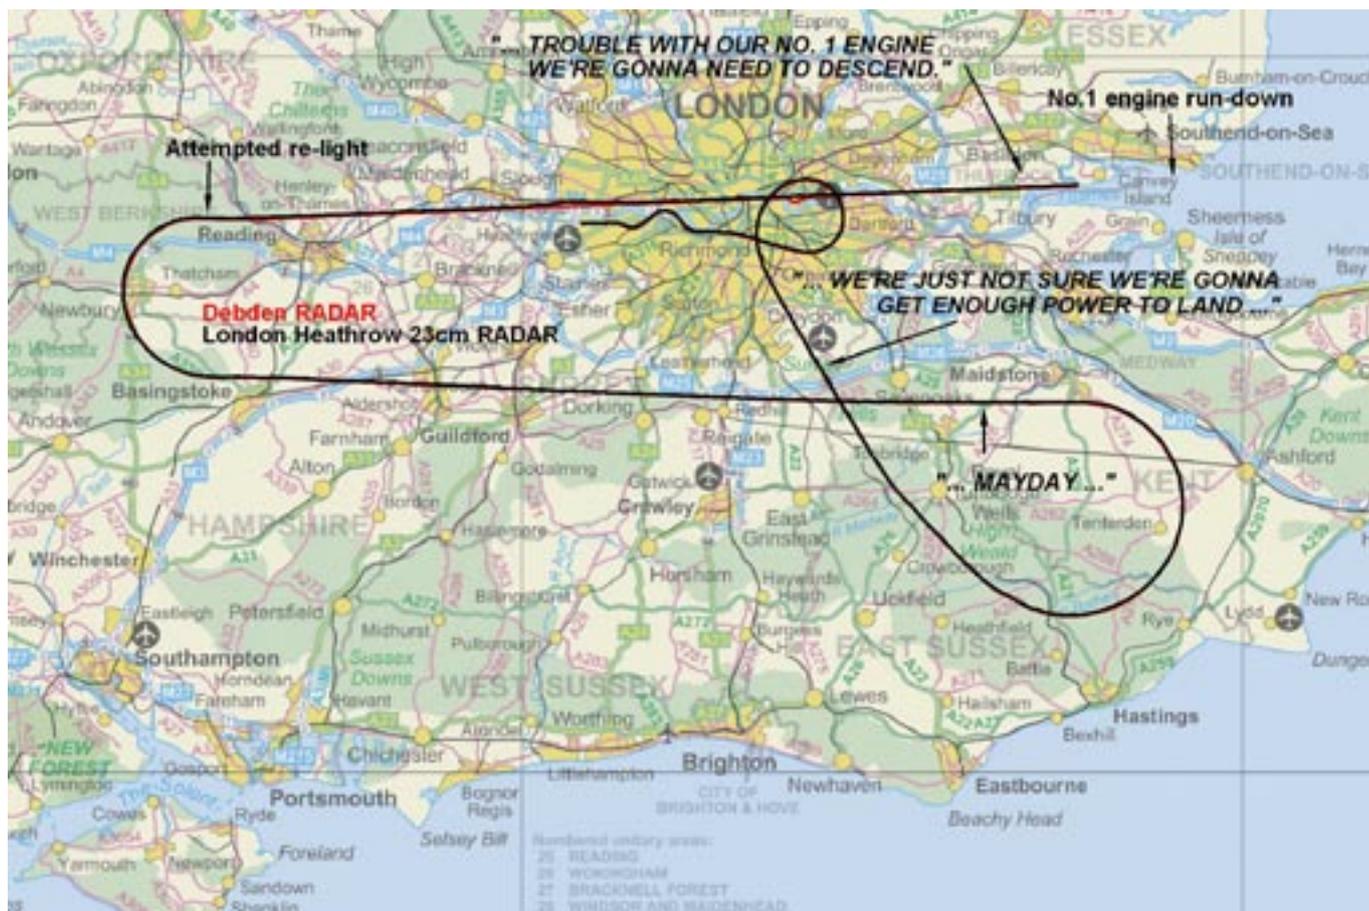
**Figure 1**

Primary and secondary radar data from the radar heads at Debden and London Heathrow (23cm) were available for the incident flight, with radar returns every 6 and 4 seconds respectively. Both radar tracks (Figure 1) begin over the east of London above the Thames estuary and end at London Heathrow.
