Report 06-009

**Boeing 767-319
ZK-NCK**

fuel leak and engine fire

30 December 2006

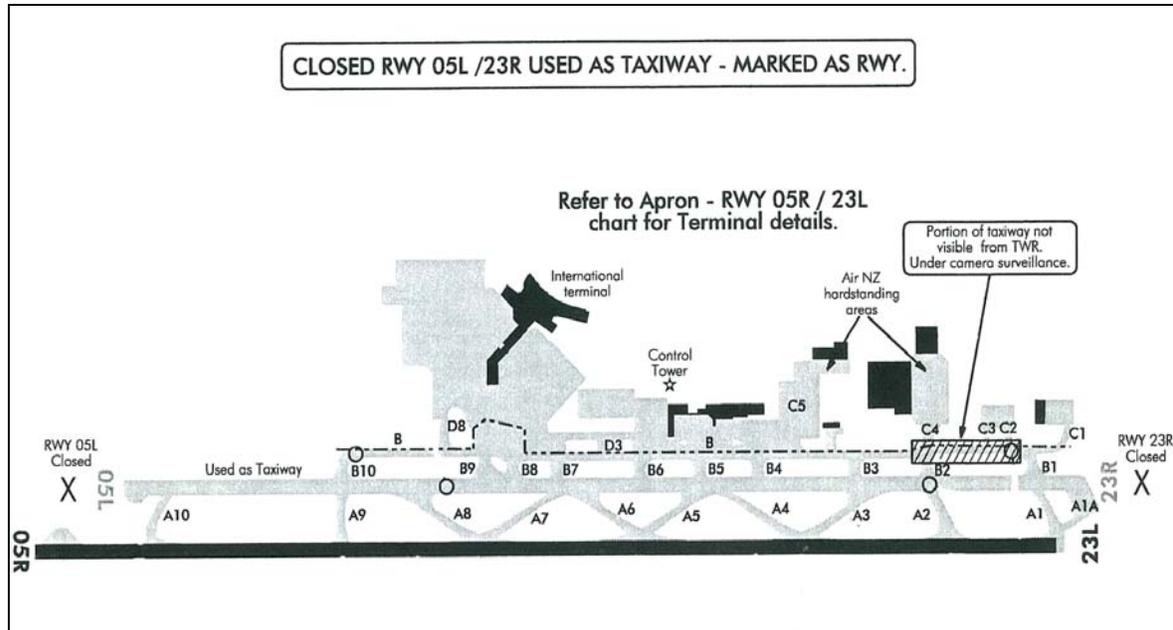
Figure 1
Auckland International Airport plan

- 1.1.2 At 0705 on 30 December 2006, the first officer landed the aircraft on runway 23L at Auckland under visual meteorological conditions. He used full reverse thrust, which was cancelled at approximately 60 knots prior to turning off the runway at taxiway A8 (see Figure 1).
