After takeoff from London Heathrow Airport a vapour trail was seen streaming aft of the aircraft. The flight crew diagnosed that the aircraft was probably leaking fuel from the centre wing fuel tank. They declared an emergency and decided to jettison fuel to reduce to maximum landing weight before returning to Heathrow. Their intention was to minimise heating of the brake units during the landing roll in order to reduce the risk of fire if fuel was to leak onto the wheelbrakes. After landing, the aircraft was met by the Airfield Fire and Rescue Service who reported some vapour emanating from the left landing gear but no apparent fuel leaks.

The fuel leak was caused by fuel escaping through an open purge door inside the left main landing gear bay, on the rear spar of the centre wing tank. The purge door had been removed during base maintenance at the operator's maintenance organisation in Cardiff, between 2 May and 10 May 2004, and had not been refitted prior to the aircraft's return to service.

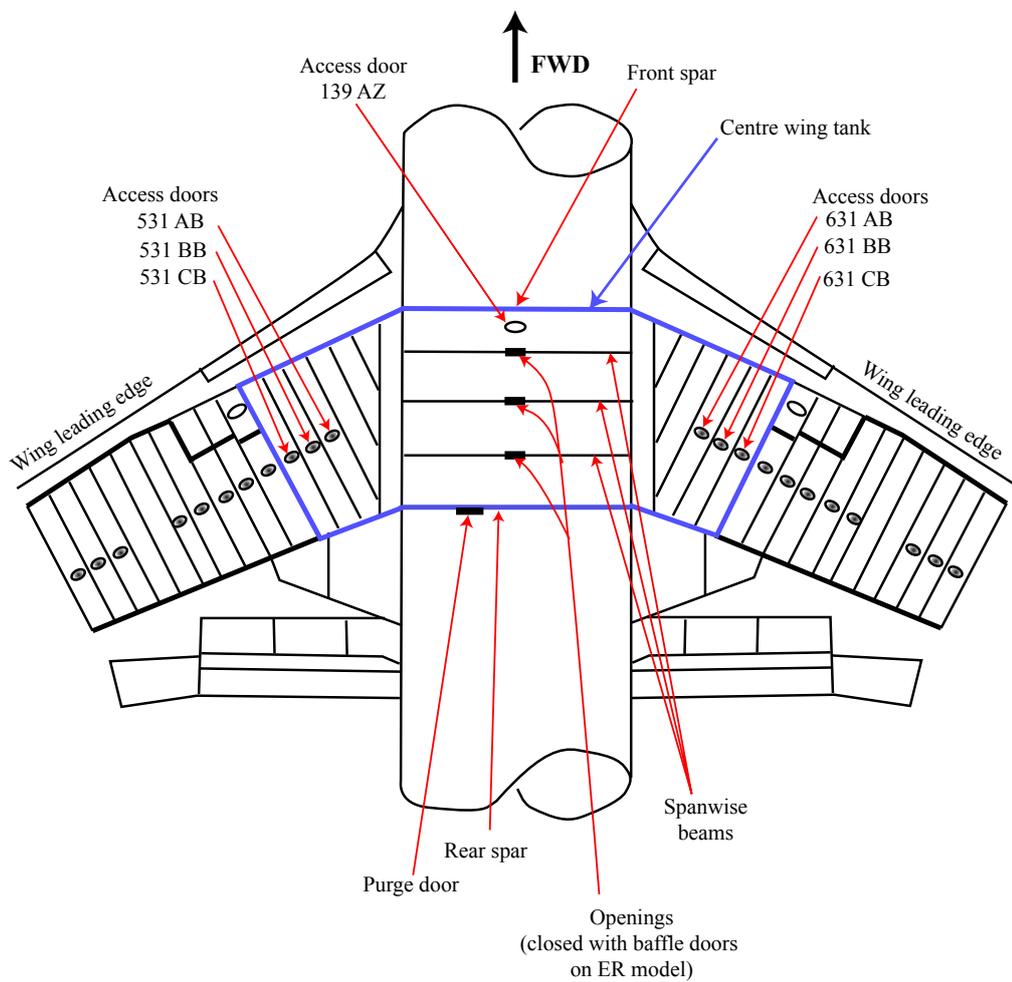
Figure 6

Access into the CWT can be gained via seven access doors. The central section of the CWT has one access door on its lower surface towards the front of the tank (door 139AZ), while the wing sections of the CWT each have three access doors on each side on the lower surface of the wings (see Figure 6).

Spanwise beams separate the centre wing section of the CWT into four bays (see Figure 6). Each spanwise beam has an opening to permit access between the bays. On 'B market' models such as G-YMME, these spanwise beam openings are closed-off with removable baffle doors (see Figure 7). The baffle doors serve to prevent rapid fuel movement (fuel slosh) between spanwise beams due to changes in pitch attitude or longitudinal acceleration. The basic 777-200 with a 'dry' centre wing does not have these baffle doors. The only other door that forms part of the CWT is the purge door.

Boeing 777 centre wing tank configuration

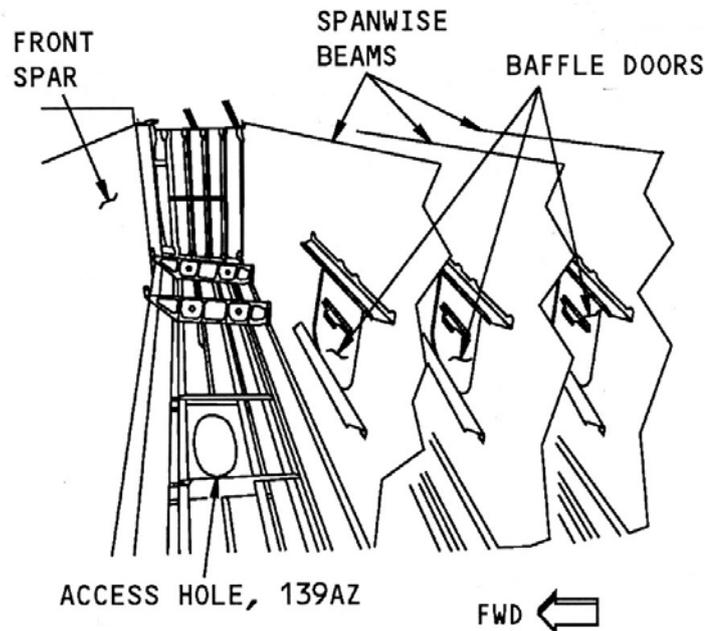
Figure 7

Baffle doors in the spanwise beam openings of the 777-200 ER
 (Copied with permission of The Boeing Company)

The centre section of the CWT is separated into four bays by spanwise beams (see Figure 6, page 10). Each spanwise beam has an opening to permit access between the bays. On 'wet' centre wing 777 aircraft such as G-YMME, these spanwise beam openings are closed with removable baffle doors (see Figure 7, page 11). The Boeing 777-200 variant with a 'dry' centre wing does not have

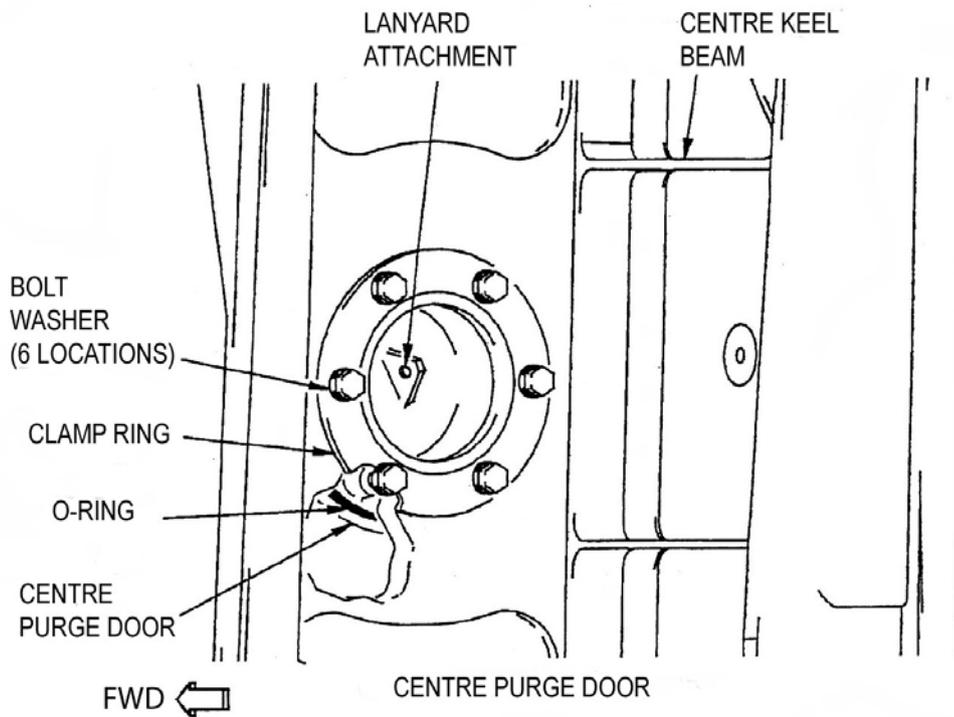
Figure 9

The purge door is located on the rear spar of the centre section of the CWT approximately 7 inches left of the aircraft centreline (see Figures 6 and 8). It can be accessed from inside the left wheel well or from inside the CWT. The purge door is a circular panel of approximately 4.5 inches diameter with 6 bolt holes around its circumference. It is a plug type door which is pressed into the purge door opening from within the tank (see Figure 9). The purge door opening has a diameter of 2.5 inches and is visible from the ground when the left inboard main gear door is open. For all normal operations this main gear door remains closed; it opens only briefly to permit the landing gear to extend and retract. The door can be opened on the ground to conduct maintenance inside the wheel well but it would not be normal to do this during a turn-around between flights. When the inboard main gear door is closed the purge door is not visible from ground level.

Boeing 777 purge door installation diagram
 (Copied with permission of The Boeing Company)

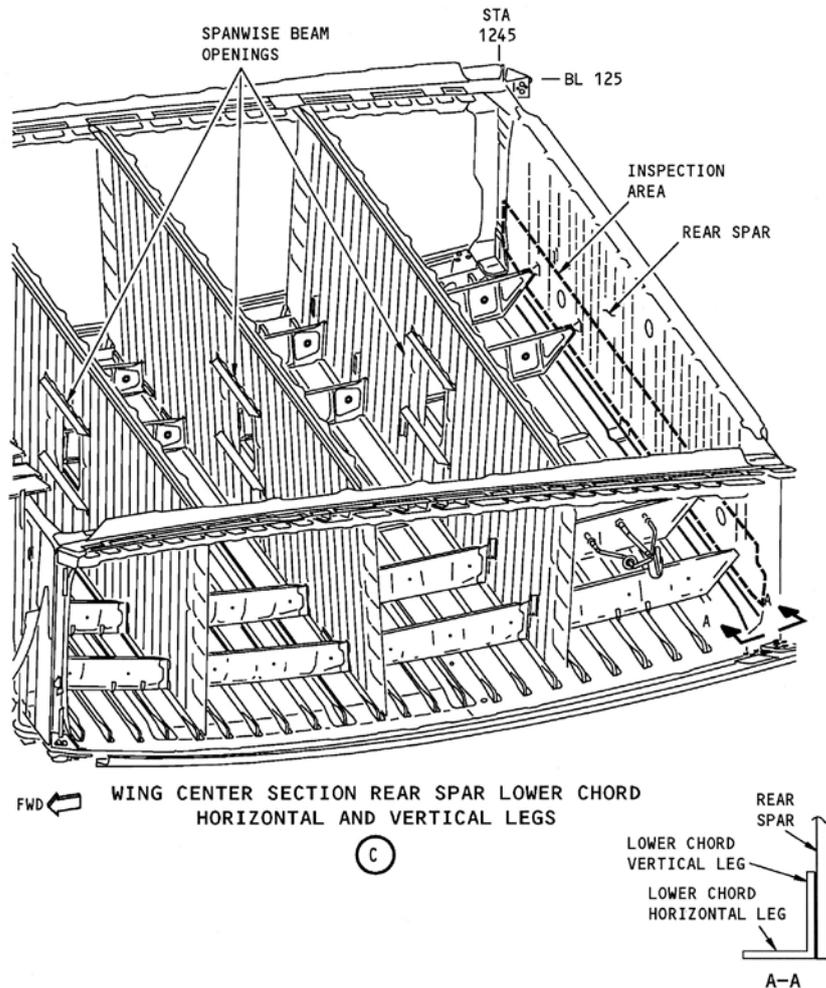
The rear spar forms the aft wall of the centre section of the CWT. It can only be inspected by entering an access hole (139AZ) in the front section of the tank, removing the baffle doors and then passing aft through the exposed openings in the spanwise beams (see Figure 11, page 26). A pictorial description of the area to be inspected was provided on a Boeing task card. This task card (revision May 2003) incorrectly showed the front spar or forward spanwise beam (depending upon interpretation – see section 1.6.11.2) as the area to be inspected and did not detail the access requirements. The engineer who carried out the inspection on G-YMME followed the pictorial description and incorrectly inspected the forward spanwise beam instead of the rear spar. Consequently, the engineer did not remove the baffle doors or enter the rear section of the CWT where the purge door was located.

There are a number of errors in Figure 10 and these can best be visualised by comparing it to a corrected diagram in Figure 11. Both figures depict the forward section of the centre section of the CWT, but Figure 10 has the front spar incorrectly labelled as the rear spar, the STA (station) numbers are reversed and the FWD arrow in the lower diagram of Figure 10 points the wrong way. In Figure 10 the area shown to be inspected (A-A) is the lower section of the front spar but it could be interpreted to be the lower section of the forward spanwise beam due to the FWD arrow pointing the wrong way. A new diagram, Figure 12, clearly shows the aft section of the CWT and the area to be inspected on the rear spar.

Revised diagram for rear spar inspection, part 1 (Rev 5 September 2004)
(Copied with permission of The Boeing Company)

The revised and corrected diagrams shown in Figure 11 and Figure 12 were published in a revised Boeing task card on 5 January 2005. Figure 11 was published in a revised AMM on 5 September 2004 and Figure 12 was published in a revised AMM on 5 January 2005 (interim diagrams were published prior to these - see section 5.2.1 on safety action for details).

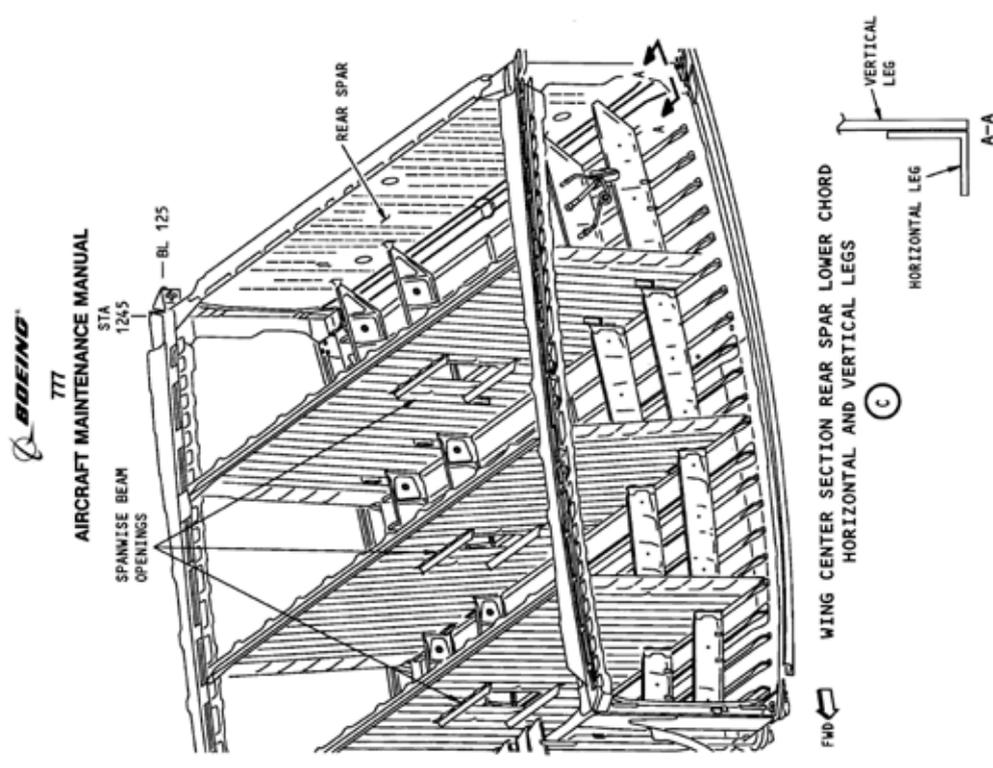
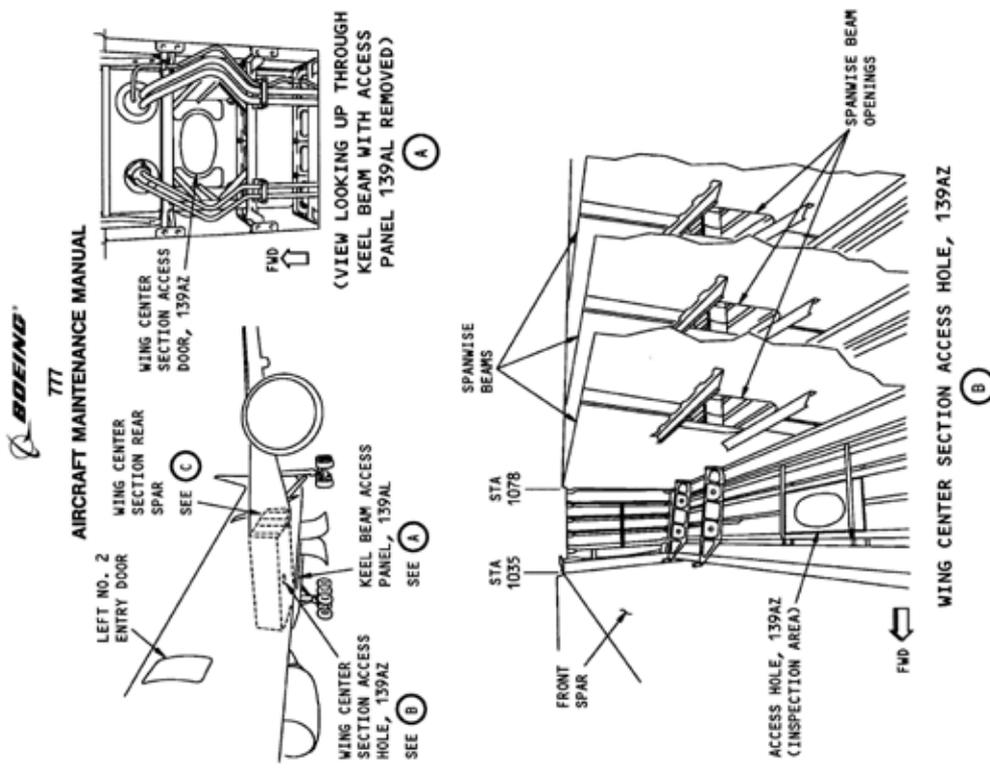
A corrected version of the rear spar inspection diagram was published in the 5 May 2004 revision (Revision 41) of the AMM and of the Boeing task cards (see Appendix 3, it is an earlier version of Figures 11 and 12). This AMM revision was shipped to the operator on a CD (Compact Disc) on 22 April 2004 but, for unknown reasons, it was not received by the operator until 8 June 2004 (a month after the G-YMME maintenance). However, even without this delay the revised diagram would not have been sent to the maintenance organisation in time for G-YMME's maintenance because the operator and the maintenance organisation were under an AMM freeze period and were still using AMM revision 39, dated 5 September 2003 (see section 1.17.11 for the reason behind the freeze). This AMM freeze continued at the maintenance organisation until 24 January 2005. However, following the G-YMME incident, a copy of the revised diagram was sent to the maintenance organisation on a CD on 19 July 2004.

Rear spar inspection from 777 Aircraft Maintenance Manual Revision 41 (5 May 2004)
(earlier versions of the diagrams depicted in Figures 11 and 12 of the report)
(Copied with permission of The Boeing Company)
