## Boeing 737 Pilot Flying Selects Incorrect Altitude in Holding Pattern, Causes Dangerous Loss of Separation with MD-81

*The B-737 pilot correctly read back an ATC clearance, but set the wrong flight level in the autopilot mode control panel. Separation between the B-737 and a McDonnell Douglas MD-81 in the same holding stack was reduced to less than one-half mile (0.8 kilometer) horizontally and 100 feet (30.5 meters) vertically at their closest.*

FSF Editorial Staff

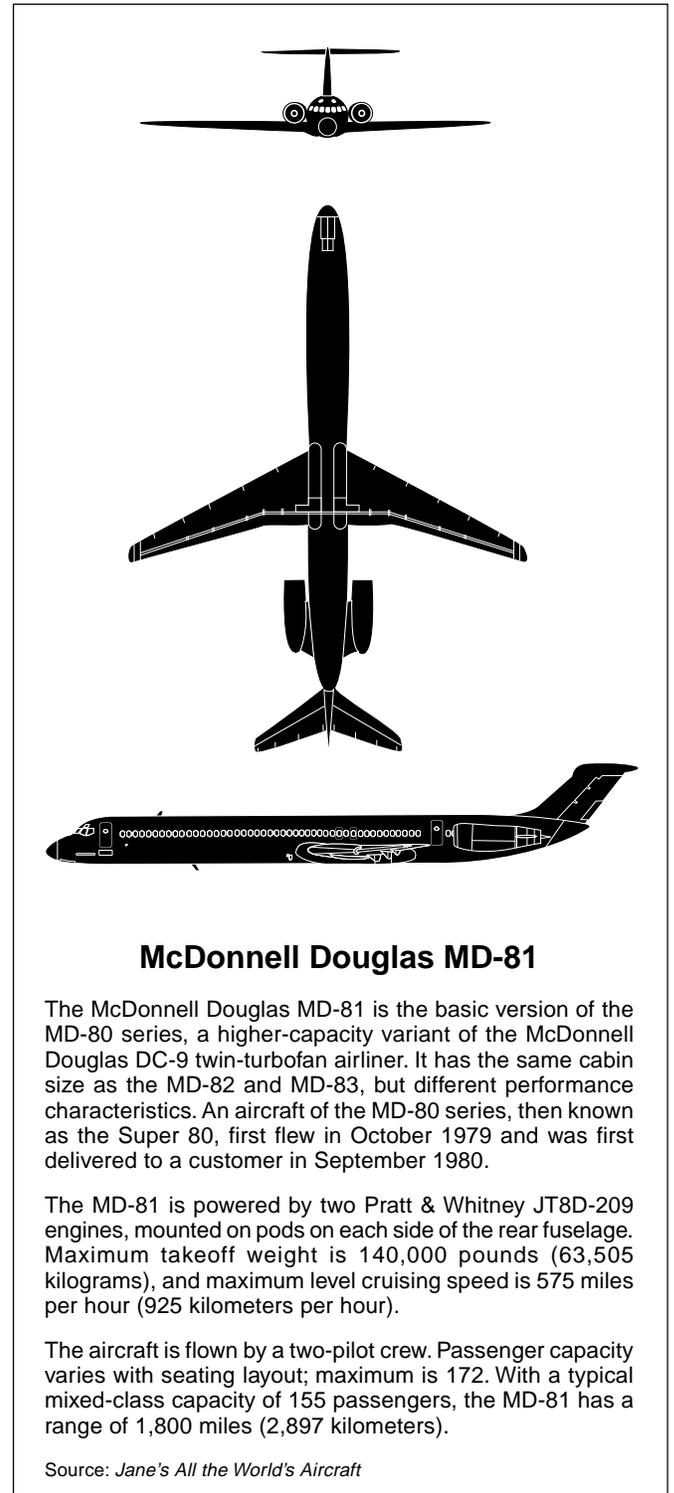
and between 2,231 feet and 2,690 feet horizontally, from 1643:54 to 1643:59.

“The B-737 had executed a slightly smaller-radius turn than the MD-81, which resulted in the B-737 being slightly ahead and to the left of the MD-81 at the time of the closest proximity, with both aircraft having left bank applied for the turn, about 25 degrees in the case of the B-737,” said the report.

Digital flight data recorder data from the B-737 revealed that the aircraft had descended as low as 14,052 feet, and had descended at a rate of about 1,000 feet per minute (305 meters per minute) while below FL 150, with the autopilot and autothrottles engaged.
