**NATIONAL  
TRANSPORTATION  
SAFETY  
COMMITTEE**

**AIRCRAFT INCIDENT REPORT**

Japan Airlines Flight JL726

B747-300 JA8178

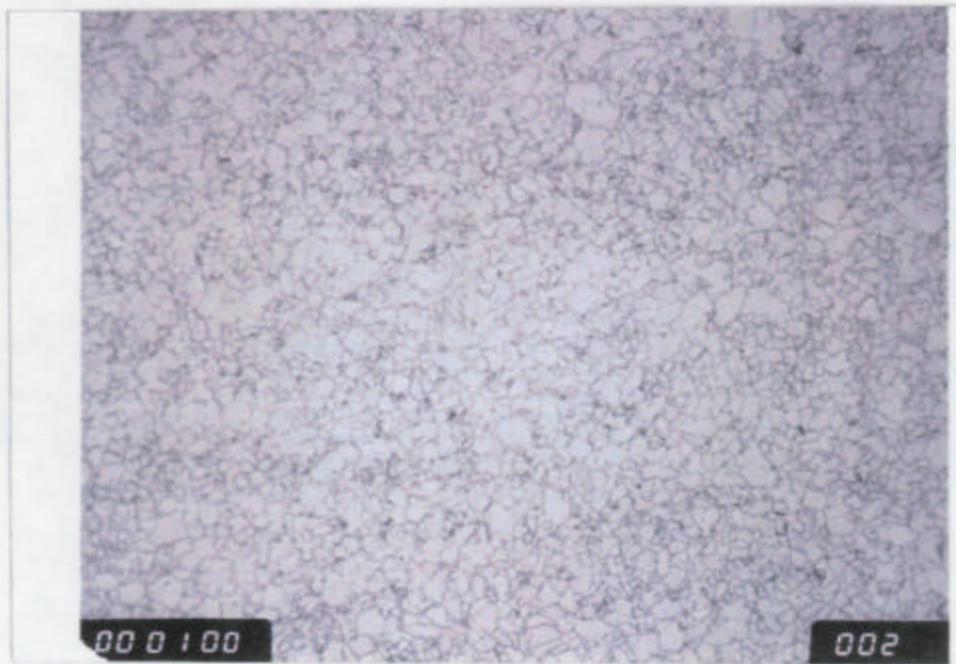
titled "Alloy Bars, Forgings, and Rings, Corrosion and Heat Resistant, (Inconel 718)", indicated that the grain size should be "6 or finer, with occasional grains as large as 5 permissible." Examination of section "Y-Y" in figure 1 revealed that the grain size in the web portion at the fracture origin area was predominantly 5 with several grains that were 4. This grain size is larger than permissible. All areas within the bore, the inboard portion of the web, and the inboard portion of the rim contained equiaxed grains whose size was within the specified range. The outboard portion of the web contained equiaxed grains that were larger than permissible. The mid and outboard portion of the blade retention post contained equiaxed grains; however, these areas also contained several elongated grains that were larger than permissible. The result of the grain size evaluation is summarized in Table 1. Figures 13 through 20 contain typical photomicrographs at various areas of the disk.

Figure 13. Photomicrograph of section "Y-Y" (see figure 1 for location) at the inboard portion of the bore showing typical grain size. Etched with Tucker's reagent. (100X)

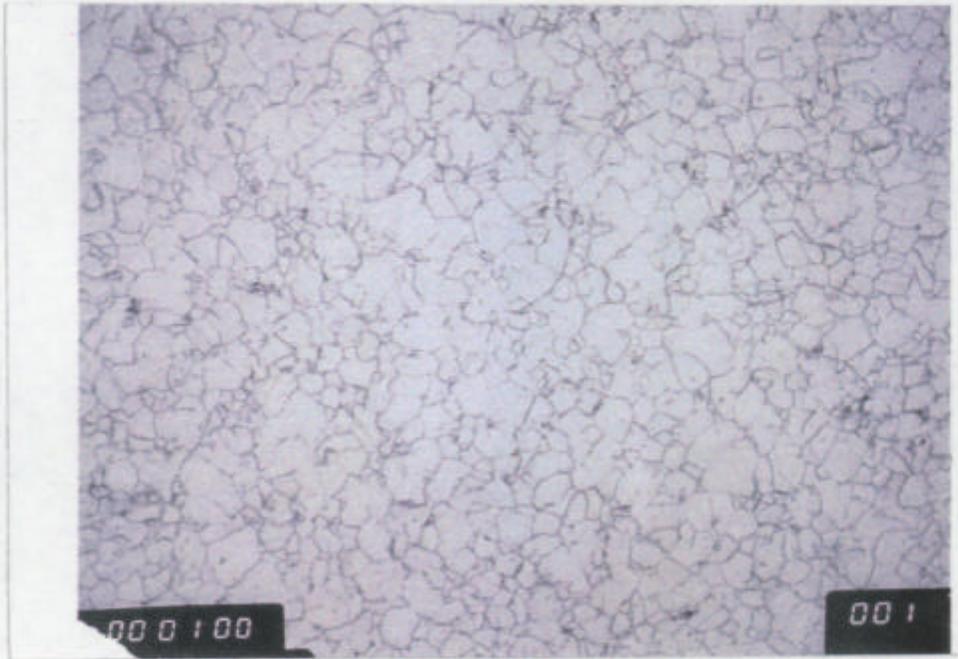
Figure 14. Photomicrograph of section "Y-Y" at the outboard portion of the bore showing typical grain size. Etched with Tucker's reagent. (100X)

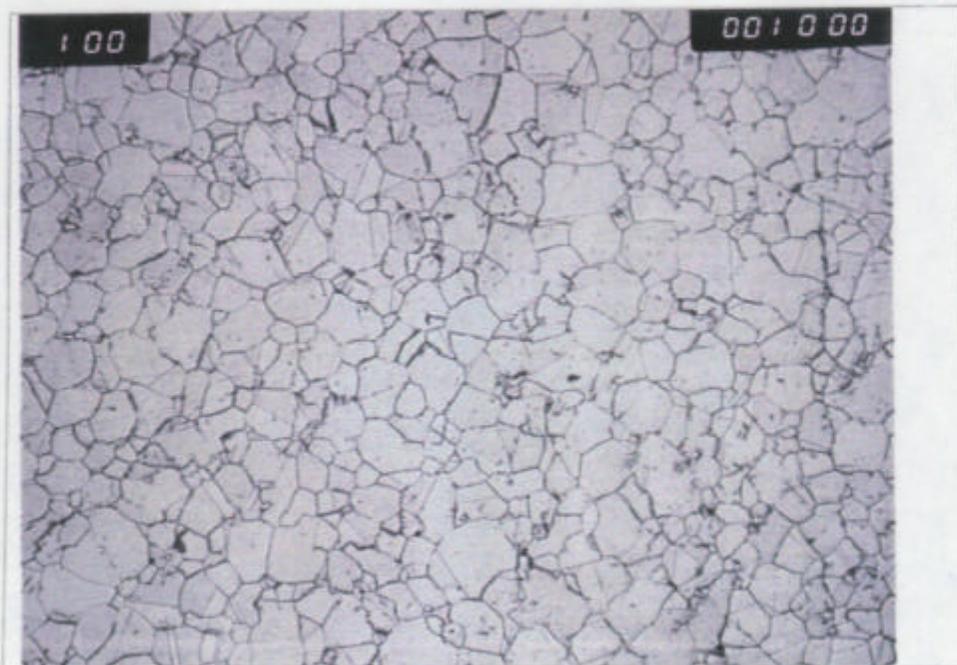
Figure 15. Photomicrograph of section "Y-Y" at the inboard portion of the web showing typical grain size. Etched with Tucker's reagent. (100X)

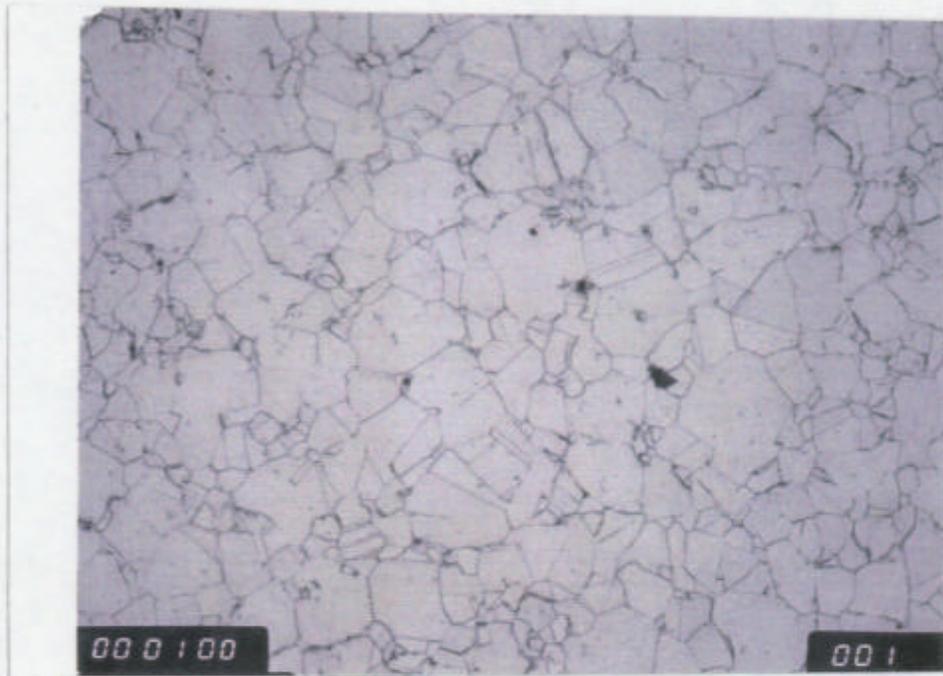
Figure 16. Section "Y-Y" at the web and in the area below the fracture origin area showing typical grain size. Etched with Tucker's reagent. (100X)

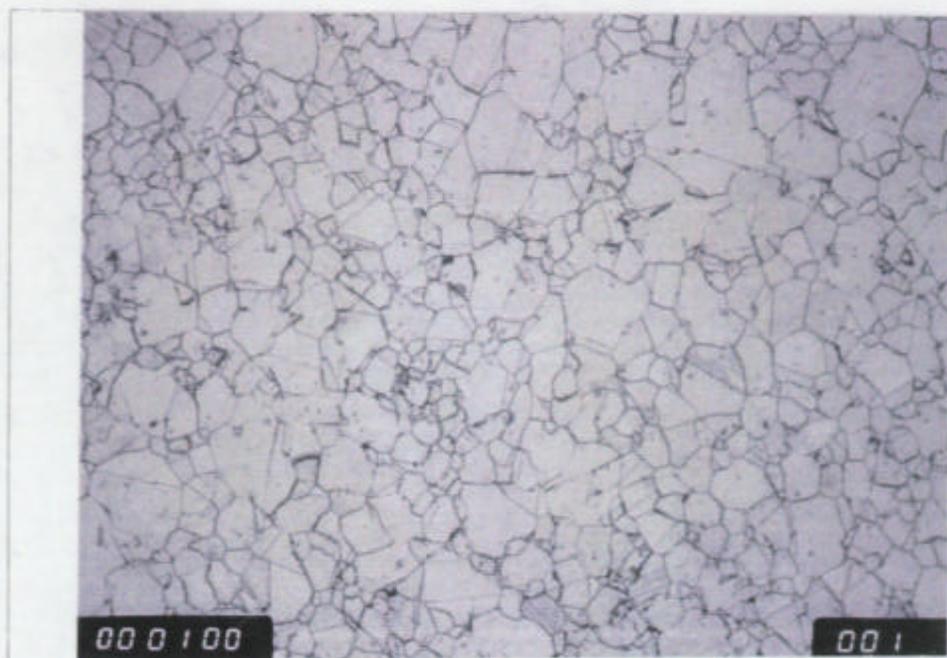
Figure 17. Section "Y-Y" at the outboard portion of the web showing typical grain size. Etched with Tucker's reagent. (100X)

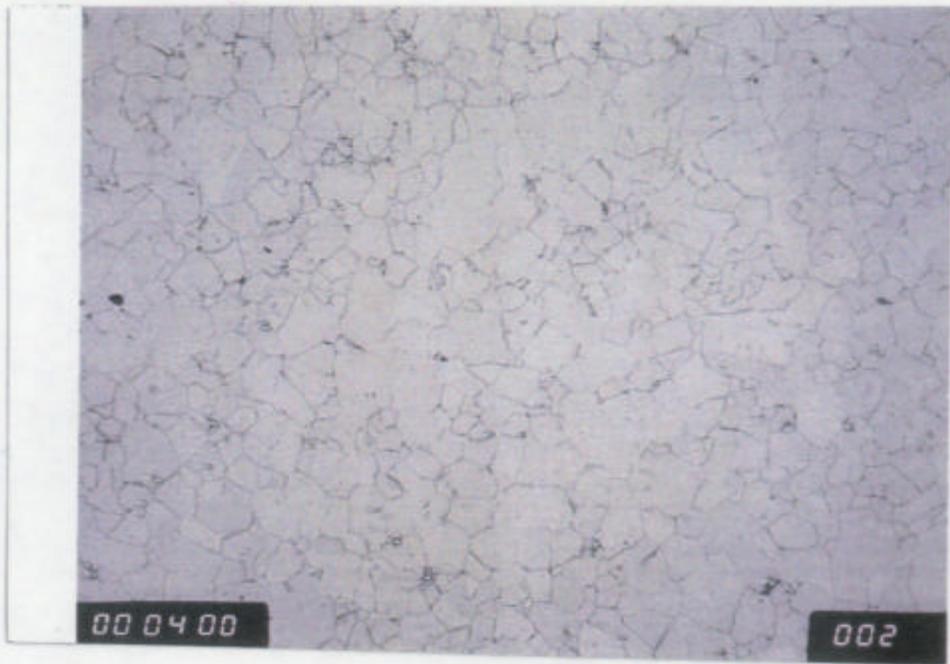
Figure 18. Section "Y-Y" at the inboard portion of the rim showing typical grain size. Etched with Tucker's reagent. (100X)

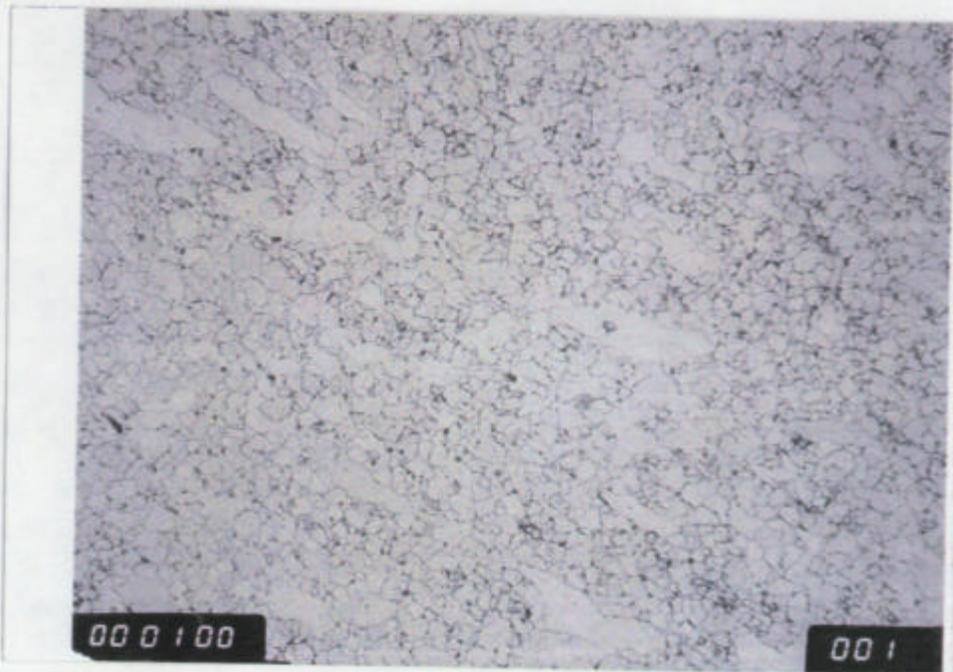
Figure 19. Section "Y-Y" at the mid portion of the rim showing typical grain size. Etched with Tucker's reagent. (100X)

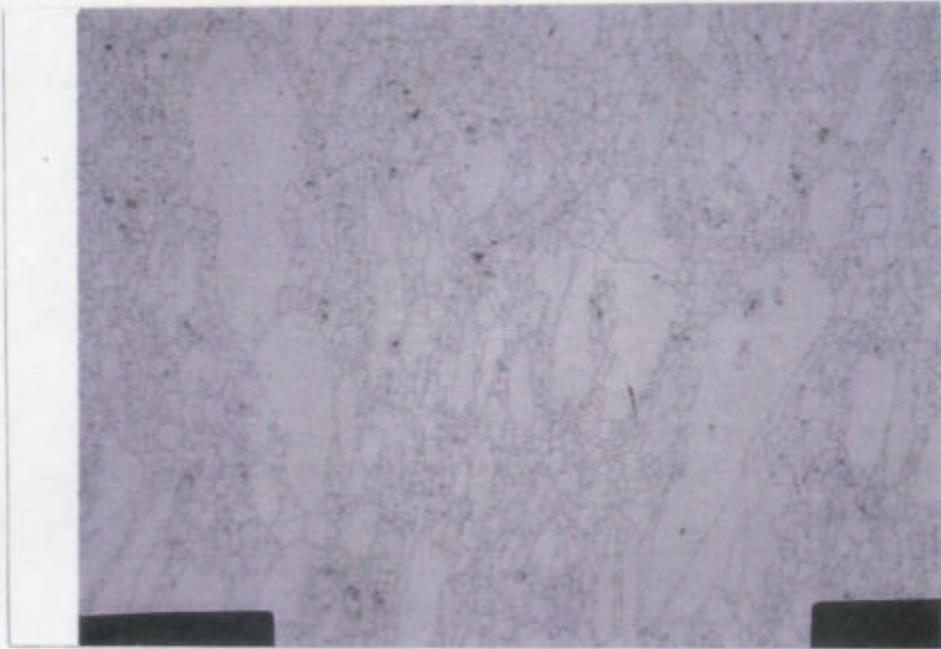
Figure 20. Section "Y-Y" at the most outboard portion of the blade retention post showing typical grain size. Etched with Tucker's reagent. (100X)

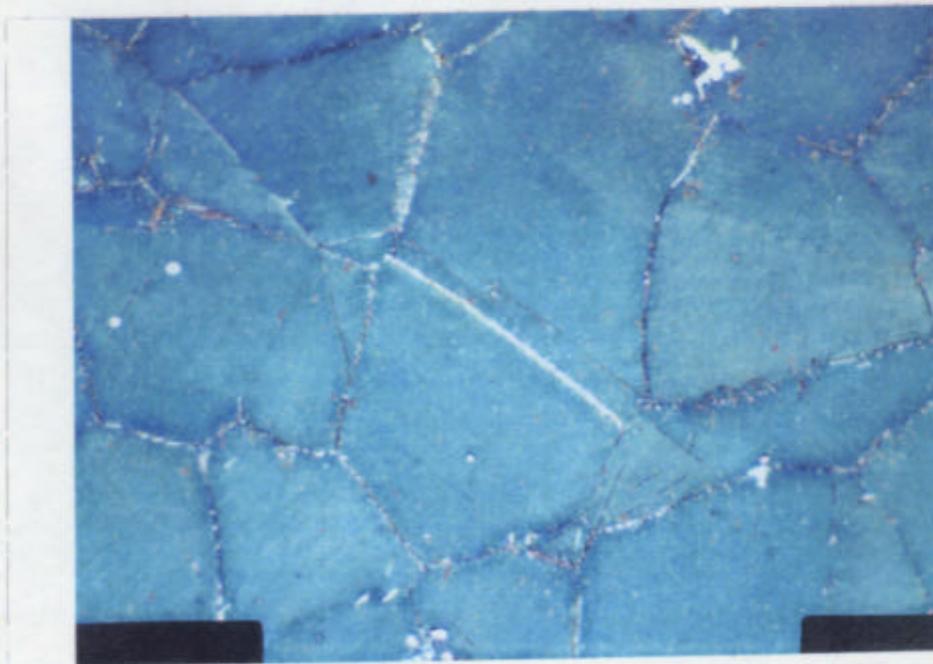
elongated particles of what appeared to be delta phase at the grain boundaries. The delta phase at the grain boundaries reportedly is used to control grain size in wrought materials. The typical microstructure of the sections is shown in figures 21 through 29.

Figure 21. Section "Y-Y" at the web in the area below the fracture origin area showing typical microstructure. Etched with Tucker's reagent and followed by electrolytic etch with a phosphoric acid reagent. (500X)

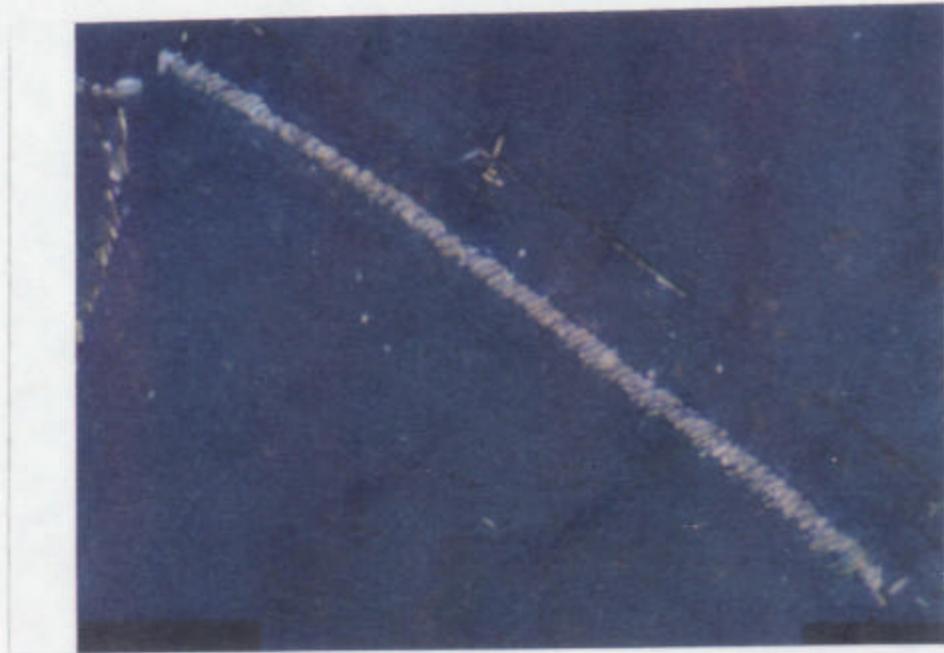
Figure 22. Higher magnification photomicrograph of the area in the center of figure 21. (1,500X)

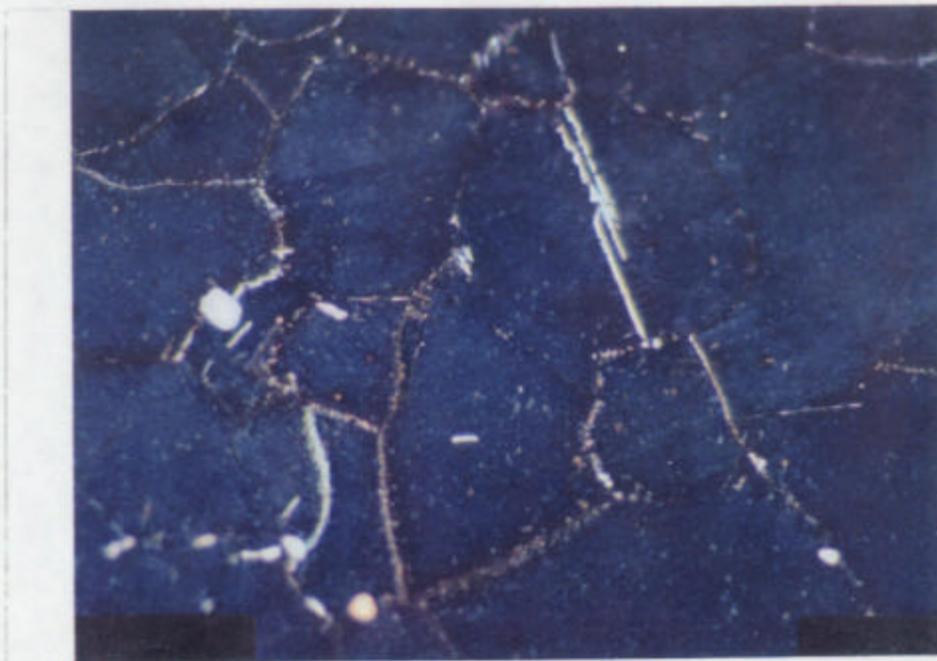
Figure 23. Section "Y-Y" at the web in the area below the fracture origin area showing typical microstructure. Etched with Tucker's reagent and followed by electrolytic etch with a phosphoric acid reagent. (500X)

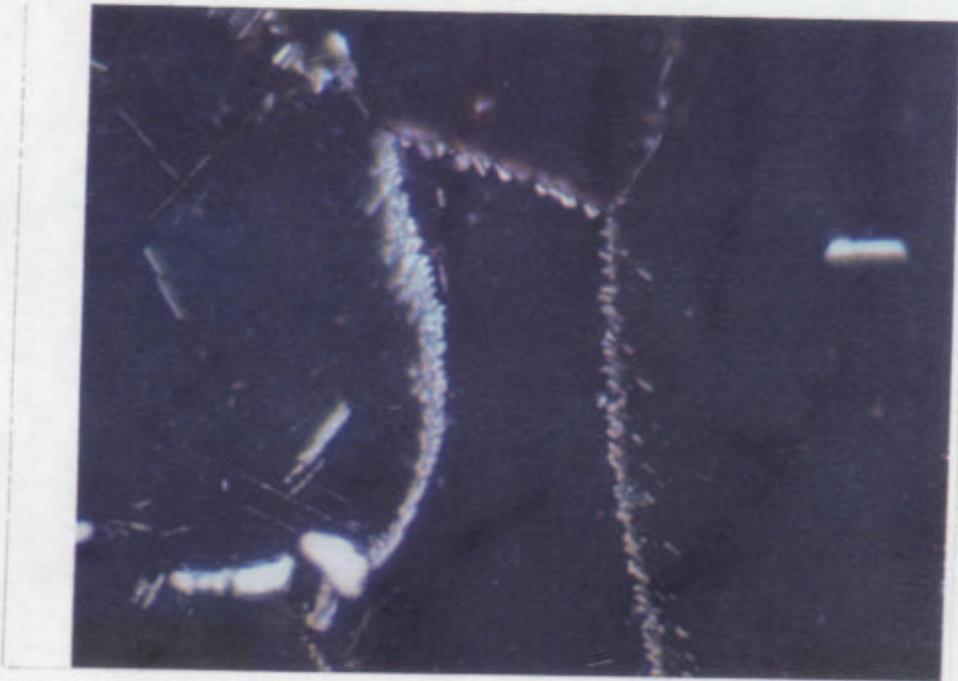
Figure 24. Higher magnification photomicrograph of an area located at the left lower corner in figure 23. (1,500X)

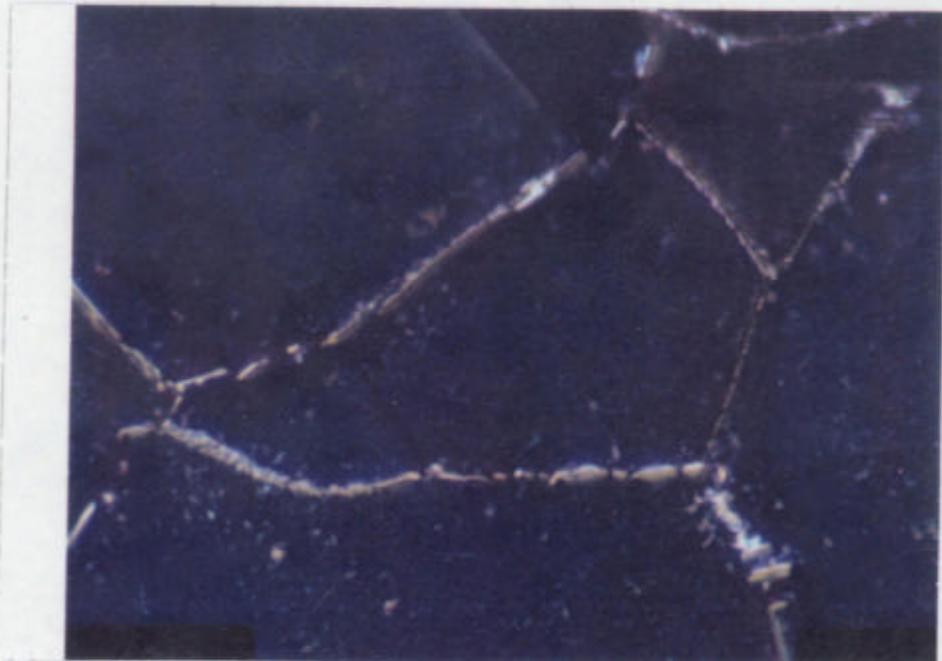
Figure 25. Higher magnification photomicrograph of an area located at the left upper corner in figure 23. (1,500X)

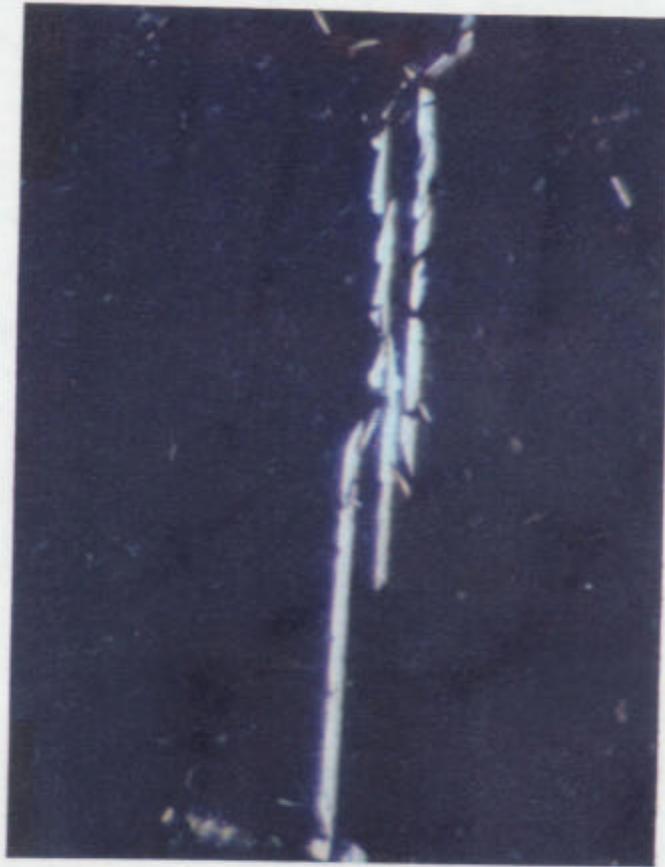
Figure 26. Higher magnification photomicrograph of an area located at the mid upper edge in figure 23. (1,500X)

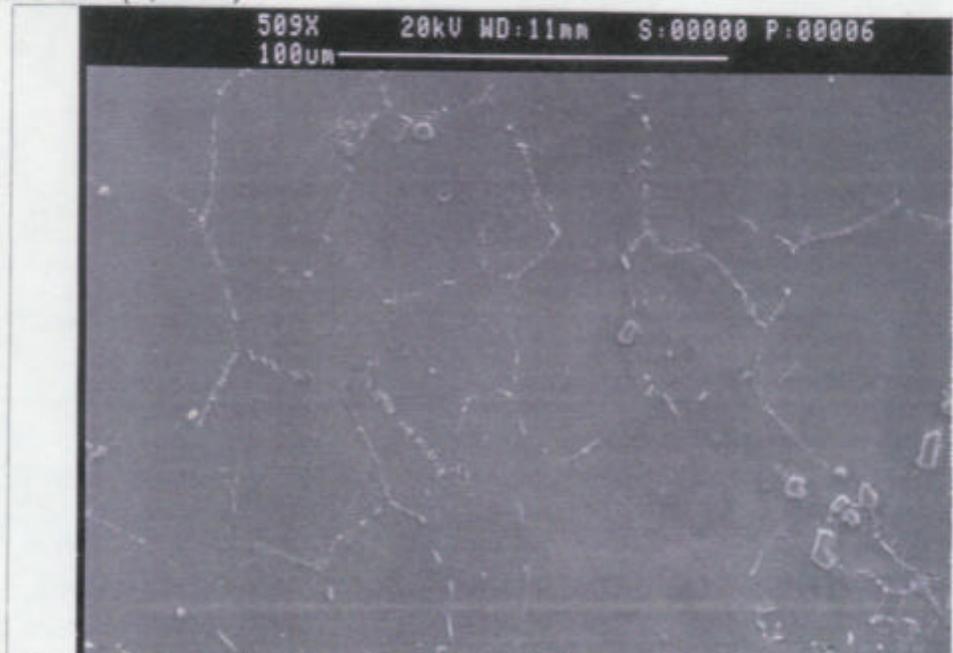
Figure 27. SEM photograph of section "Y-Y" at the web in the area below the fracture origin area. The section was etched with Tucker's reagent, followed by electrolytic etch with a phosphoric acid reagent, and sputter coated with gold-palladium. (509X)

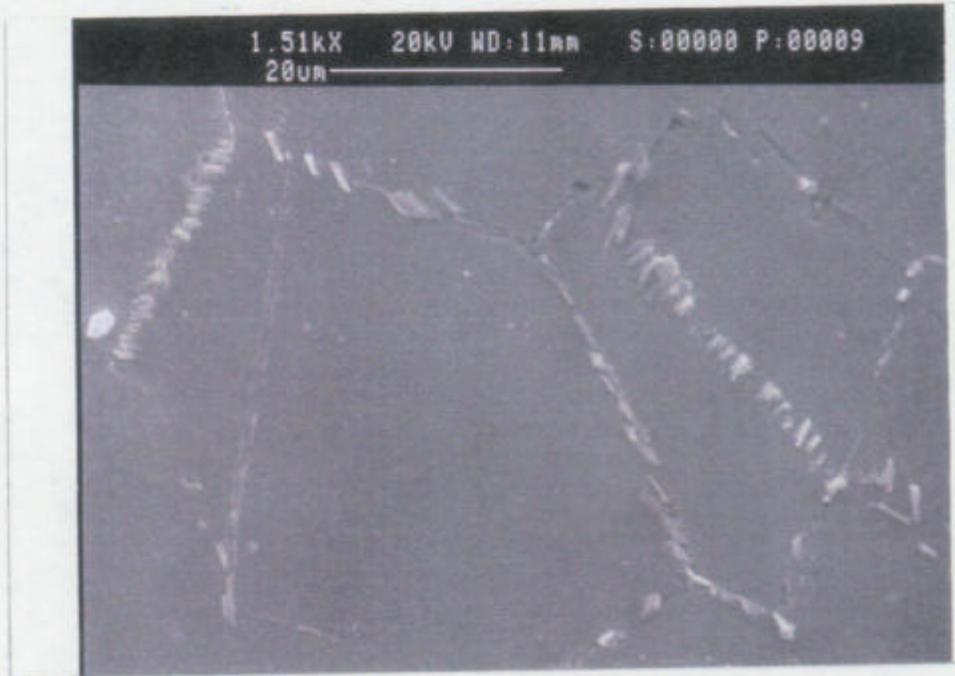
Figure 28. Higher magnification SEM photograph of an area located at the left lower corner in figure 27. (1,501X)

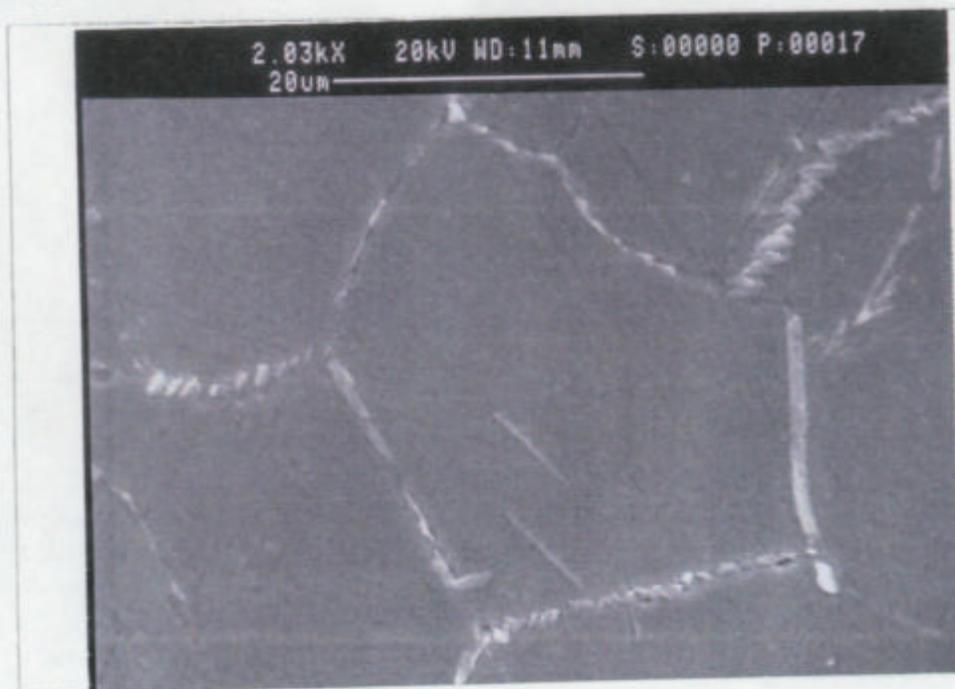
Figure 29. SEM photograph of section "Y-Y" located at the web and below the fracture origin area showing a typical microstructure. (2,030X)

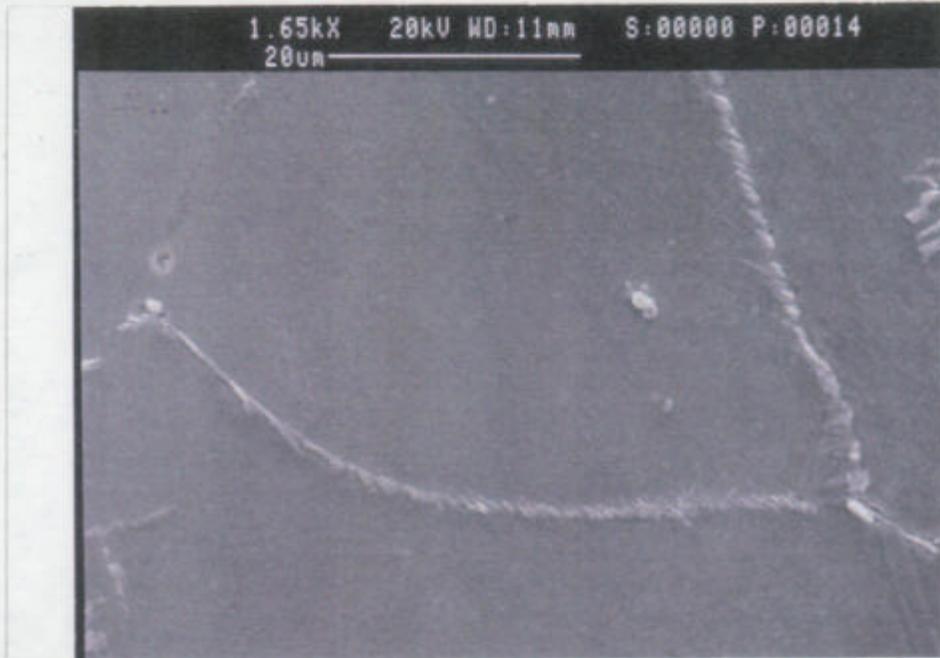
Figure 30. SEM photograph of section "Y-Y" located at the web and below the fracture origin area showing typical microstructure. (1,650X)

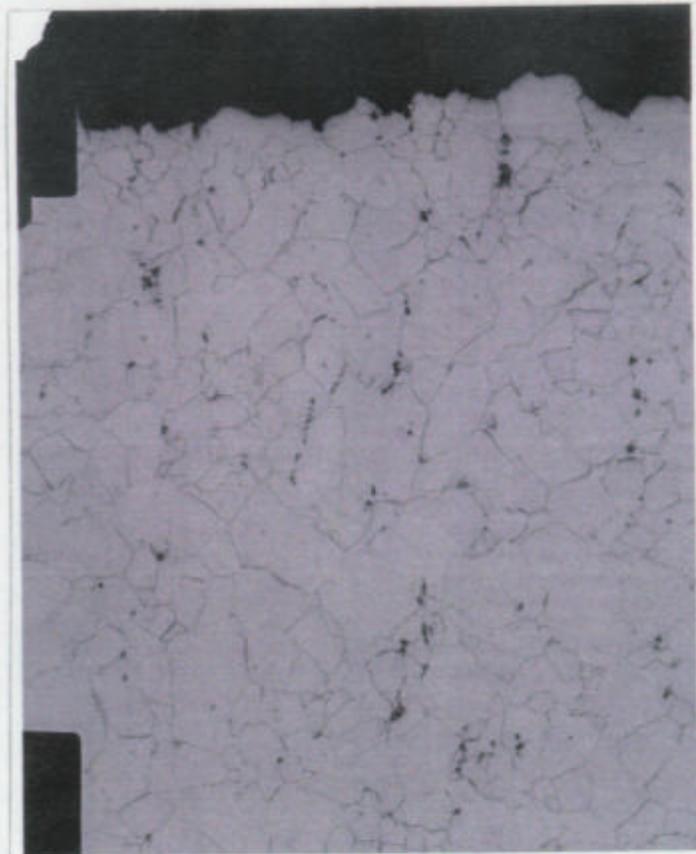
A section was made through the approximate center of the fracture origin area, in the location indicated by line "T-T" in figure 3. The section was encased in a metallurgical mount, polished and etched with Tucker's reagent. Examination of the section revealed intergranular cracking at the fracture surface. The cracking extended between grains and typically did not exceed the thickness of two grains. The cracking at the grain boundaries generally was oriented nearly perpendicular to the fracture surface, with no evidence that these intergranular cracks extended parallel to the fracture surface. The grain boundaries contained no voids. The microstructural constituents in the section through the fracture origin area appeared similar to those found in the metallographic sections from the bore and rim portions of the disk. Figures 32 through 34 show photographs of typical microstructure of the section through the fracture origin.

Figure 31. Section through the approximate center of the fracture origin area at the location indicated by section line "T-T" in figure 3, showing typical grain size in the area adjacent to the fracture surface (top of photograph). Etched with Tucker's reagent. (100X)

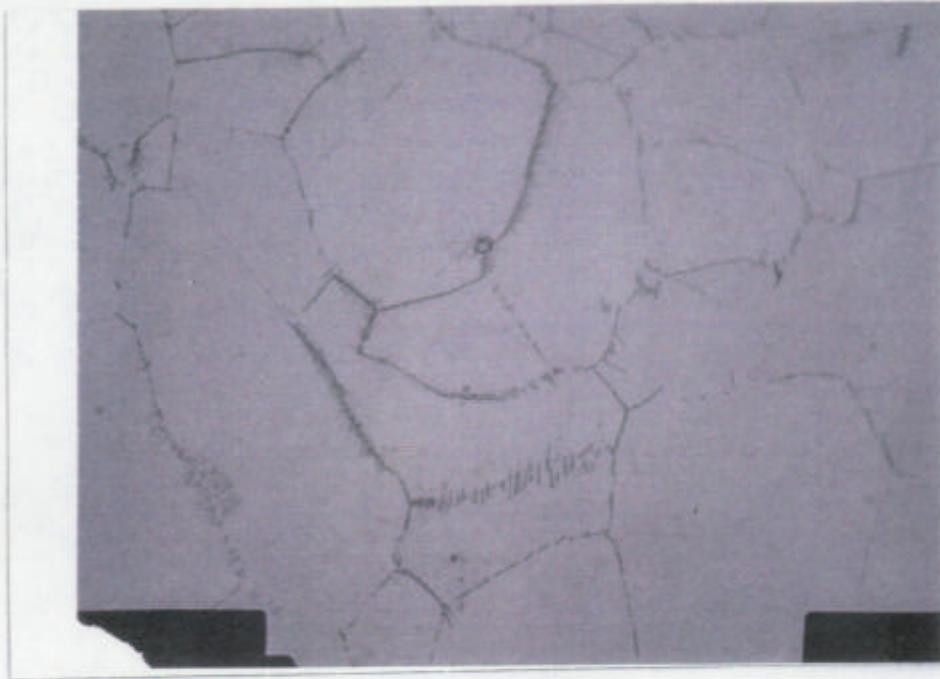
Figure 32. Typical microstructure near the fracture origin area. Etched with Tucker's reagent. (500X)

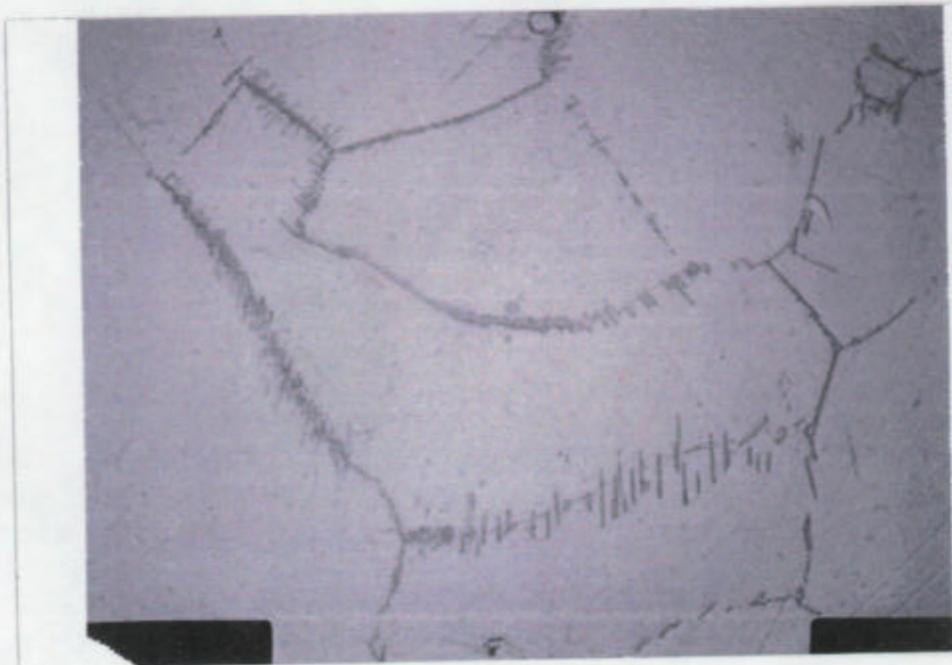
Figure 33. Higher magnification photomicrograph of typical microstructure near the fracture origin area. Etched with Tucker's reagent. (1,000X)

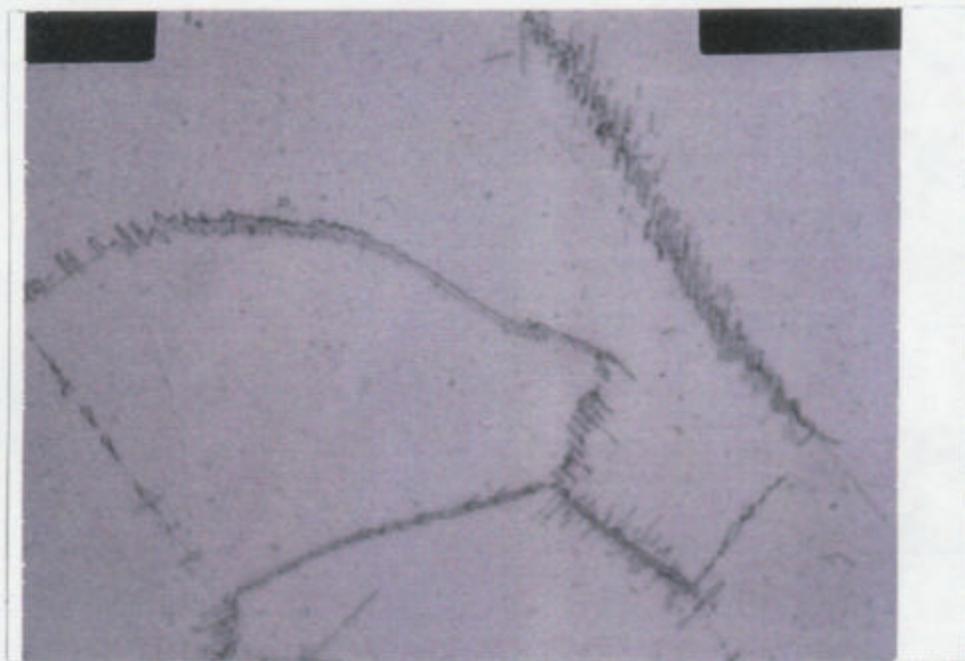
Figure 34. Higher magnification photomicrograph of typical microstructure near the fracture origin area. Etched with Tucker's reagent. (1,500X)
