Aviation Occurrence Report Volume I

IN-FLIGHT BREAKUP OVER THE TAIWAN STRAIT

CHINA AIRLINES FLIGHT CI611

BOEING 747-200, B-18255

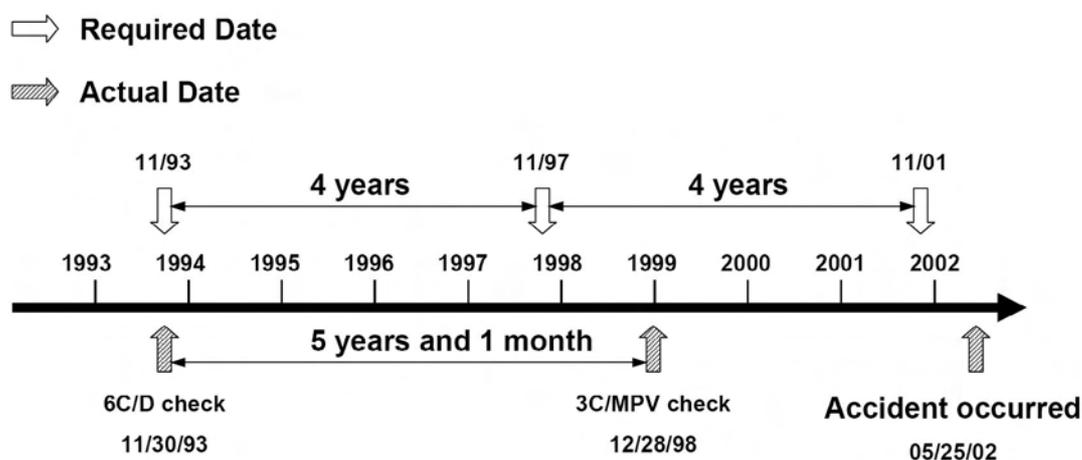
Figure 1.6-6 Deviations on CPCP item 53-125-01 required for B-18255

When the Safety Council reviewed the CAL B747-200 AMP with respect to B-18255’s maintenance history, it was noted that AMP CPCP item 53-125-01 inspection of the bilge was delayed in implementation for 13 months until the 1998 MPV check. The AMP required this item to be inspected every 4 years.

Other than CPCP item 53-125-01, another 28 items were found to have been deferred beyond the time intervals of the AMP required scheduled inspection dates. Neither CAL nor the CAA were aware of this CPCP schedule delay issue before November 5, 2003, the time when the Safety Council conducted investigation of this issue.

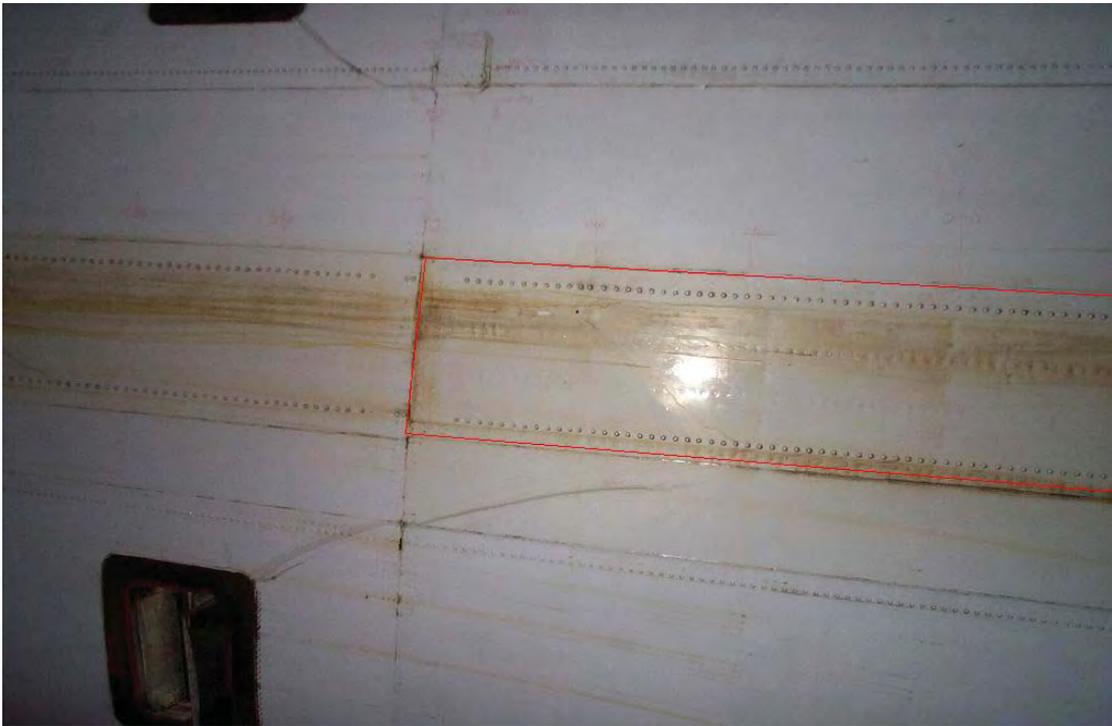
Figure 1.6-8 Aft of No.16 doubler (Picture taken on Nov 26, 2001)

The B-18255 repair doubler mapping chart is shown in Figure 1.6-7. Photographs of number-16 doubler, the repair as the result of the 1980 tail strike, are shown in Figure 1.6-8 and 1.6-9. Number-16 doubler consists of two patches. The size of forward patch is 125 inches in length and 23 inches in width from STA 2060 to STA 2180. The aft patch is 60 inches in length and 23 inches in width from STA 2180 to STA 2240.

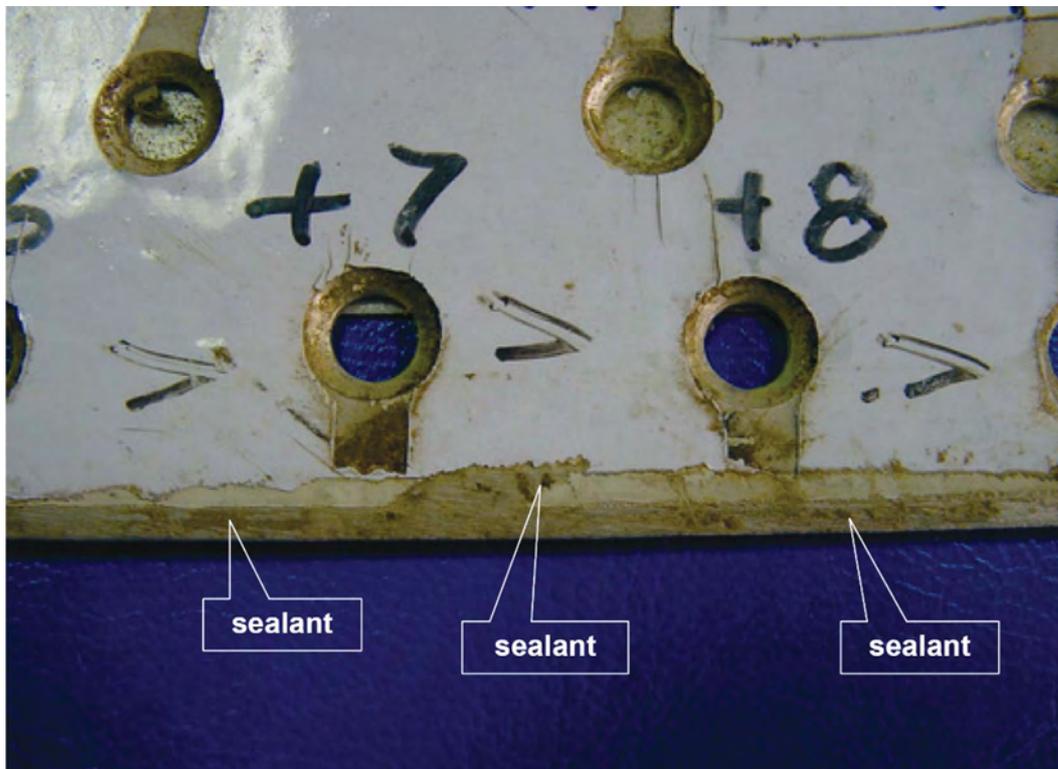
Figure 1.6-11 Paint removed from the doubler edge with sealant remaining

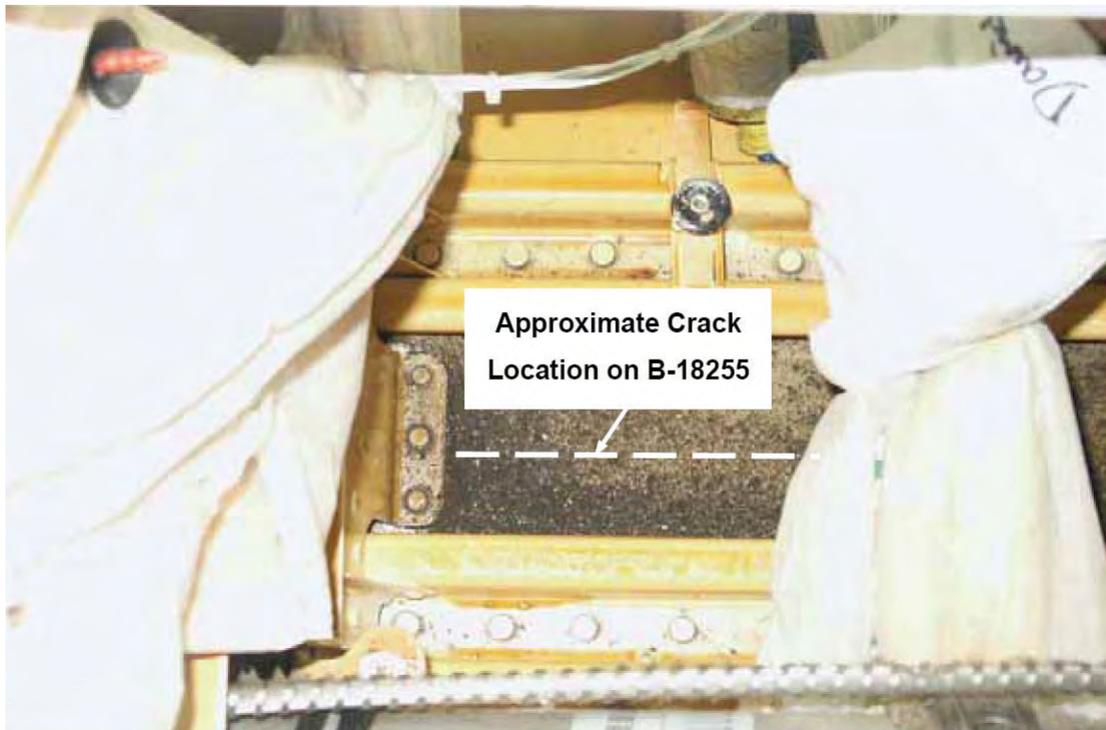
Figure 1.6-12 shows a B747-200 freighter bilge after cleaning. Figure 1.6-13 shows the bilge before corrosion inhibit compound and dust was removed from a B747-400 freighter. The stain on the lower lobe skin cover part of the paint. The bilge was covered with dirt and residue on two adjacent insulation blankets in the bulk cargo lower lobe bay.

Figure 1.6-13 A B747-400 aircraft bilge area without removing CIC and dust

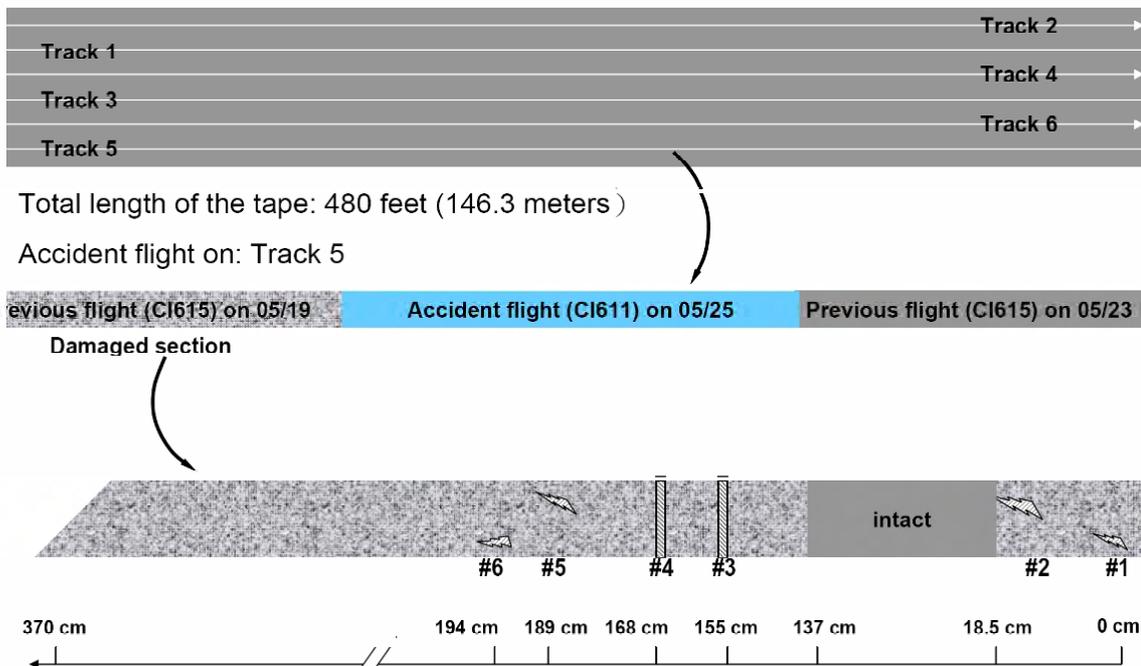
Upon arrival, the FDR enclosure was open immediately and the magnetic tape was found damaged. Pictures of the damaged FDR tape are shown in Figures 1.11-3 and 1.11-4. There are six crinkle marks on the tape.

Figure 1.11-4 Sketch of damaged tape locations and conditions

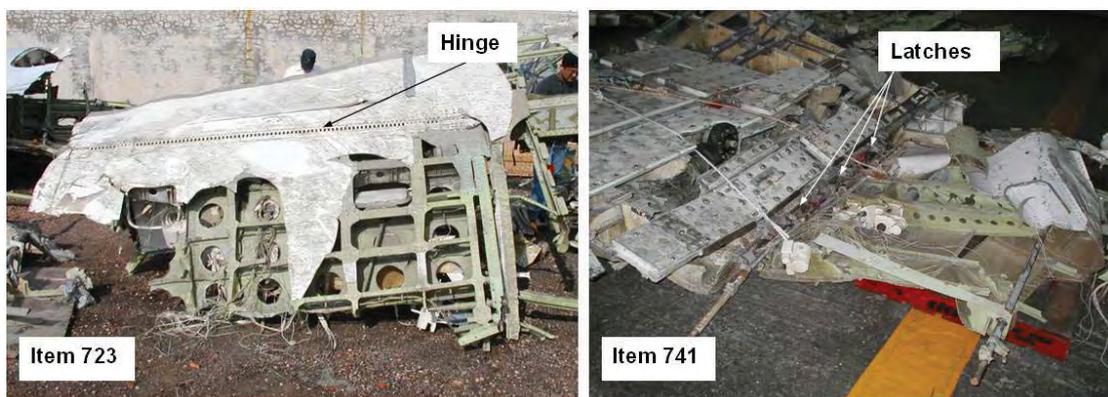
Figure 1.12-4 Item 723 (left) and item 741 (right)

The lower portion of the door (item 741 in Figure 1.12-4 right), including three forward pairs of latches, was recovered still latched and the locks engaged. Only a few pieces of the skin and stringers remained on the frames.

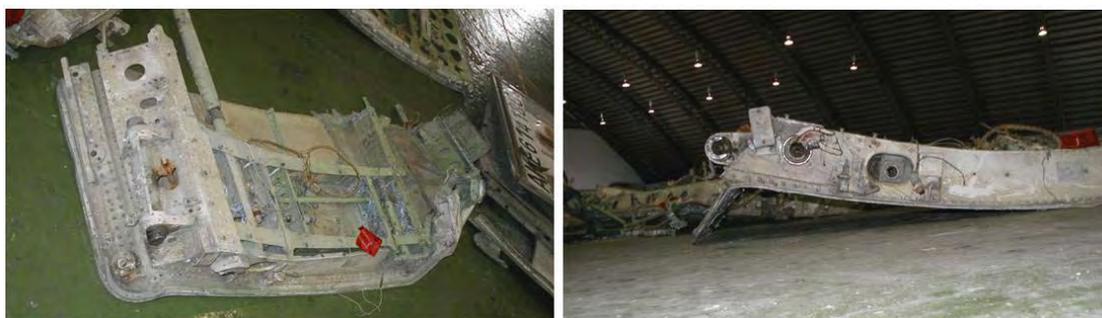
Figure 1.12-5 Item 2019

The lower aft portion of the door (item 2019 in Figure 1.12-5), including the aft pair of latches, was found separately. The lower portion of the door skin was bent outboard approximately in 45 degrees. Examination of the hinge, latches, and the other mechanisms was consistent with the aft cargo door being closed at the time of the aircraft breakup.

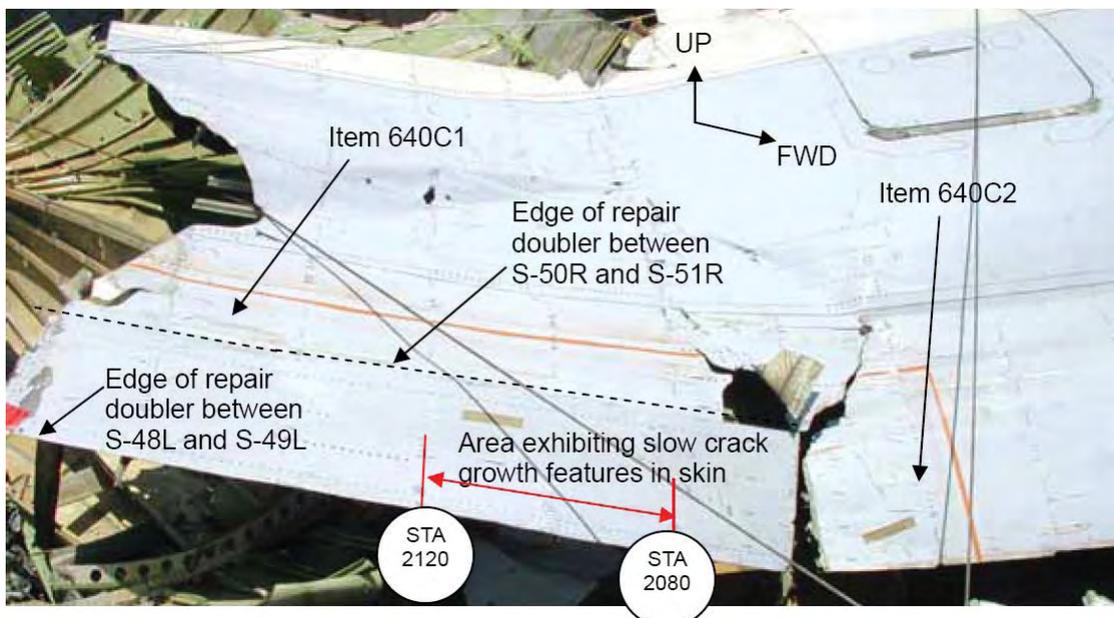
Figure 1.12-6 Item 640

Also included in item 640 is the bulk cargo door. The segment was recovered with the door closed and latched. The lower portion of the bulk cargo door seal protruded through the space between the door and the sill.

The forward portion of item 640 includes the aft portion of the aft cargo door cut out frame. There are deformations at the lower latch fitting attachment location.

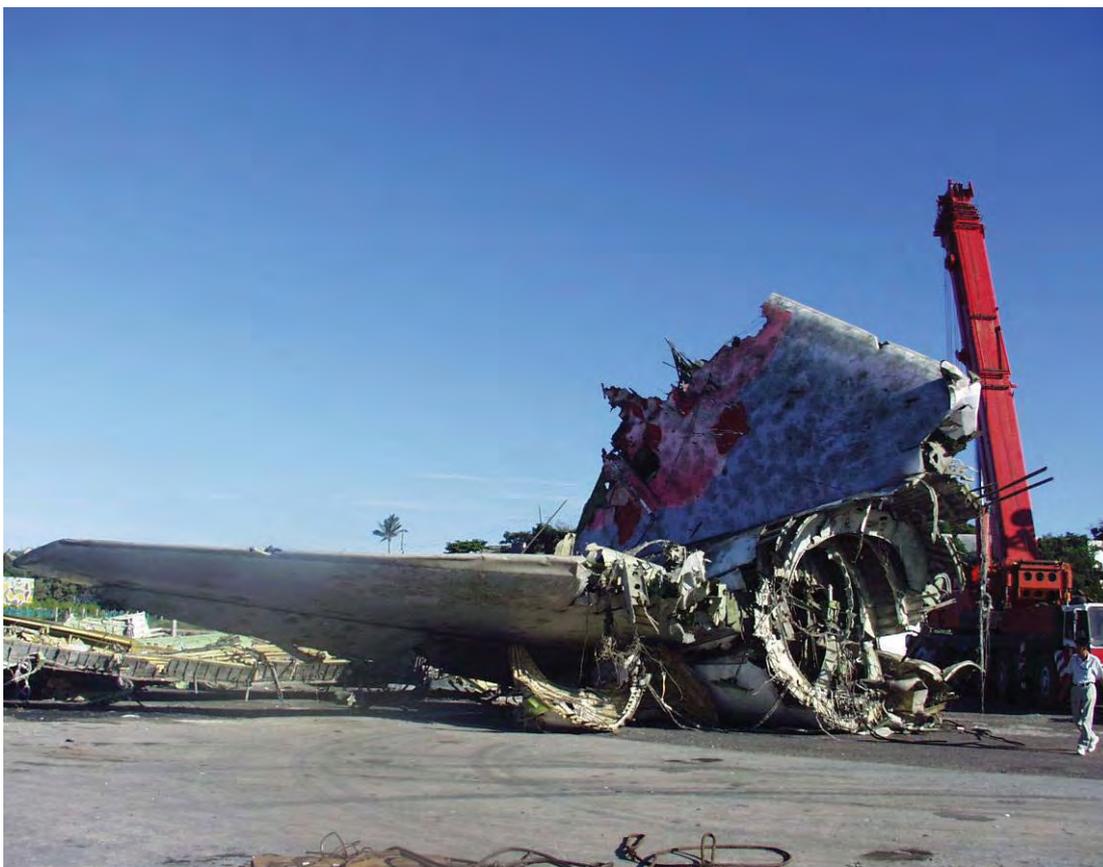
Figure 1.12-9 Item 630

The section 48 and empennage structure (the aft pressure bulkhead and all structure aft) was found in the red zone (Figure 1.12-8). The horizontal stabilizer, the majority of the skin/stringer/bulkhead structure, and the lower third of the vertical fin were found attached with very little damage (Item 630, Figure 1.12-9).

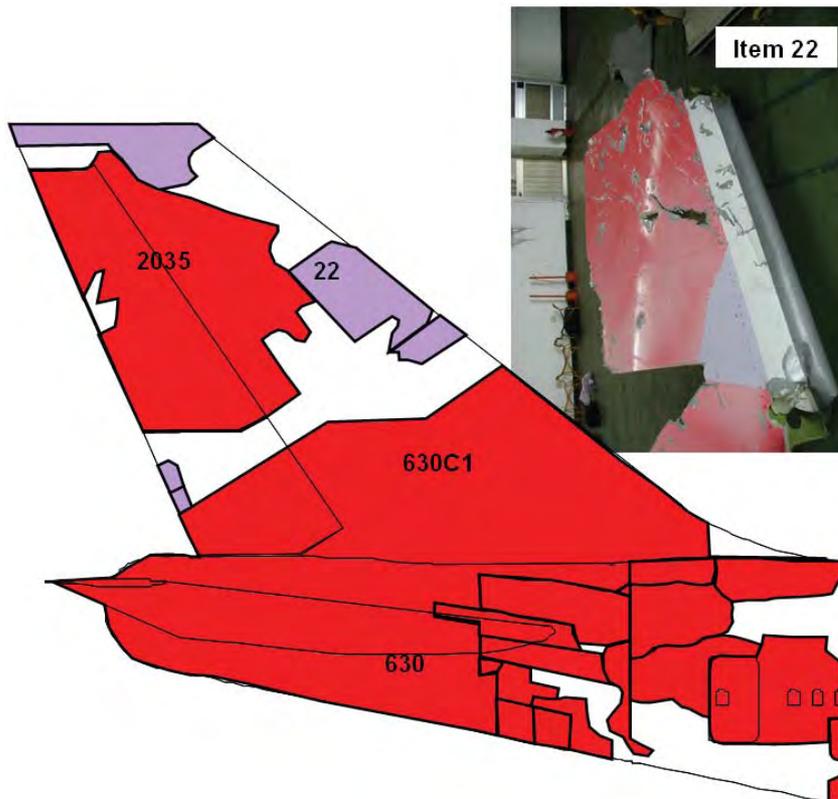
Figure 1.12-11 Vertical fin and item 22

Some fin structure, including leading edge structure and the fin cap (items 22, 23, and 960) were recovered as floating debris. A large upper portion of the fin and rudder was found separate from item 630.

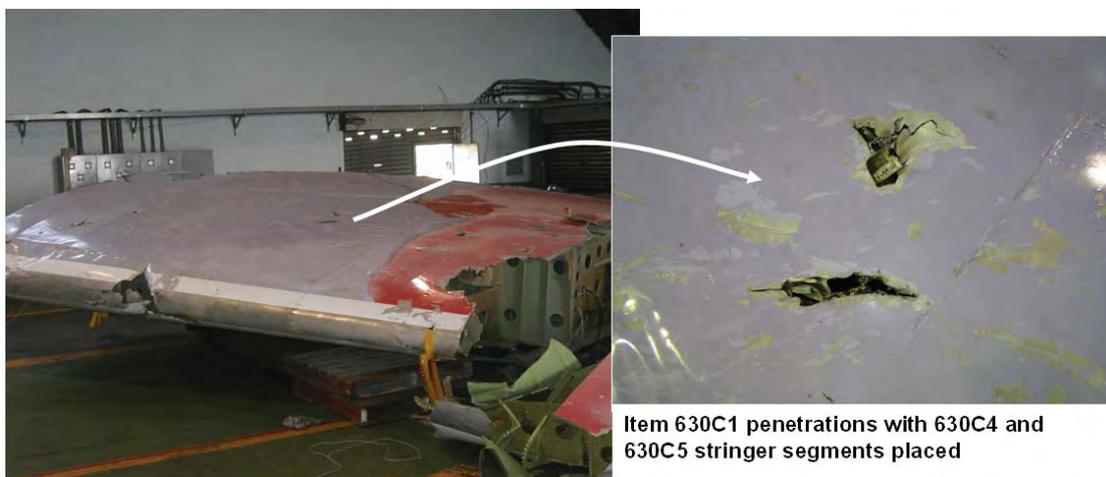
Figure 1.12-12 Item 630C1

The lower portion of the fin (item 630C1), the upper portion of the fin (item 2035), and several of the floating pieces (item 22) show similar evidence of impact damage on the right side.

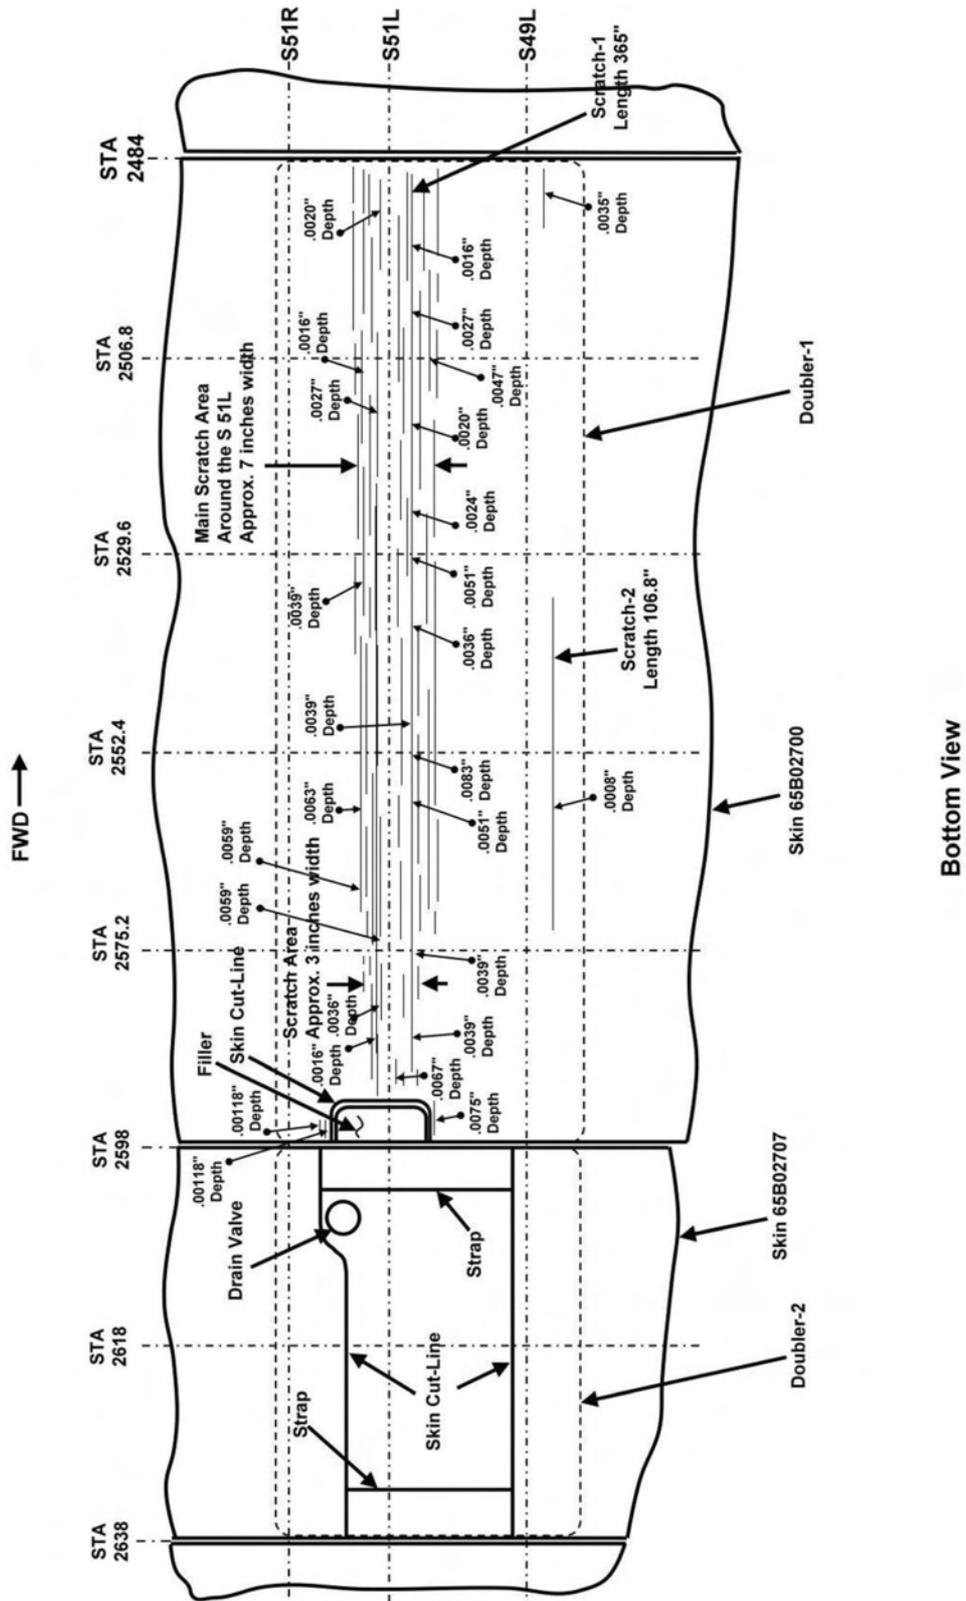
Figure 1.12-14 The schematic diagram of the doublers in Section 48

width of approximately 7 inches. At STA 2575.2, the area is 3 inches in width, and ends at STA 2598. Scratch-2 is in vicinity of S49L and starts from STA 2535 with the length of 42 inches. No evidence of crack was identified in this region. There are dents at STA 2567 and STA 2610, which was the result of wreckage handling.

It was noted that the former topcoat, enamel and primer (original painting before the skin repair) remained on the skin covered by Dubler-2.

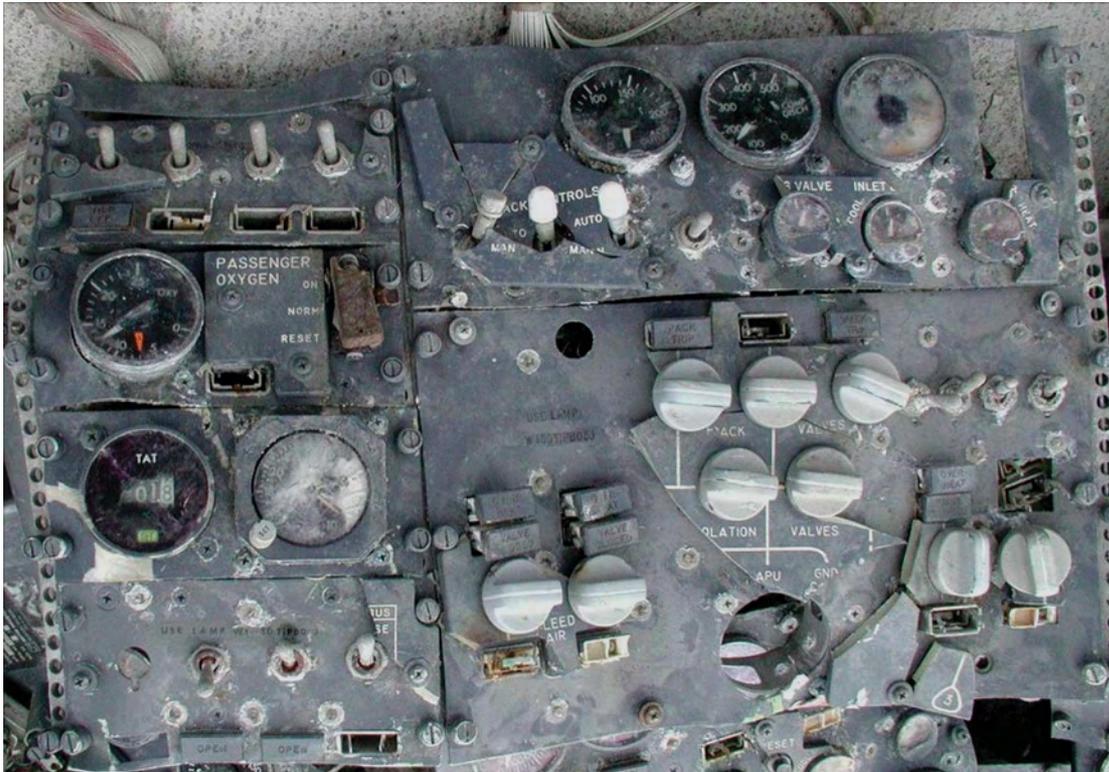
Figure 1.12-17 Flight engineer panel

Bleed Air switch was found in OPEN.

- MODE SELECT switch was found in MAN (manual) mode.
- The ALTITUDE tape was delaminated and partially missing.
- Both OUTFLOW VALVES indicator needles were found detached from their respective internal armature/wiper attachment mechanisms.

- The three PACK VALVES switches were found in the OFF position.
- Engine numbers 1 and 2 BLEED AIR switches were found in the OFF position.
- Engine numbers 3 and 4 BLEED AIR switches were found in the ON position.

- PASSENGERS OXYGEN needle at 700 psi. (which was disconnected from its driving rod either during or before disassembly).
- PASSENGER OXYGEN control switch was found in NORM position. Switch is functional.
- Switch guard breakaway wire is broken.
- Switch guard is damaged with portion missing.

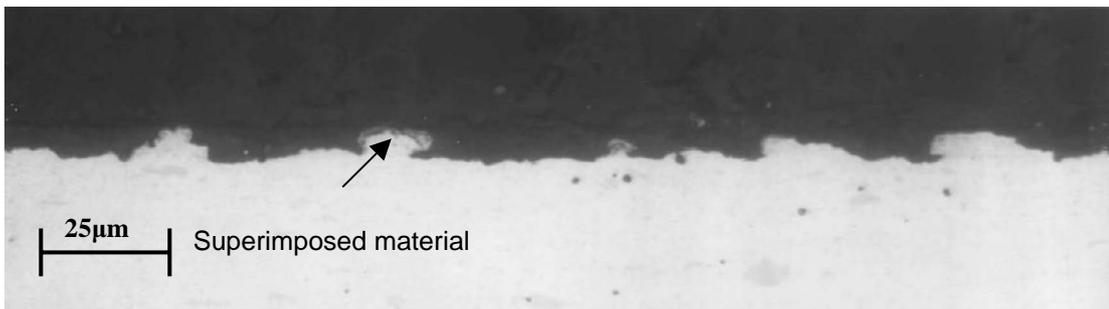
Figure 1.16-10 Metallographic photograph of the profiles marked by data sampling cut #1 in Figure 1.16-9

On the overhanging portion on the faying surface of the repair doubler, numerous areas exhibited signs of localized fretting above the S-49L fracture surface (Figure 1.16-8). Features of these fretting marks were described as follows:

- The fretting marks observed from STA 2061 (hole +16) to STA 2132 (hole 49) are associated with most of the rivet locations. The most significant fretting damage was present between holes 8 and 43.
- The fretting marks near hole 32 and an optically magnified photograph of the area of contact is shown in Figure 1.16-9. It shows that the area of contact exhibits many colors and some hoop-wise scratches (marked by arrows).
- Two cross-section locations were chosen to characterize the area of contact. Figures 1.16-10 and Figure 1.16-11 show the metallographic photographs through the area marked by data sampling cut #1 and data sampling cut #2 respectively. It is observed that there was some material superimposed over the grooves of the scratches.

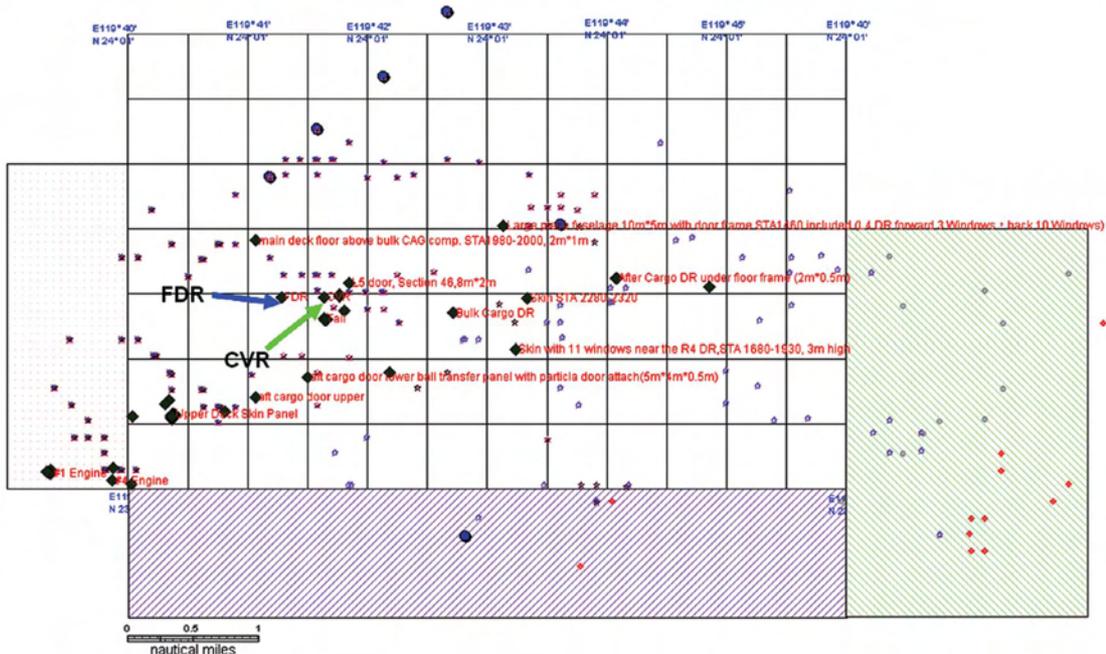
Figure 1.18-3 Relative position of the two recorders and the wreckage

The Distance between the two recorders was about 610 meters. Relative positions of the two recorders, as well as the wreckage distribution are shown in Figure 1.18-3.

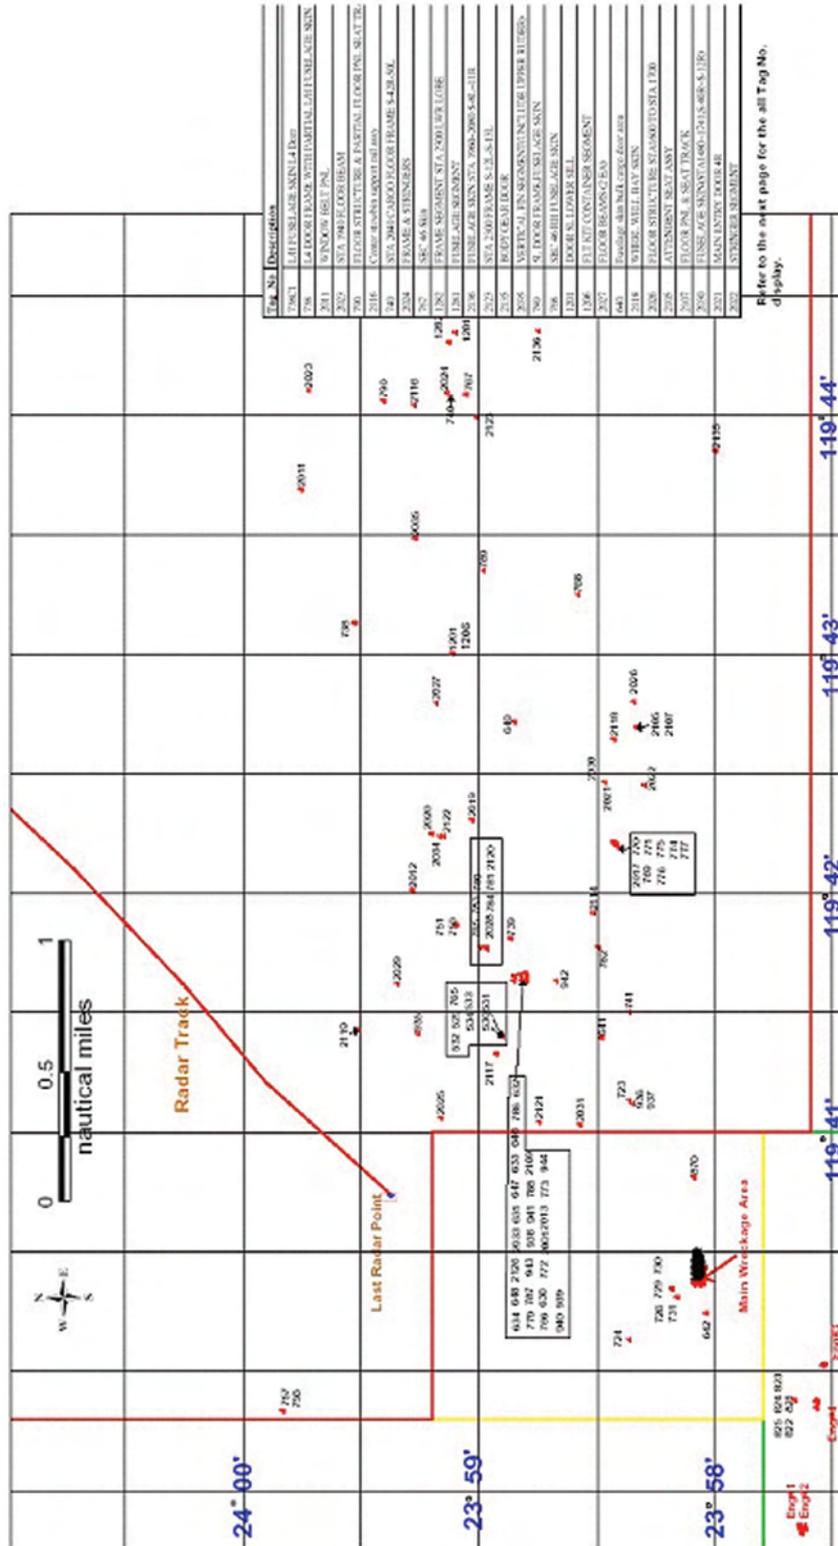
Figure 1.18-4 The wreckage distribution map

As a whole, the wreckage recovery operation for the CI611 accident investigation lasted nearly 5 months, recovered approximately 1,500 pieces, and 175 bodies. After combining all the survey sources and the wreckage recovery locations, the wreckage map is shown in Figure 1.18-4. There are still 50 bodies and a major portion of the Section 46 uncovered.

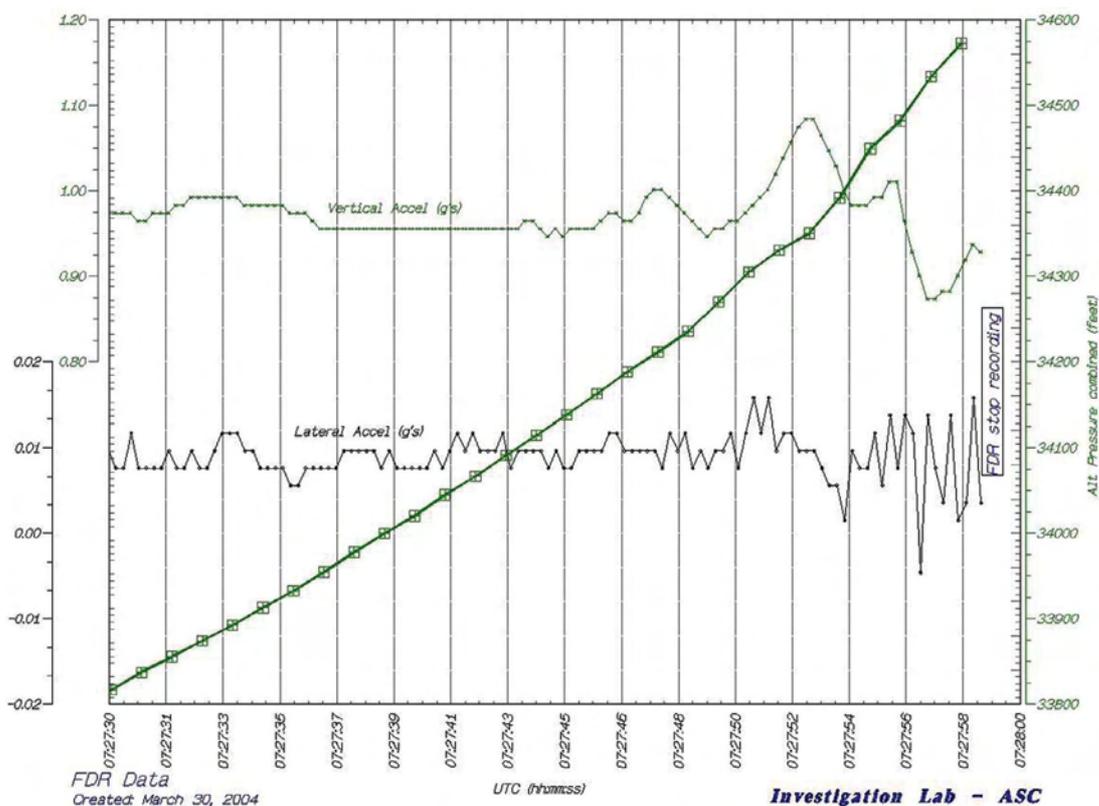
Figure 2.1-1 CI611 vertical and lateral acceleration data (last 30 seconds)

10 seconds prior to the loss of power of the flight recorders, there was a slow increase in both the vertical acceleration and lateral acceleration, as shown in Figure 2.1-1. By comparing the lateral acceleration parameter of the previous two flights of B-18255, before approaching its cruising altitude of 35,000 ft, similar oscillatory behaviors were found, as shown in Figure 2.1-2. Comparison was also made of the vertical acceleration parameter of CI611 and the two previous flights. A more pronounced increase in magnitude of the vertical acceleration was observed. These data led to the consideration that a preliminary breakup of the fuselage structure might have been in progress before the power loss of the FDR.

However, on Boeing 747 aircraft, the accelerometers are mounted along STA 1310, which is near the aircraft's center of gravity. These instruments measure accelerations of the aircraft associated with maneuvering, turbulence etc. They do not accurately measure the frequencies of vibrations that may pass through the fuselage. With the limited data available, the Safety Council could not determine what led to the slight increase in vertical acceleration prior to the break-up of the aircraft.

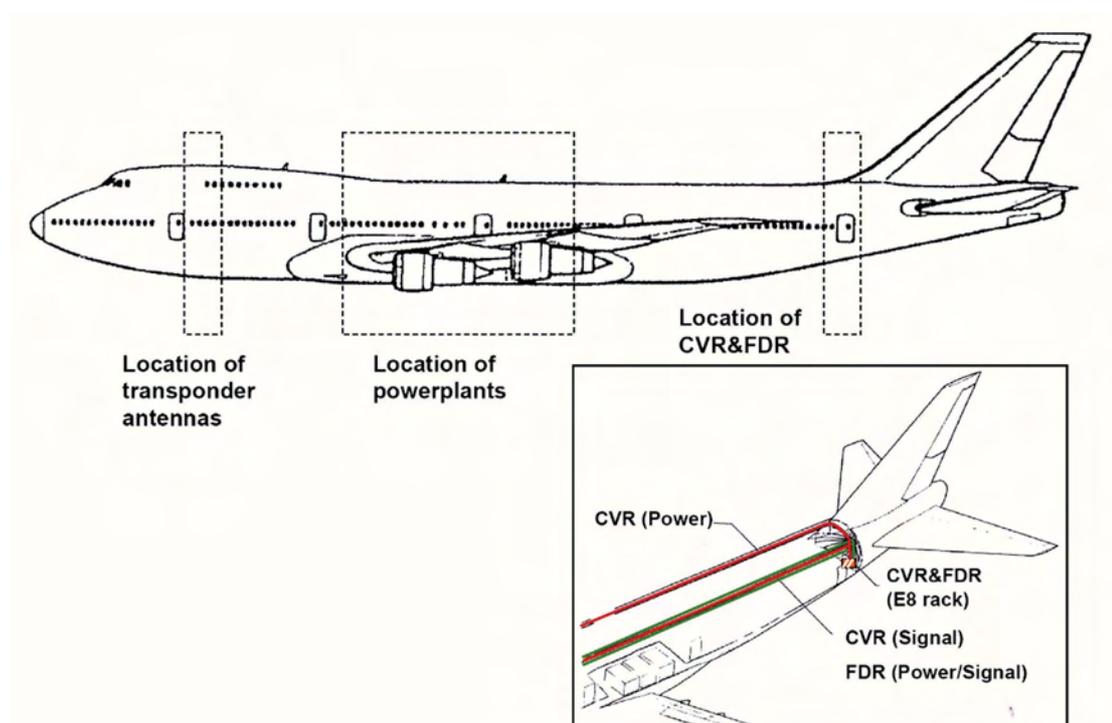
Figure 2.2-1 Locations of flight recorders, transponder antennas, and power plants

1527:59. However, the radar transponder continued to transmit for about 15 seconds longer. Therefore, the breakup should occur between the power plants and the recorders.

The Aviation Safety Council concludes that the loss of power to the CVR and FDR was the result of damage to electrical wires in the aft-pressurized fuselage area as the aircraft began to breakup. The forward portion of the aircraft continued to have power to the Mode-C transponder system for about an additional 15 seconds, before power to the transponder was interrupted.

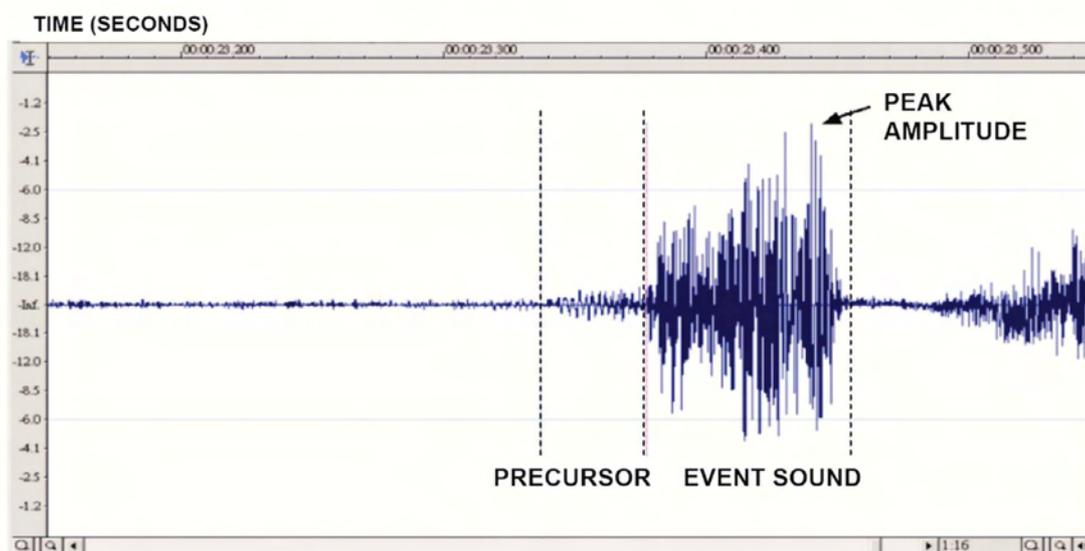
Figure 2.2-2 Typical precursor and event sound signatures

Based on different sound wave propagating speed via air and via the aircraft structure, the travel time of the sound wave from an event source via air or aircraft structure to reach a specific point on the aircraft are different, such time difference can be referred to as the precursor in the CVR recording. When the event source is away from cockpit, the arrival time of precursor to the CAM is always ahead of the event sound because the sound wave propagating speed in metal is much faster than in the air. Figure 2.2-2 shows the CI611 CVR recorded precursor and event sound signatures. By comparing both signatures can provide the possible propagation path of event sound.

As the sound propagates, the propagation media would affect the magnitude of precursor and event sound differently. When the event sound propagated through fuselage, the fuselage structure will greatly attenuate the sound wave energy and the magnitude of the event sound sensed by CAM would be much less than the sound propagated only via air. In other words, if the breakup is occurred in the non-pressurized area, the fuselage structure will behave like a sound insulator that reduces the magnitude of the sound wave to the CAM; therefore, the event sound level would be less than the precursor level. In the case of CI611, the event sound level is much higher than the precursor sound level. Based on these assumptions, the Safety Council concludes that the structural breakup of the accident aircraft was most likely occurred in the pressurized area. The detail CVR sound spectrum analysis is in section 2.6.

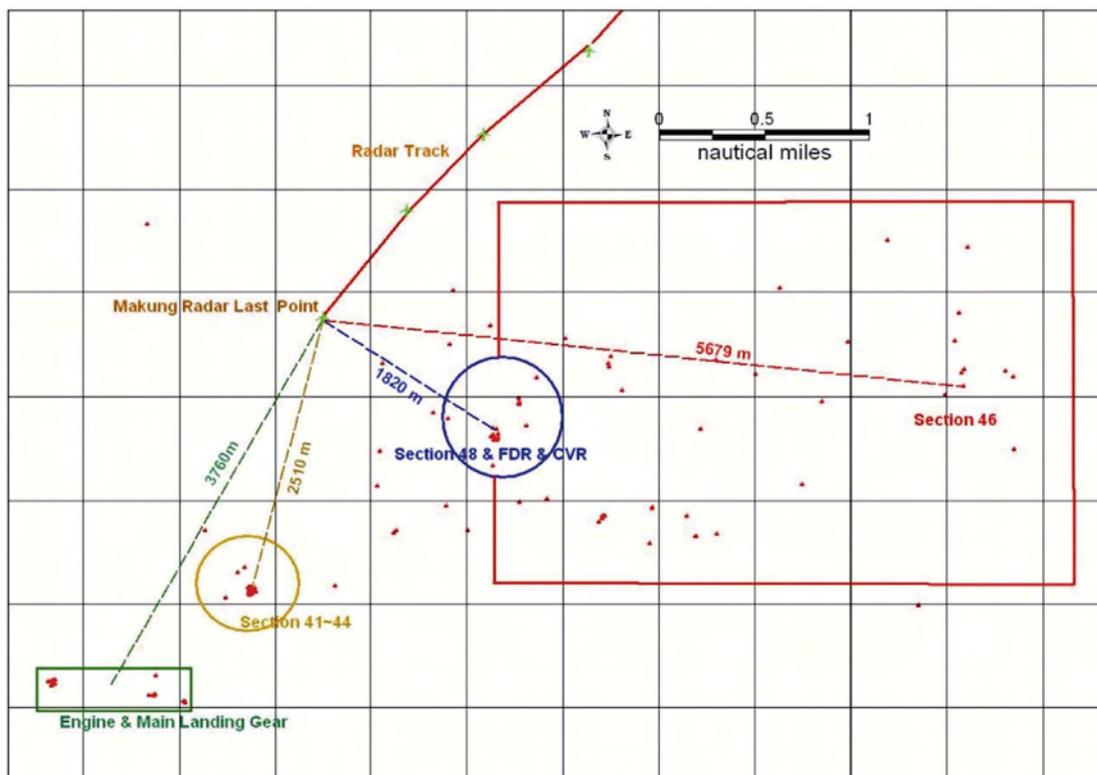
Figure 2.2-3 Relative location of the wreckage

Figure 2.2-3 shows the relative locations of the CI611 wreckage. The wreckage distribution pattern matches the four groups of aircraft wreckage detected by PSR.

The wreckage distribution data show that the distance between the tail (section 48 with lower portion of fin) and forward portion of fuselage (section 41-44) was 1.5 nautical miles. The distance between the tail and most eastbound wreckage (section 46), which was recovered under water, was 3 nautical miles.

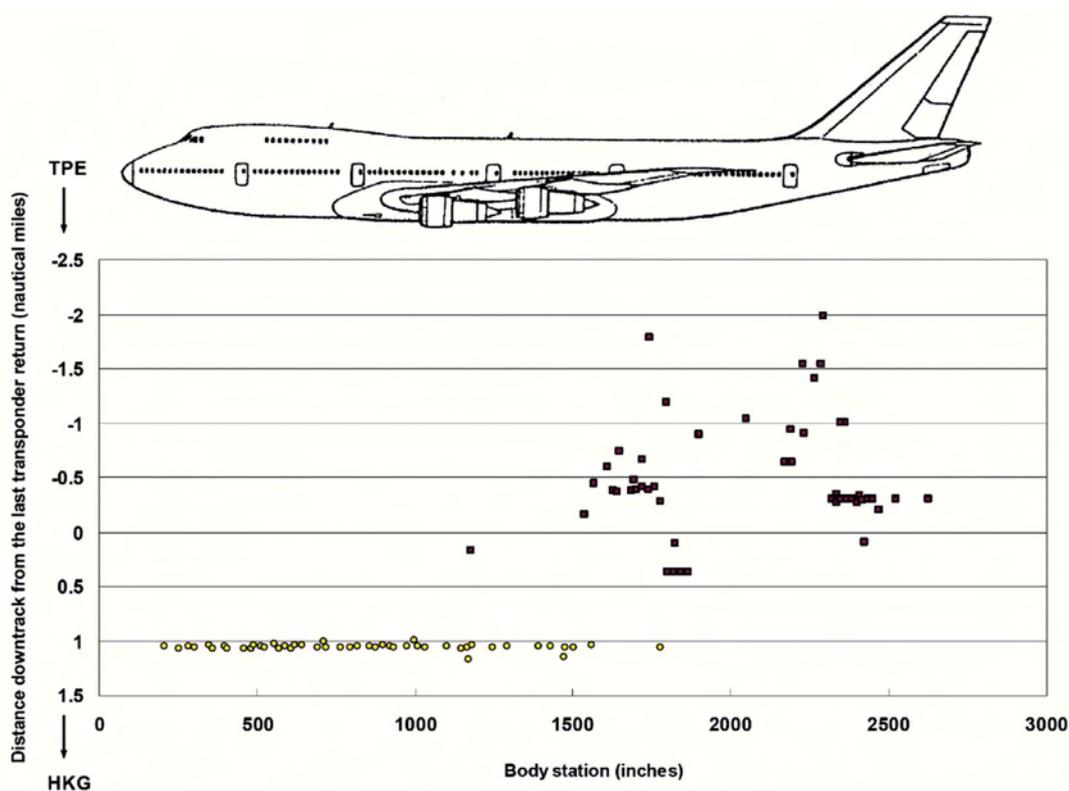
Figure 2.2-4 Wreckage distributions along the flight path

The wreckage distribution can also be plotted along the flight path from Taipei to Hong Kong, which is shown in Figure 2.2-4. One can readily see that the wreckage pieces from the cockpit, engines, wings, all landing gears, and sections 41, 42, and 44 are distributed along a very concentrated segment while section 46, 48, and the tail empennage are spread widely.

The figure also shows a step jump from the forward portion of the aircraft to the aft sections. It shows that the fuselage section 46/48 structure aft of the aft wheel well bulkhead at STA 1480 was separated from the rest of the aircraft.

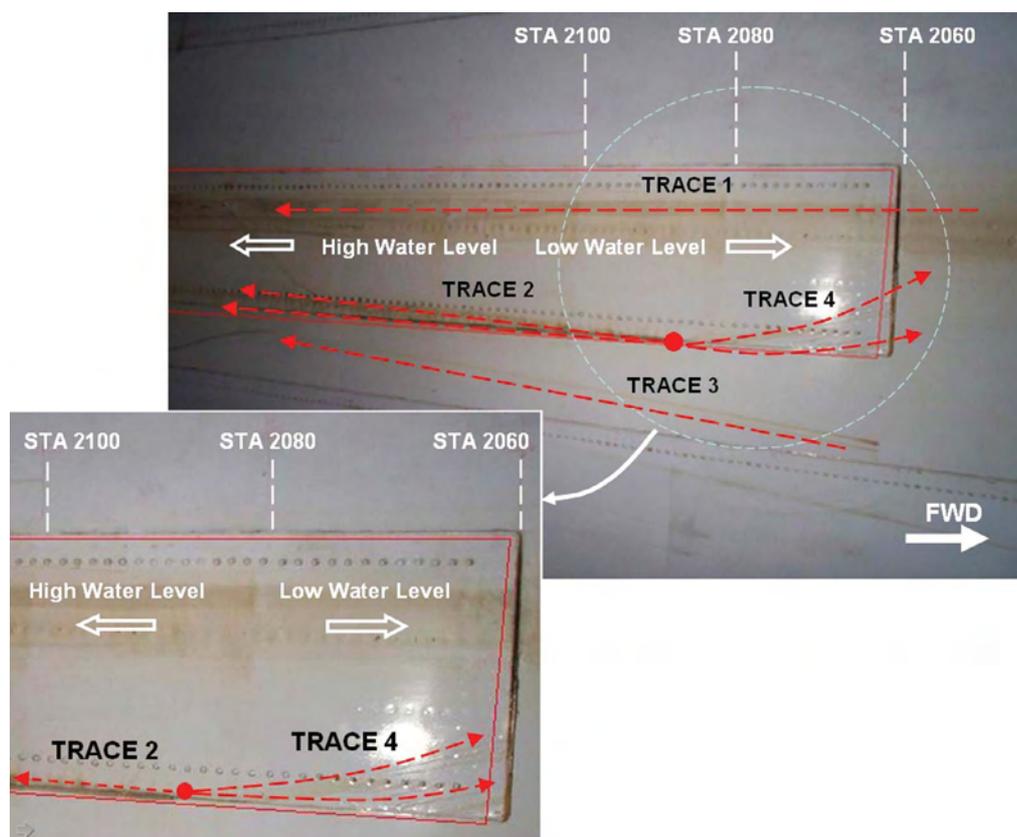
Figure 2.2-5 Comparison of Trace 1,2,3 (straight line) and 4 (curve)

The photograph was taken from underneath the aircraft looking up towards the fuselage. This area of the aircraft belly slopes upward towards the rear of the aircraft. When the aircraft is parked, the forward end of the doubler is closer to the ground than the aft end. There were several traces observed on the doubler and the skin around STA 2100. Traces 1, 2, and 3 are brown in color and straight toward the aft of the aircraft, suggesting that the traces were induced by the relative wind during flight. Trace 4 shows several curved lines of transparent condensate liquid that flowed from STA 2090 toward the forward (lower) end of the doubler, consistent with flow due to gravity when the aircraft was parked. The traces seen in the November 2001 photographs were not evident on the wreckage when it was recovered.

Traces 2 and 4 began at the same origin but went in different directions. It suggests that trace 2 occurred as the aircraft was in the air, but trace 4 occurred when the aircraft was on the ground. The darkness of the traces shows the accumulated time and quantity of the flow. The color of trace 2 is the darker, which suggests a larger quantity of flow escaped into the air stream in flight.

This phenomenon, discovered during the accident investigation upon examination of photographs of the 1980 repair doubler, showed that there was possibility hidden skin damage beneath the doubler in the vicinity of STA 2100, at the time when the photographs were taken.

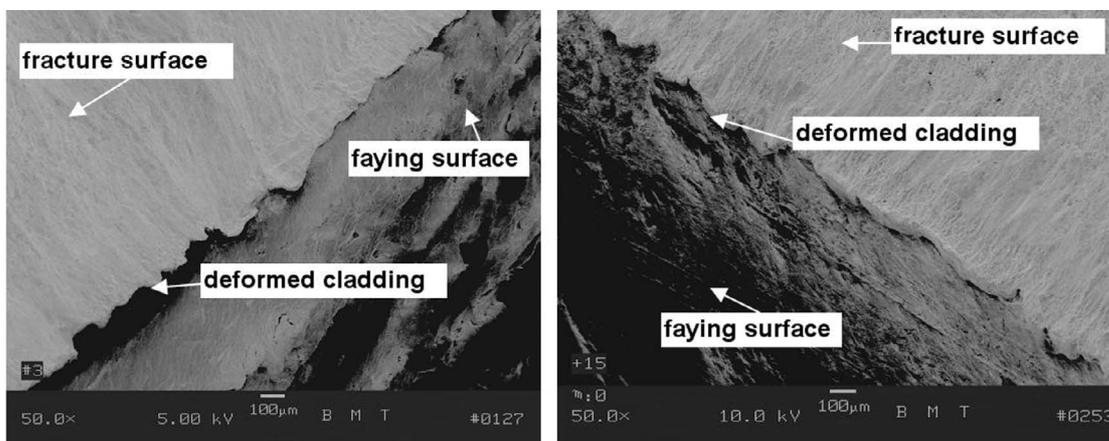
Figure 2.2-10 SEM photographs of the cladding near hole 3 (left) and +15 (right)

Cyclic rubbing of the fracture surface and associated compressive deformation of the cladding was observed along the faying surface shown in Figure 2.2-10 providing additional evidence of pre-existing crack. The cladding displayed compressive deformation due to cyclic crack closure as far forward as hole +17 and as far aft as hole 62. The remaining fracture aft of hole 62 displayed “necking”, which is typical of continuous tensile loading to ultimate tensile separation (Figure 2.2-11).

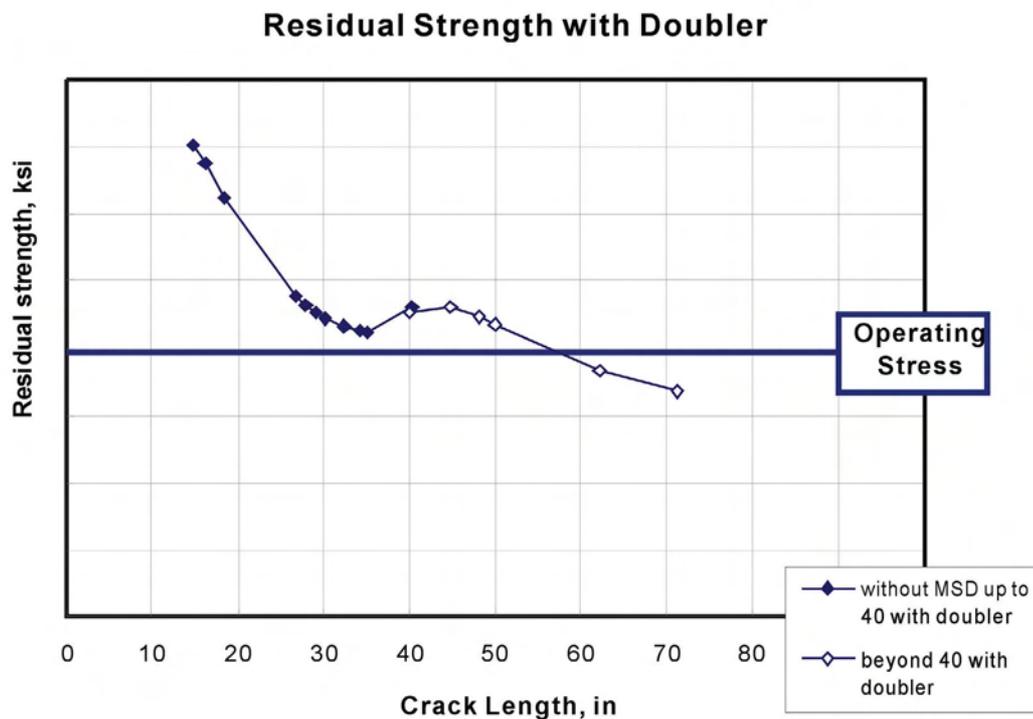
Figure 2.2-13 Residual strength of cracking

From the residual strength analysis discussed in section 2.5, when the crack was over 58 inches, the residual strength of the skin assembly would go below the operating stress (Figure 2.2-13), therefore caused the skin assembly beyond the capability limit

under the application of normal operational loads.
