Aviation Occurrence Report Volume I

IN-FLIGHT BREAKUP OVER THE TAIWAN STRAIT

CHINA AIRLINES FLIGHT CI611

BOEING 747-200, B-18255

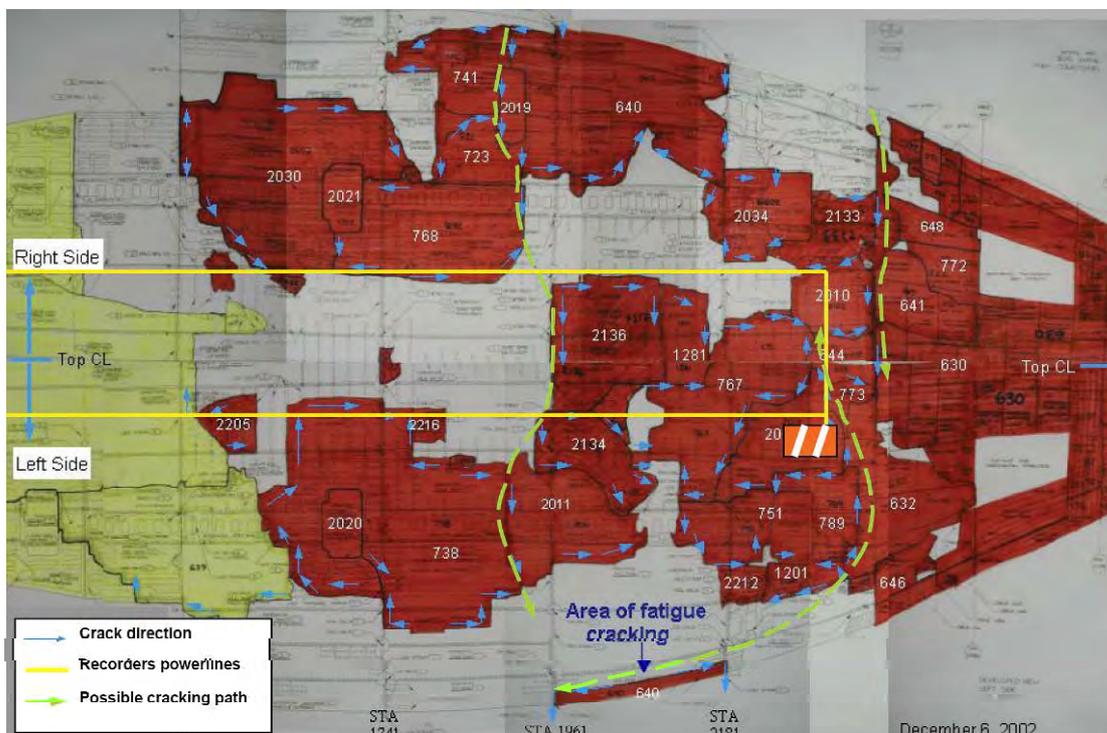
Figure 2.2-14 Directions of fracture propagation

Figure 2.2-14 shows the direction of the crack propagation on each piece of the wreckage in section 46. The methodology used to determine the direction of the cracking is described in Appendix 18. Once a portion of the structure failed, it could no longer sustain the integrity of the entire fuselage structure. The propagation pattern of the fracture is highly nonlinear and extremely dynamic. Without the recovery of all the wreckage pieces, it was nearly impossible to draw a conclusive break-up sequence of the aircraft. Therefore, the following observation only provides one possibility for the cracking to link together accordingly and formed a possible propagating sequence.

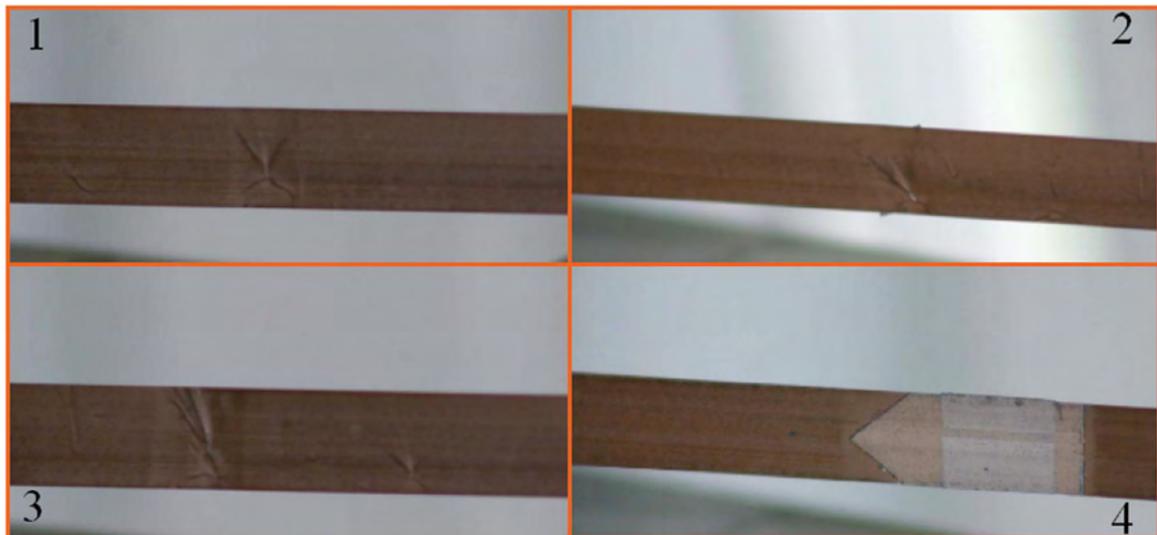
Figure 2.6-1 Damaged and spliced tape areas

Eight unidentified sounds were attributed to the tape damage and one with no signal was attributed to the tape splicing. Figure 2.6-1 frame #1 to #3 shows the typical

tape damage and frame #4 shows the spliced area. Several sounds were identified as possible sounds from a toggle switch, or other switches. Because of high noise background, sounds from switches are difficult to be identified, such as momentary switch, switch movements, keyboard entries on the INS panel, switch on the audio selector panel, etc. Some unidentified sounds are likely the sound of crew motions but they might not be directly related to any operational action. Table 2.6-2 lists the unidentified sounds and their associated possible events.

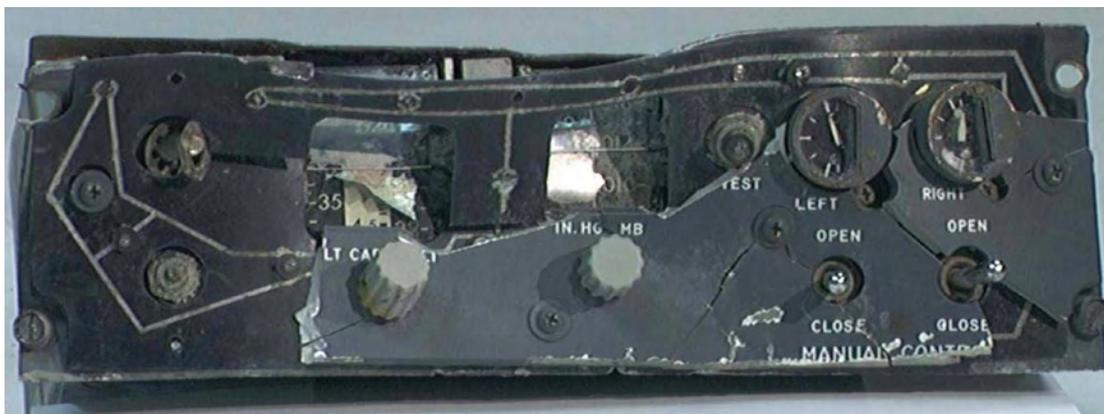
Figure 2.7-1 Cabin pressure control selector panel

Based on the examination, the Cabin Pressure Control Selector Panel (shown in Figure 2.7-1) is deformed, delaminated and fractured. The examination and test results show that the mode switch was in the “MAN” (manual) position.

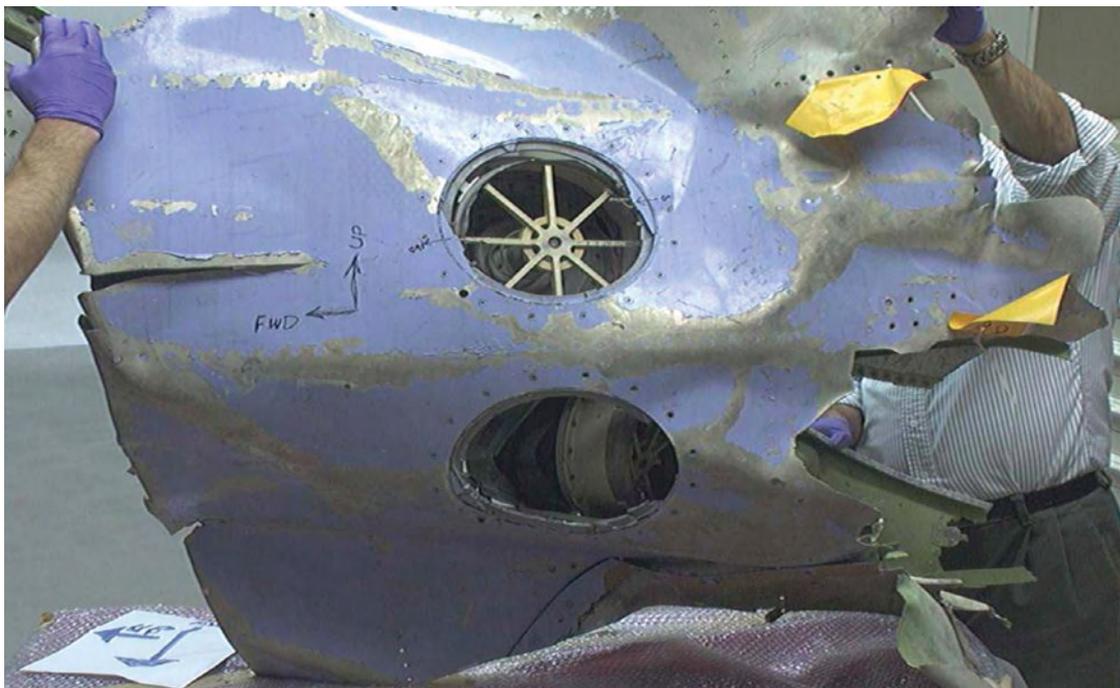
Figure 2.7-3 Pressure relief valves.

Two cabin pressurization relief valves are installed to relieve excessive pressure in the cabin. Both valves were recovered as shown in Figure 2.7-3. All flapper (blowout) doors (upper and lower for both valves) and some hinge pins are missing. The Lower Pressure Relief Valve was no longer attached to the structure. The structure between the upper and lower valves was buckled outward.

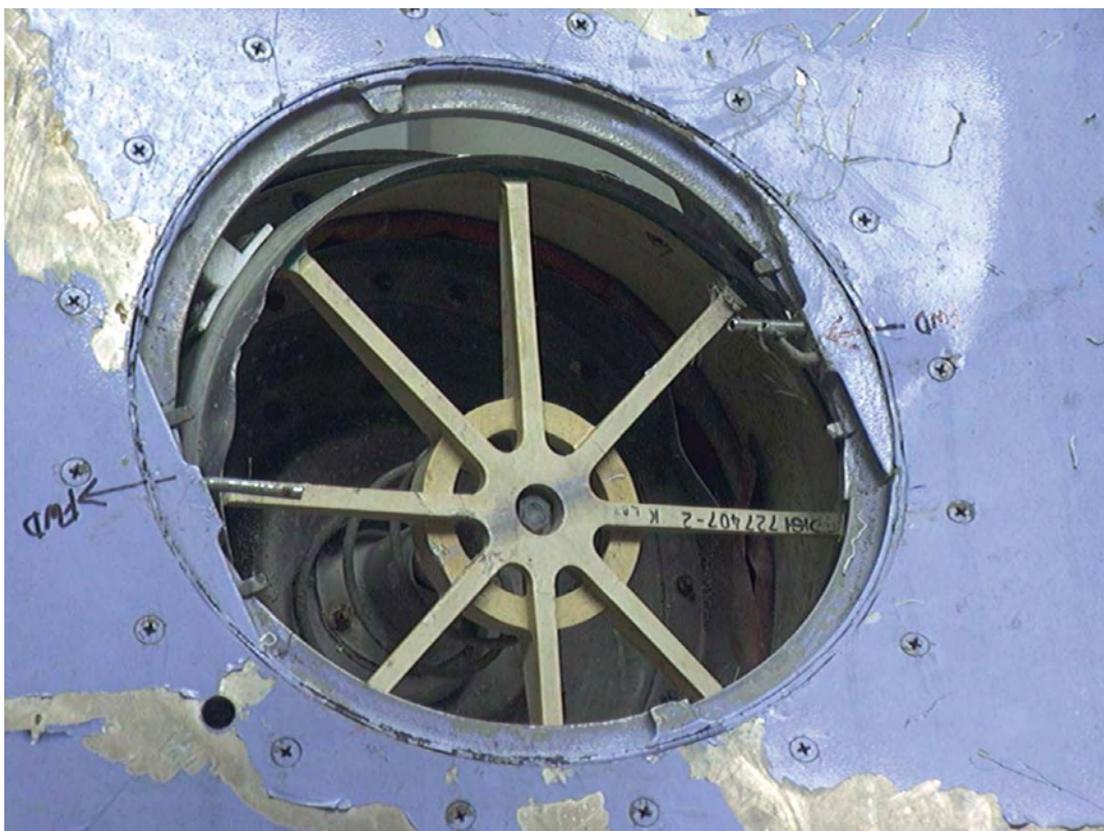
Figure 2.7-5 Upper pressure relief valve

The visual inspection result shows the Upper Pressure Relief valve (Figure 2.7-5) has been deformed inward, the blowout doors are missing, the gate web fractured, FWD upper hinge pin is bent, lower hinge pin missing, AFT lower hinge pin is bent and all hinge pins are moveable.

The wreckage examination results show that the upper pressure relief valves had been deformed inward, the flapper doors were missing and the three out of four existing shear pins were bent-in, but moveable. It could be that outside-in forces crushed the relief valve and damaged the flapper doors and the web gate. Those three pins of item 275 were still attached to the shear pins and are parallel to the relief valves housings (aircraft fuselage skin) that might indicate the valve doors was open before the water impact. However, based on the test results, the Safety Council could not conclude

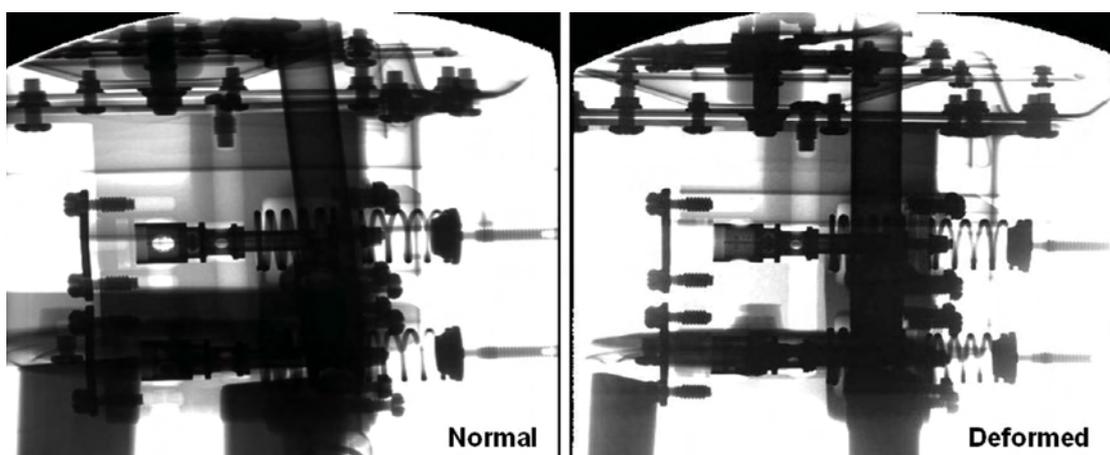
Figure 2.7-6 X-ray check results

X-Ray on the upper relief valve control switch was conducted. The results show that the control sensor assemblies were deformed from their original setting as shown in Figure 2.7-6.

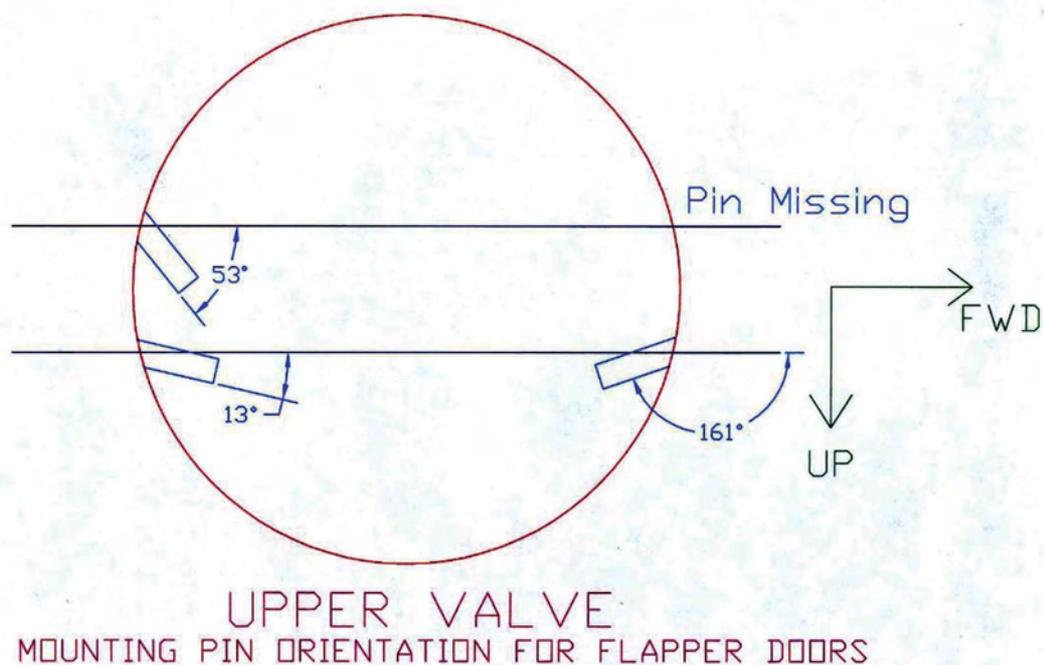
Figure 2.7-7 Upper flapper doors pins measurement results

The measurement of pin angles was performed using a flat reference plane (outer skin of aircraft); using two imaginary reference lines running between the centerlines of the pin mounting holes (upper fwd to upper aft) & (lower fwd to lower aft). All angular measurements were based from these two imaginary lines as shown in Figure 2.7-7. Results of the measurements are:

Upper aft pin was approximate 13°; Upper fwd pin was approximate 161°; Lower aft pin was approximate 53°

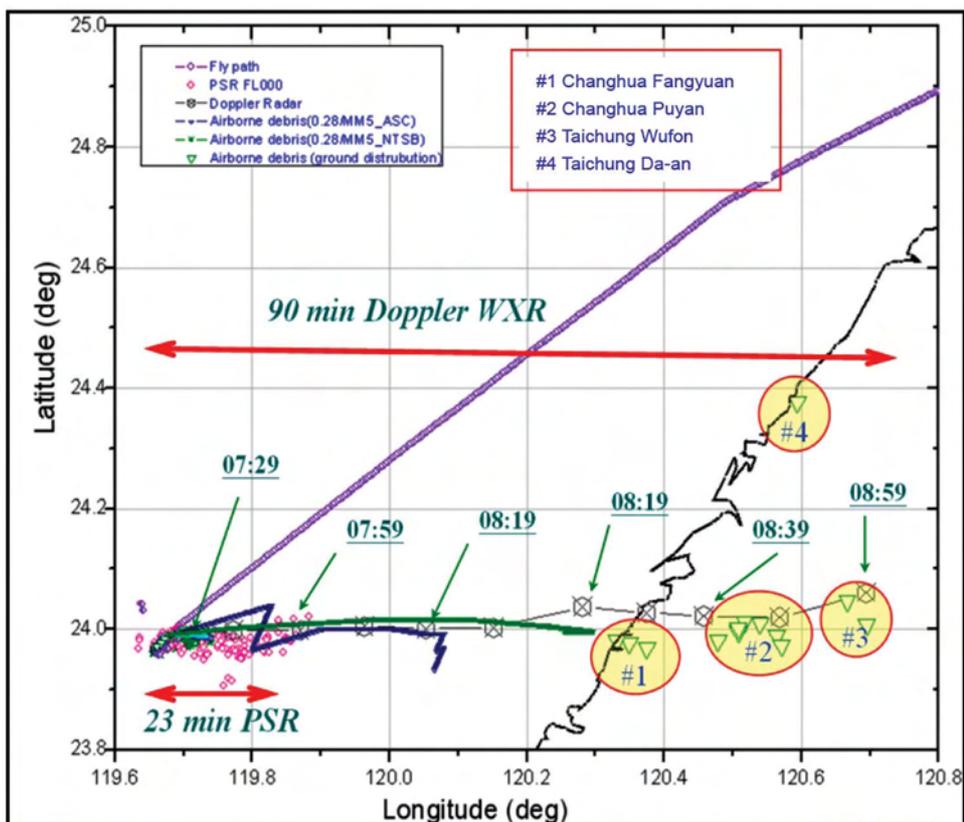
All the ballistic trajectories were consistent with the salvaged wreckage positions. The average distance error is less than 1,000 ft. Figure 2.9-7 (denoted as blue and green) shows the superposition of ballistic trajectories, SSR track, PSR returns, Doppler weather radar trajectory, and airborne debris distribution. Two trajectories using different wind profiles with the same breakup initial condition (BC assumed to be 0.28). These trajectories indicated that airborne debris initiated descent at the altitude about 35,000 ft. Doppler radar trajectories and the recovered location of those light pieces of debris match with the computed ballistic trajectory.

Figure 2.9-7 2D ballistic trajectories, SSR, PSR returns, and airborne debris
