THE "CALI" ACCIDENT

Original idea from the Flight Safety Foundation

The crew of a Boeing 757-223, Flight 965, was transitioning from cruise flight to a very high frequency omni-directional radio range (VOR) / distance measuring equipment (DME) instrument approach to runway 19 at the Alfonso Bonilla Aragon International Airport (SKCL), Cali, Colombia, when the aircraft collided with a mountain 53 kilometers (33 miles) northeast of the CALI VOR.

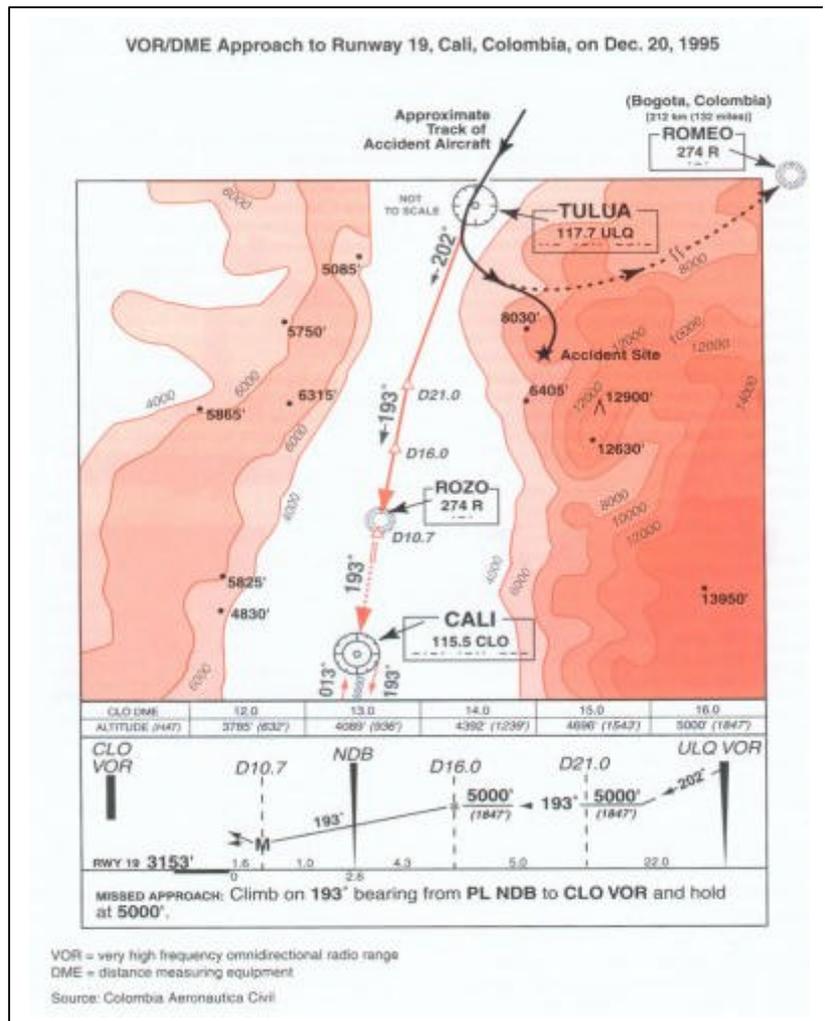
The B757 Flight Path Crew Actions/CVR

The captain then told the first officer he had entered a direct route to the CALI VOR in the FMS. At 2136:31, Cali Approach asked the crew if they were able to approach and land on runway 19. After a brief discussion with the first officer, the captain replied that they would accept the approach to runway 19, but would need a lower altitude immediately. The controller then cleared the flight for the VOR/ DME instrument approach to runway 19, the ROZO One Arrival, and again instructed the crew to report the TULUA VOR.

Investigators found evidence that *"either the captain or the first officer selected and executed a direct course to the identifier 'R,' in the mistaken belief that R was ROZO as it was identified on the approach chart,"* the report said.

The report said: *"The simulations found that when R was entered into the CDU, a white dashed line pointed off the map display towards the east-northeast. When R was 'executed,' the airplane turned towards R (in the city of Bogota), and the white dashed line turned to a solid magenta colored line on the display."*
