B767 DESCENDS BELOW GLIDESLOPE AND STRIKES TAIL ON LANDING ...

The tail skid and aft fuselage of a Canadian Airlines International (CAI) Boeing 767-375 were substantially damaged during landing at Halifax, Nova Scotia, Canada, on March 8, 1996; none of the nine crew members and 91 passengers aboard CAI Flight 48 were injured.

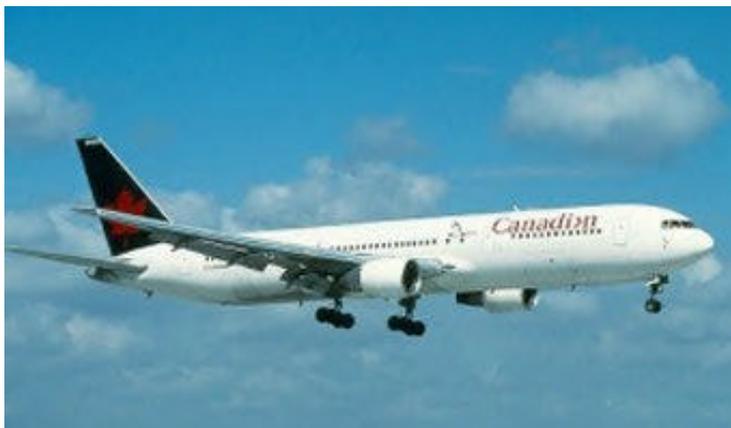
When the tail skid struck the runway on landing, the force sheared the hydraulic-actuator attachment pin and rove the actuator upward. The actuator hit the stabilizer ball assembly, which caused the tail-skid light to illuminate. Failure of the tail skid allowed the tail section to contact the runway, causing many scrapes and buckles to the fuselage skin and minor damage to the stabilizer position switches and their associated mounting brackets.

Repairs required replacement of the actuator, the left and right tail-skid housings and all hydraulic lines and hoses common to the actuator. In addition, the skin in this area, along with five frames and numerous stringers and stiffeners, was replaced before the aircraft was put back in service.
