FLIGHT SAFETY FOUNDATION

Accident Prevention

November-December 1998

After Smoke Detected in Cargo Compartment Crew Lands DC-10, Then Fire Destroys Aircraft

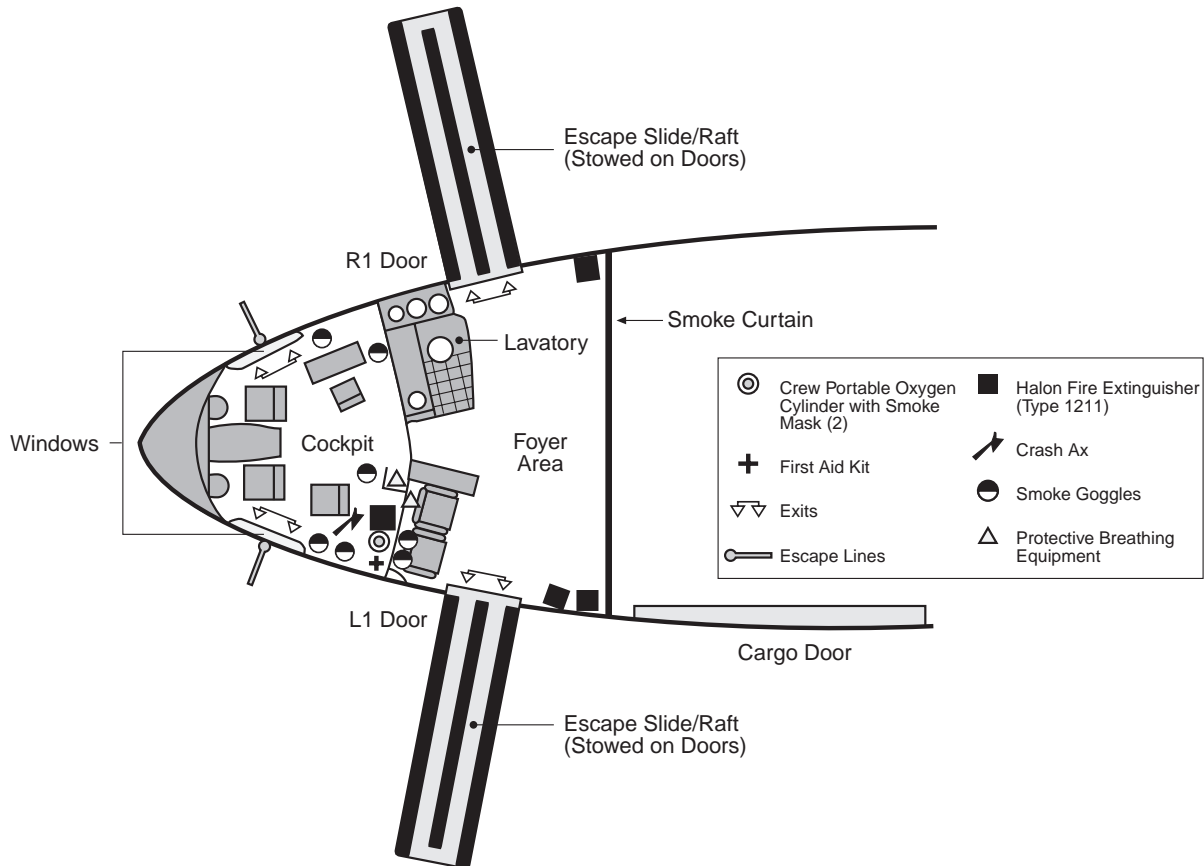
Figure 2

the captain as the pilot not flying. The two nonrevenue passengers were seated in a foyer area directly behind the cockpit (Figure 2, page 4). The flight crew said that the engine start, taxi, takeoff and climb were normal.

Forward Area of DC-10-10CF, FedEx Flight 1406, Sept. 5, 1996
