Flight Crew's Failure to Perform Landing Checklist Results in DC-9 Wheels-up Landing

FSF Editorial Staff

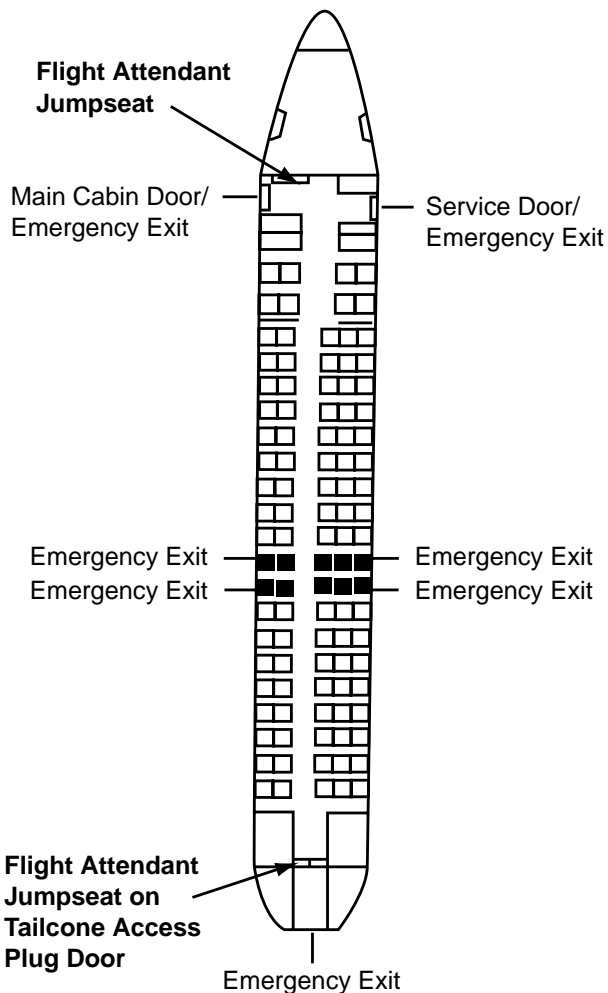
Figure 2

Accident DC-9 Cabin Configuration

During the evacuation, “access to the tailcone exit was blocked,” the report said. “One passenger stated that the tailcone access–plug door [Figure 2] could not be fully opened because a seat belt restricted its movement. The ‘C’ flight attendant [located in the rear of the aircraft] stated that she could not completely remove the plug door because of the jumpseat shoulder harness. She redirected the passengers at the rear of the plane to the overwing exits.”
