Flight Crew's Failure to Perform Landing Checklist Results in DC-9 Wheels-up Landing

FSF Editorial Staff

The crew of the Continental Airlines (COA) DC-9-32 landed wheels up on Runway 27 (photo, page 3) at Houston (Texas, U.S.) Intercontinental Airport (IAH). The airplane slid 2,089 meters (6,850 feet) before coming to rest in the grass about 43 meters (140 feet) left of the runway centerline (Figure 1, page 4).

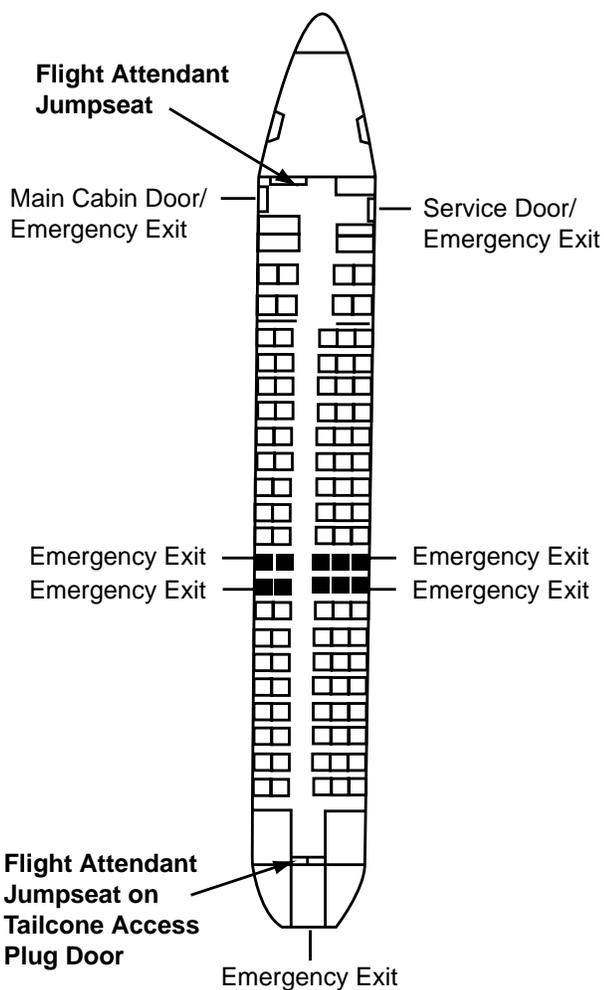
Figure 2

Accident DC-9 Cabin Configuration

During the evacuation, “access to the tailcone exit was blocked,” the report said. “One passenger stated that the tailcone access–plug door [Figure 2] could not be fully opened because a seat belt restricted its movement. The ‘C’ flight attendant [located in the rear of the aircraft] stated that she could not completely remove the plug door because of the jumpseat shoulder harness. She redirected the passengers at the rear of the plane to the overwing exits.”
