Failure of Stabilizer-trim System Blamed For Crew's Loss of Control of MD-83

FSF Editorial Staff

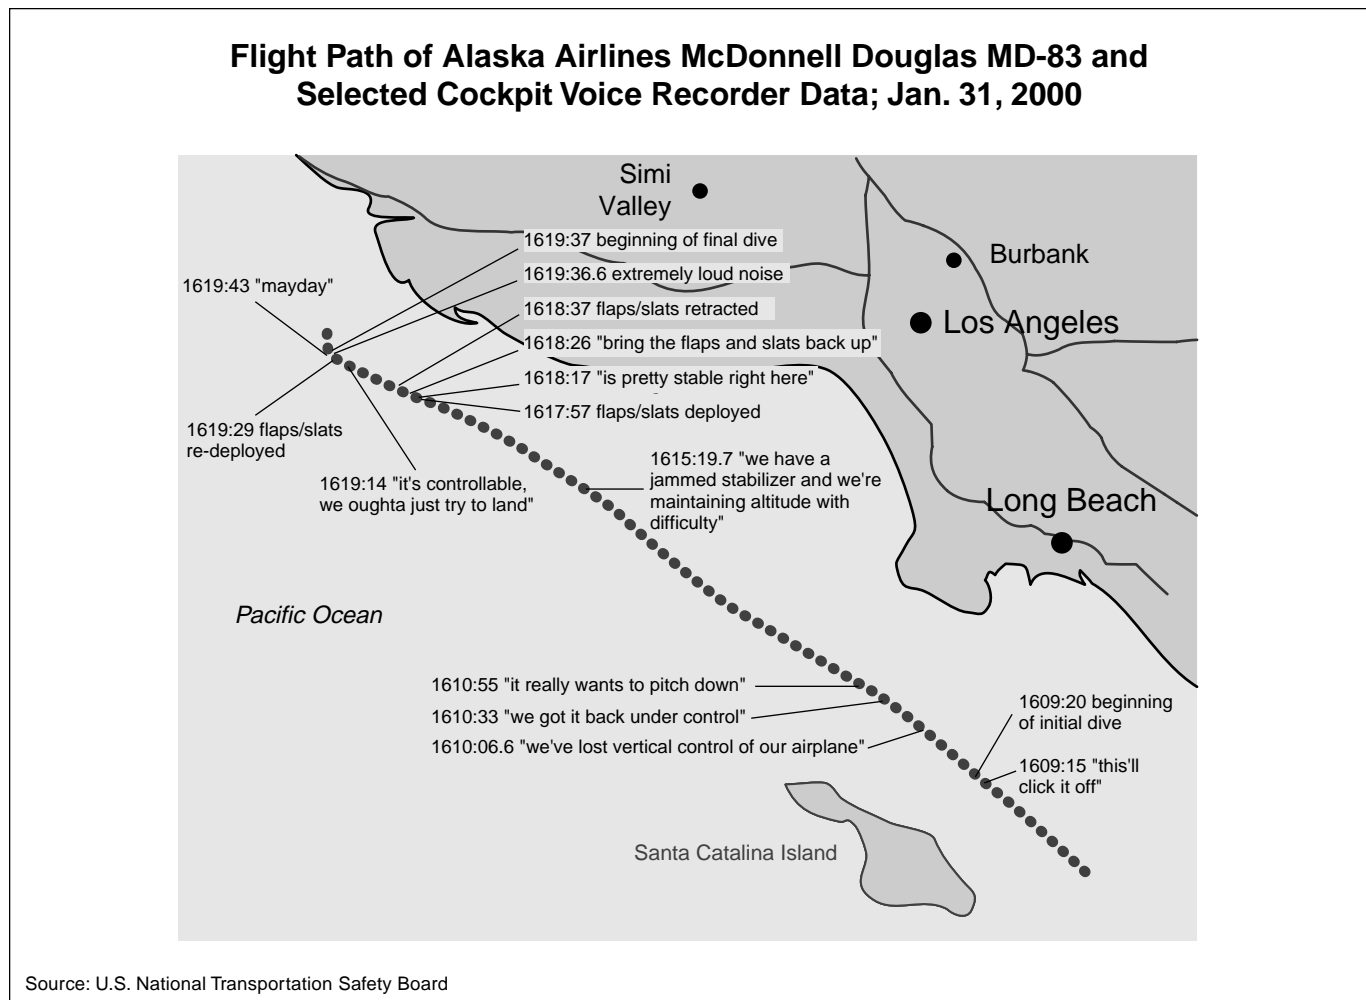
Figure 2

At 1609:13, the captain told the first officer, “Let’s do that.” The CVR then recorded the sound of a click and the captain saying, “This’ll click it off.” FDR data showed that the autopilot was disengaged. [Figure 2 shows the airplane’s position at this time.]

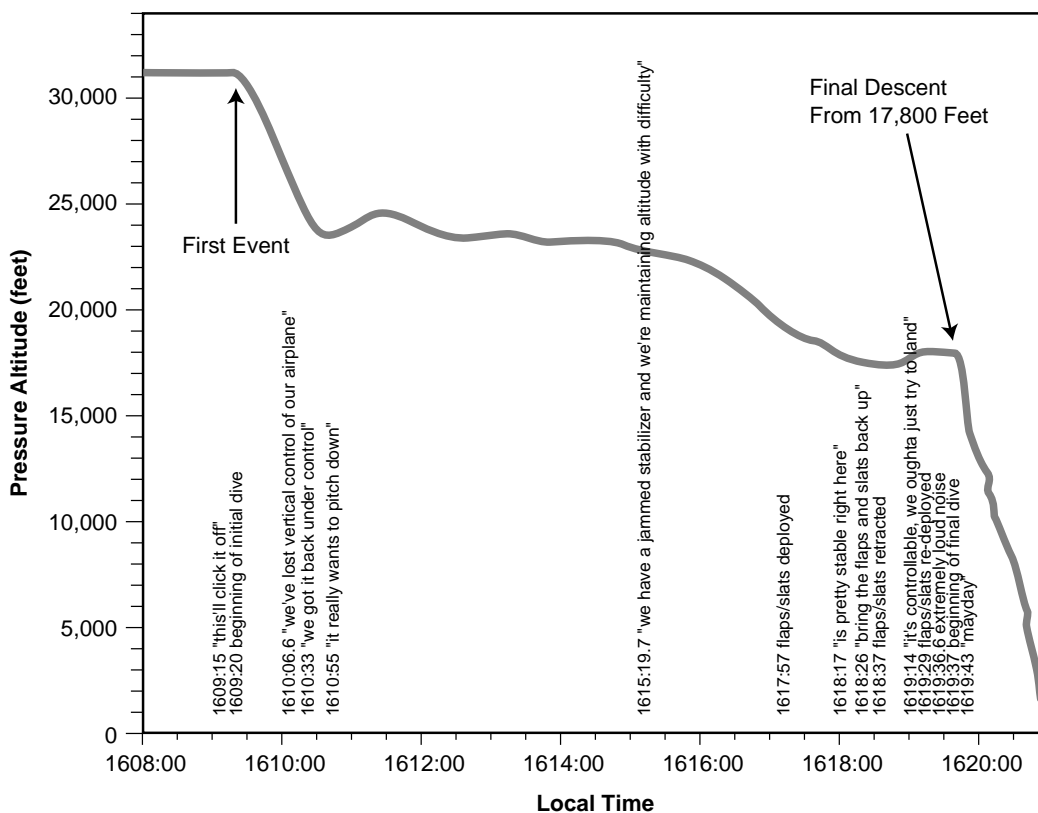
Figure 3

The airplane entered a dive at 1609:20 [Figure 3]. The CVR recorded the captain voicing an expletive and saying, “You got it?”

Vertical Flight Path of Alaska Airlines McDonnell Douglas MD-83 and Selected Cockpit Voice Recorder Data; Jan. 31, 2000
