Incident
on 18 January 2003
at Paris Charles de Gaulle airport
to the Boeing 747-412F
registered 9V-SFH
operated by Singapore Airlines Cargo

REPORT
9v-h030118a

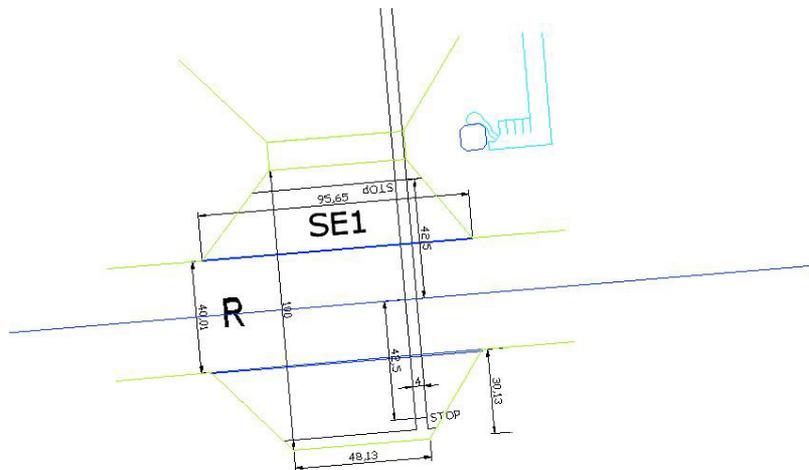
The shape of de-icing zone SE 1 can be compared to a hexagon on either side of taxiway Romeo.

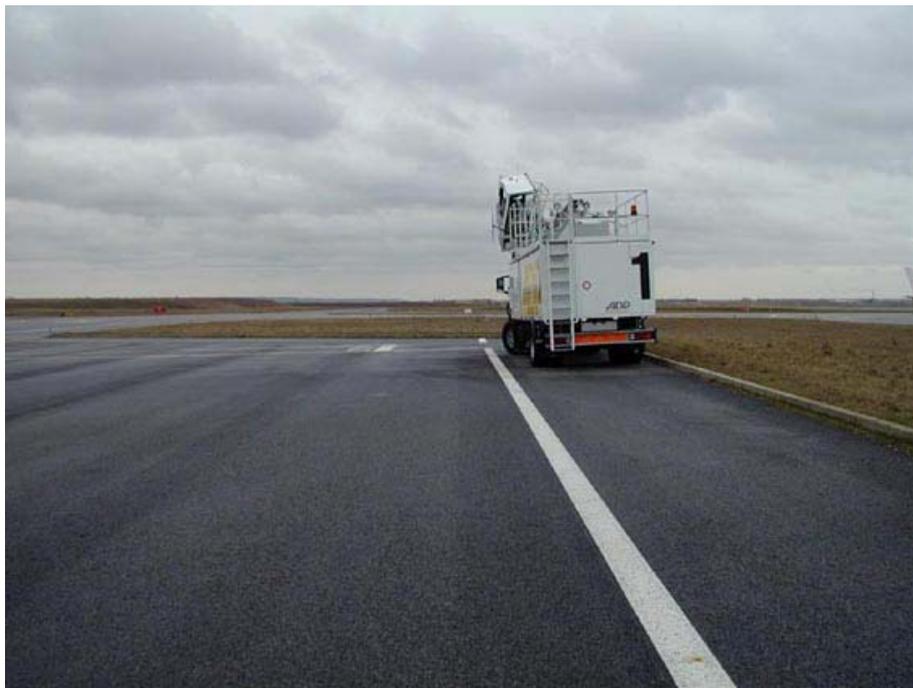
Painted white lines define the area to be left clear for aircraft to taxi.

When vehicles are positioned beyond the markings, their position allows a Boeing 747-400 to pass with a lateral margin estimated at about ten meters, as shown in the photo.

The dissymmetry between the surfaces defined by the painted lines should be noted: the surface to the north of the area is clearly larger than that to the south. As a result, the vehicle has to be parked parallel to the taxiway in order to remain within the defined area whereas to the north it can be oriented in any direction.

It should be noted that in the weeks that followed the event, ADP put in place systematic checks on the positioning of vehicles by the supervisor and by the driver of the vehicle on the opposite side.
