# NATIONAL TRANSPORTATION SAFETY BOARD

## AIRCRAFT ACCIDENT REPORT

IN-FLIGHT FIRE/EMERGENCY LANDING  
FEDERAL EXPRESS FLIGHT 1406  
DOUGLAS DC-1 0-10, N68055  
NEWBURGH, NEW YORK  
SEPTEMBER 5, 1996

**Adopted: July 22, 1998  
Notation 6800B**

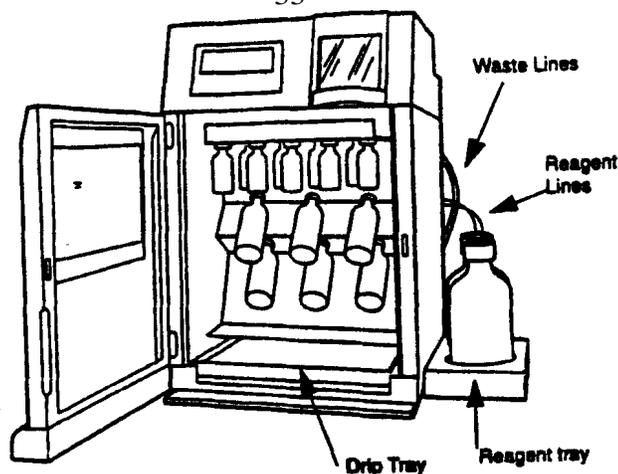
The Expedite Model 8909 DNA synthesizer was found in the center of container 6R lying on its left side with the top facing forward (as viewed from aft looking forward), the front towards the right side of the airplane, and the bottom facing aft (see figure 8 for a diagram of the synthesizer). The unit contained several bottles with labels that included flammability symbols, and some of the bottles contained liquid. One large bottle in the aft row had a very strong odor when it was removed from the unit. Because this unit was found at the lowest point of the "V" burn pattern, the Safety Board investigation evaluated and analyzed the liquids contained in this unit.

Figure 8.—Expedite Model 8909 DNA synthesizer instrument cabinet.
