## SAFETY

DAVID CARBAUGH  
CHIEF PILOT  
FLIGHT OPERATIONS SAFETY  
BOEING COMMERCIAL AIRPLANES

# HAZARDS of ERRONEOUS GLIDESLOPE INDICATIONS

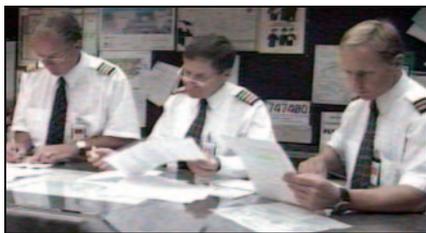
## 3 NZ 60 GO-AROUND

The captain executed a timely go-around 5.5 mi from the runway at an altitude of less than 400 ft. The crew successfully executed a second approach by using the localizer and ignoring the on-glidepath indications.

notice to airmen (NOTAM) bulletins had informed them that the ILS was unmonitored, and they discussed this during their approach briefings. They also paid attention to subtle cues that something might be wrong, even though the automatic flight system was indicating normally. Last, the crewmembers were willing to execute a go-around to give them more time to sort through the conflicting information (fig. 3).
