NATIONAL TRANSPORTATION SAFETY BOARD

AIRCRAFT ACCIDENT REPORT

**AIR CANADA FLIGHT 797
McDONNELL DOUGLAS DC-9-32, C-FTLL
GREATER CINCINNATI
INTERNATIONAL AIRPORT
COVINGTON, KENTUCKY
JUNE 2, 1983**

NTSB/AAR-86/02

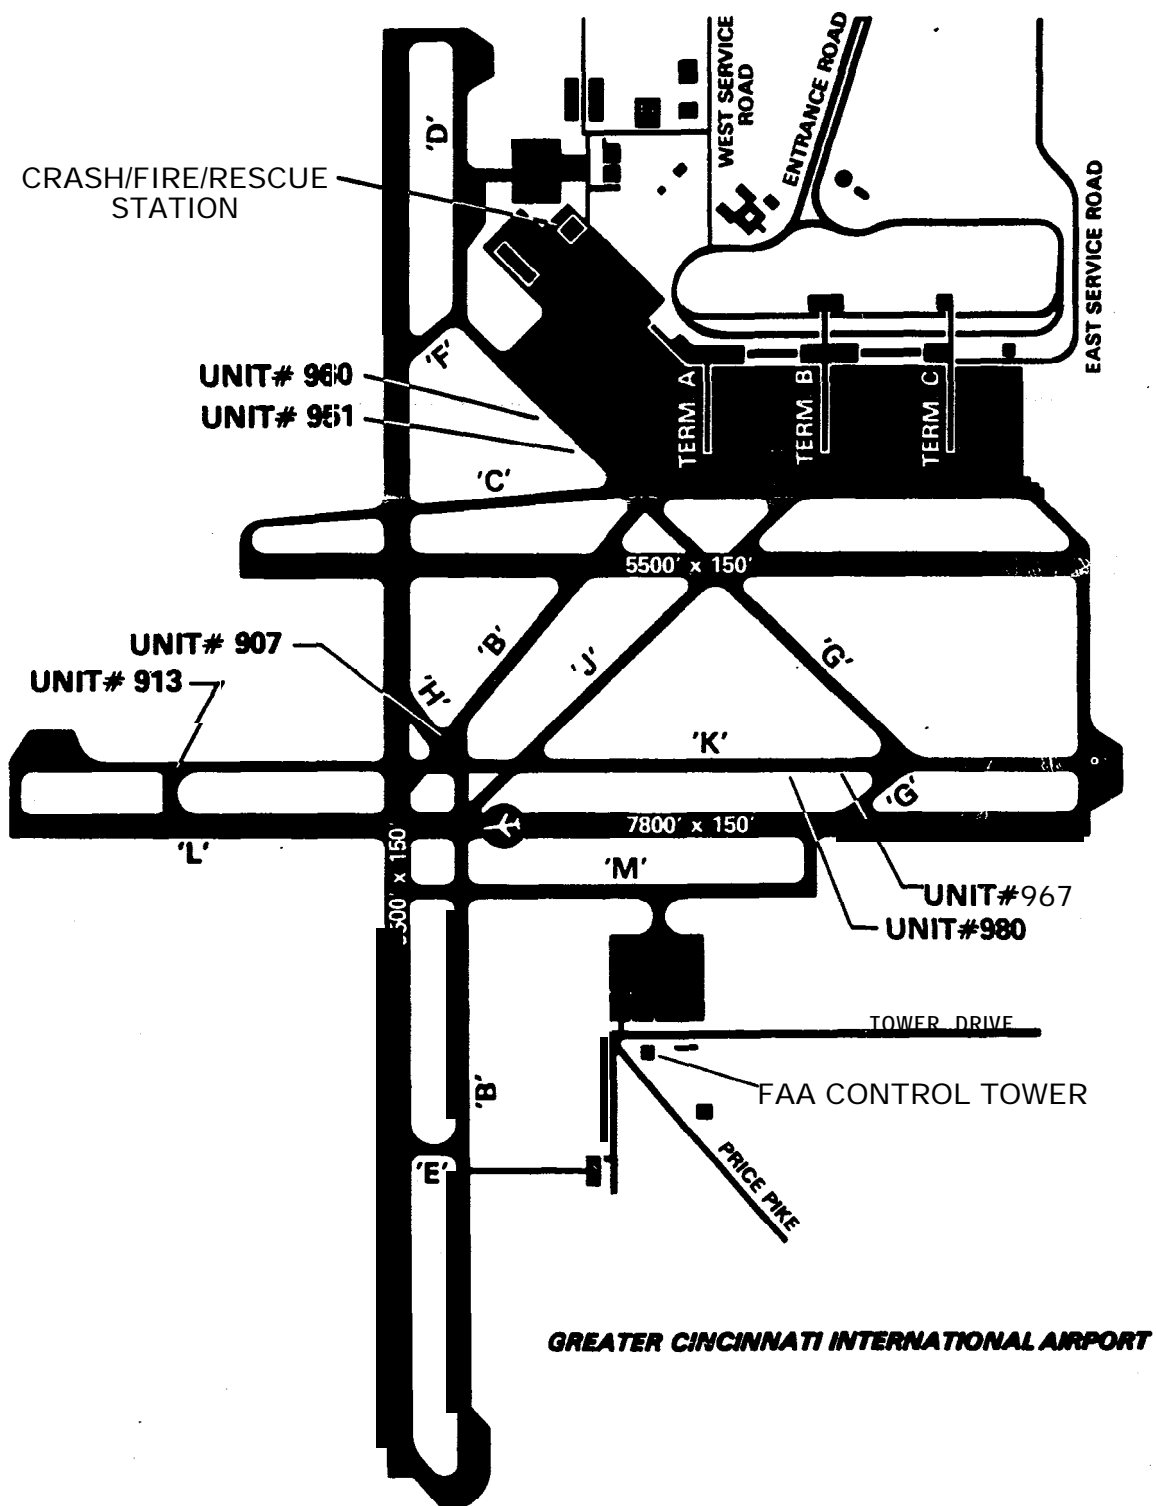
Figure 1.—Standby Positions of Crash/Fire/Rescue Units.

At **1913:38**, after Flight 797 was unable to tell him its heading because its heading instruments were inoperative, the approach controller asked the flight to turn left. The controller said that this was an identification turn and that it was also designed to place the airplane closer to the airport. At **1914:03**, after observing the target in a left turn, *the* approach controller said that Flight **797's** primary target was now ****fully** identified." He then told the flight that this was a "**no gyro**" **5/** radar approach for runway two seven left. . ." and cleared it to descend to 3,500 feet. He then told the flight that it was 12 nmi southeast of the Cincinnati Airport, cleared it to land on runway **27L**, and informed it that the surface wind was **220°** at 4 knots. He informed the tower of the change of landing runways and the tower directed *the* fire department to position its vehicles along runway 27L. (See figure 1.)

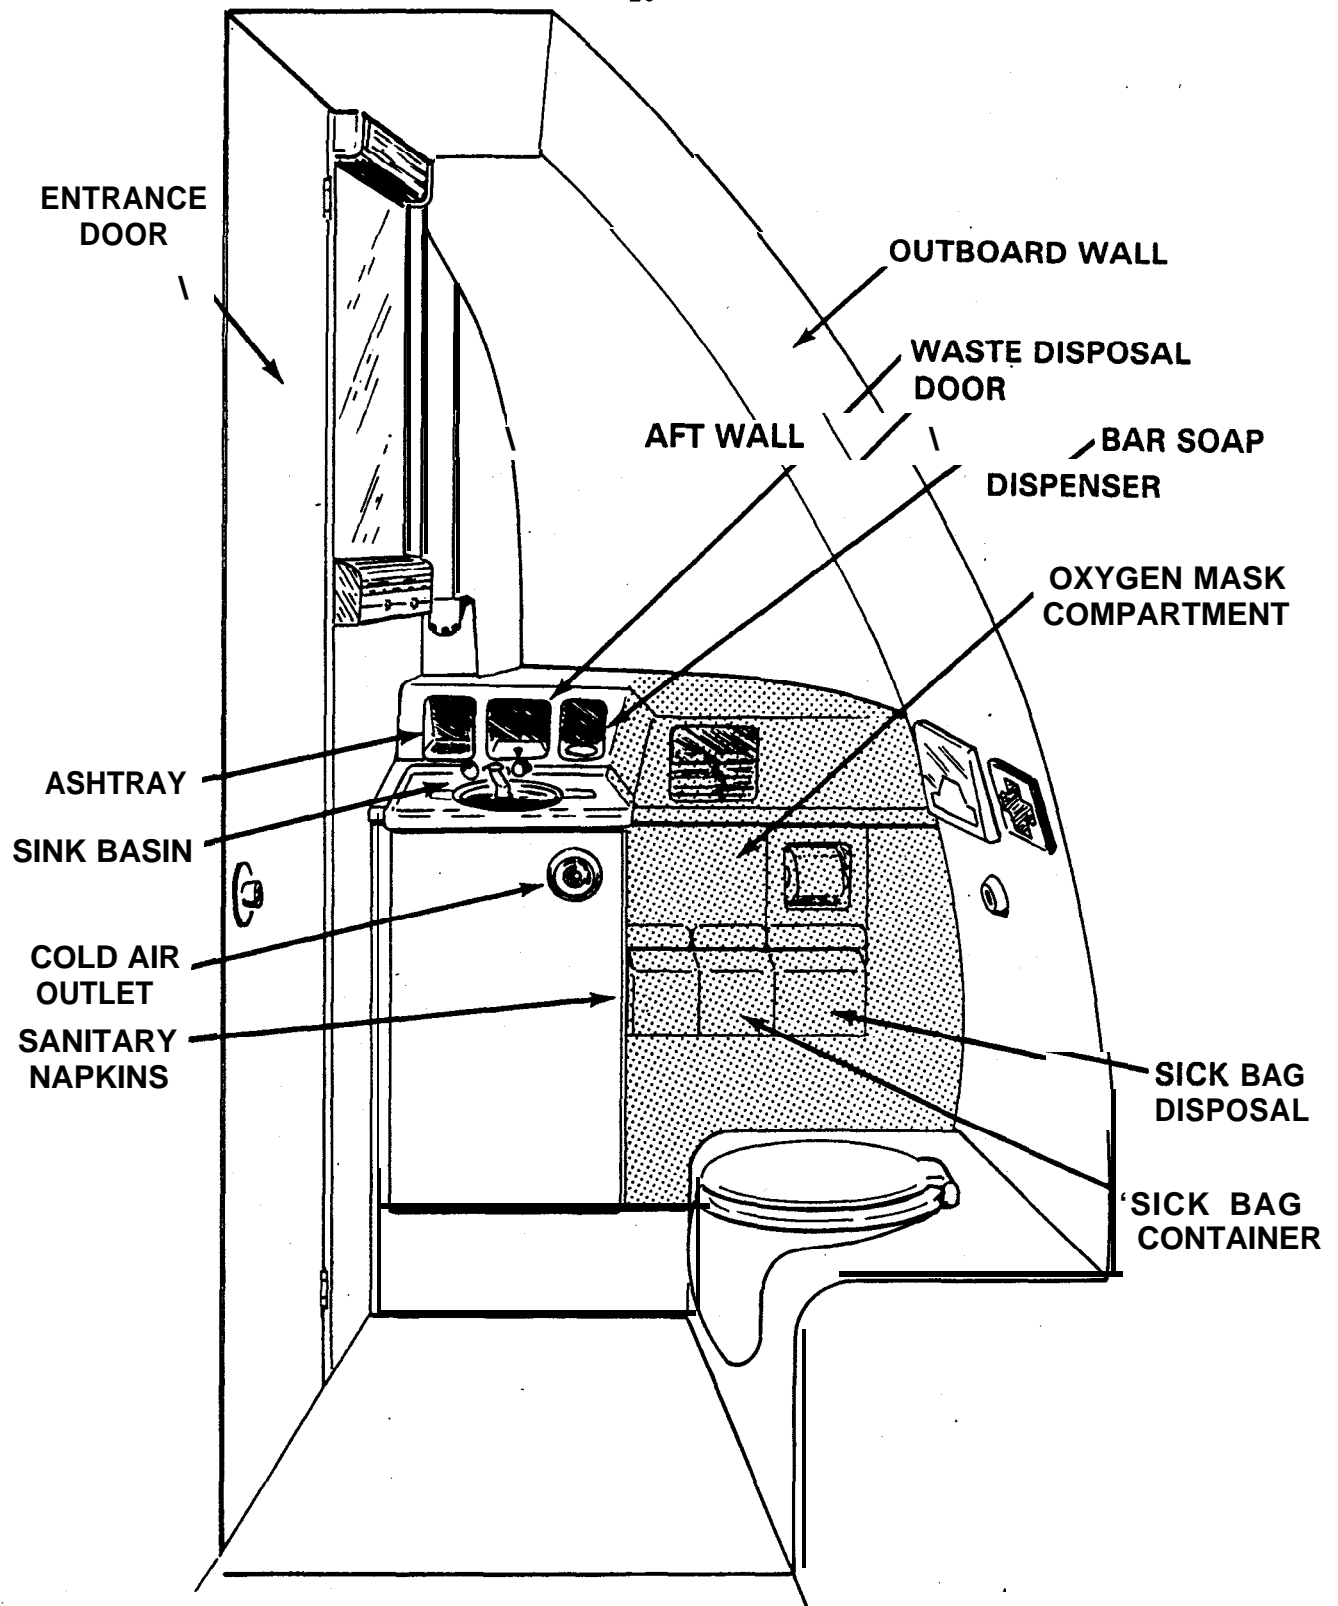
Figure 9.—Diagram of aft lavatory, viewed aft.

The aft lavatory was on the left side of the cabin, and began at FS 965 and extended aft to FS 1019, or just forward of the aft pressure bulkhead. The lavatory's outboard wall conformed essentially to the shape of the airplane's fuselage. There was a vanity section containing a stainless steel sink and amenities located along and extending forward from the aft wall. The commode containing a flushing motor was located along the lavatory's outboard wall. A trash chute and container were located below and behind the sink, and a fresh air supply outlet was positioned below the sink in the door of the vanity. Also, below the trash container, an aluminum shelf was installed. In addition, there was an oxygen outlet located in the oxygen mask compartment in the amenities section. (See figures 9 and 10.)

The amenities section of the vanity extends from the sink to the lavatory outboard wall and from the commode to the lavatory aft wall. The section contains the oxygen mask compartment and containers or dispensers for paper towels, toilet paper, sanitary napkins, and sick bags. (See figure 9.)

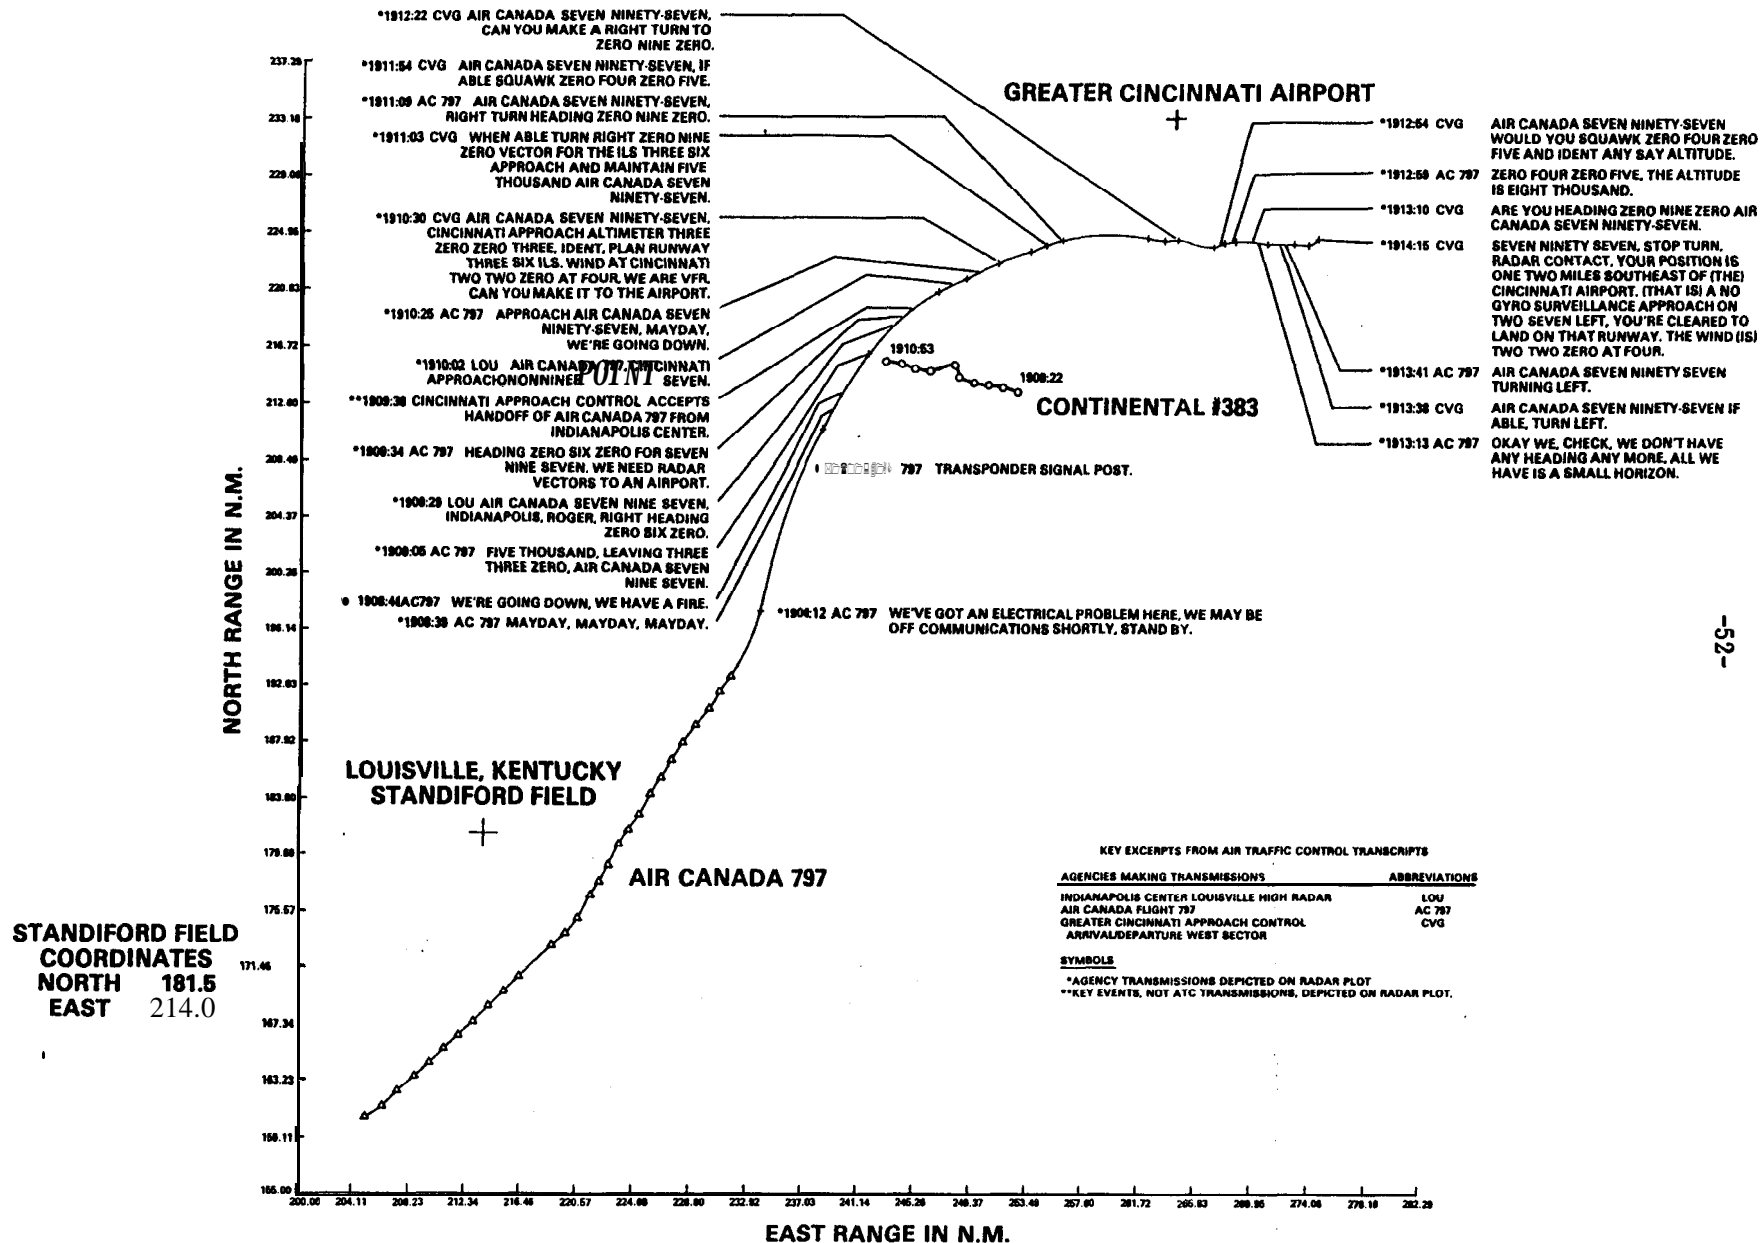
Figure 13.-Ground radar tracks for Flights 797 and 383.

18-36 of the Greater Cincinnati Airport were digitized and plotted with the ground tracks. Times of key transmissions and selected key events were included along Flight 797's radar ground track. The last radar fix retrieved from the DART's data occurred at **1914:15**, and the last transponder information from Flight 797 was received at **1906:12**. (See figure 13.)
