Runway overrun Onur Air

Runway overrun after rejected take-off of the Onur Air MD-88, registration TC-ONP, at Groningen Airport Eelde on 17 June 2003

The Hague, 6 April 2006 (investigation number 2003071)

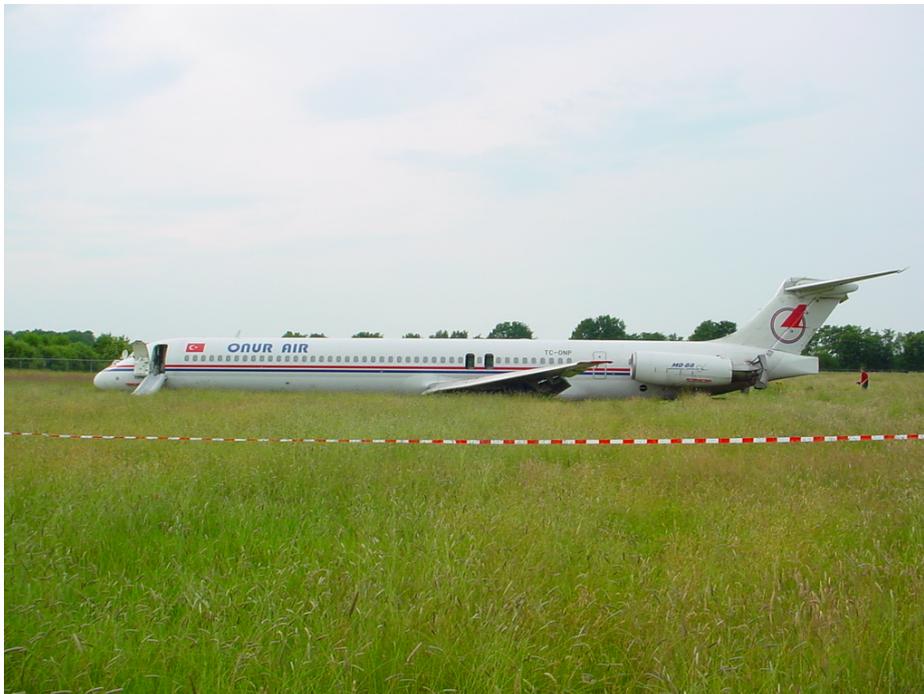
When attempting to rotate the captain experienced a heavy elevator control force. The captain stated that he needed much more than normal back pressure on his control column to lift the nose. He felt "it was impossible to make the take-off", and as the nose did not rise he decided to reject the take-off. Post accident analysis revealed that the rejection was initiated at 128 knots.

Both pilots stated that during rejection brakes and reversed engine thrust had been applied, which is confirmed by the FDR readout. The aircraft overran the runway end with a speed of approximately 75 knots. During the deceleration in the soft soil, it hit the approach lighting system, including the concrete structures embedded in the ground. It came to a stop approximately 100 meters beyond the runway end. There was no fire. All occupants evacuated the aircraft safely. Some of them returned to the aircraft and re-entered it, to pick up their belongings. In addition, the pilots remained on board and only left the aircraft when instructed to do so by the fire brigade.

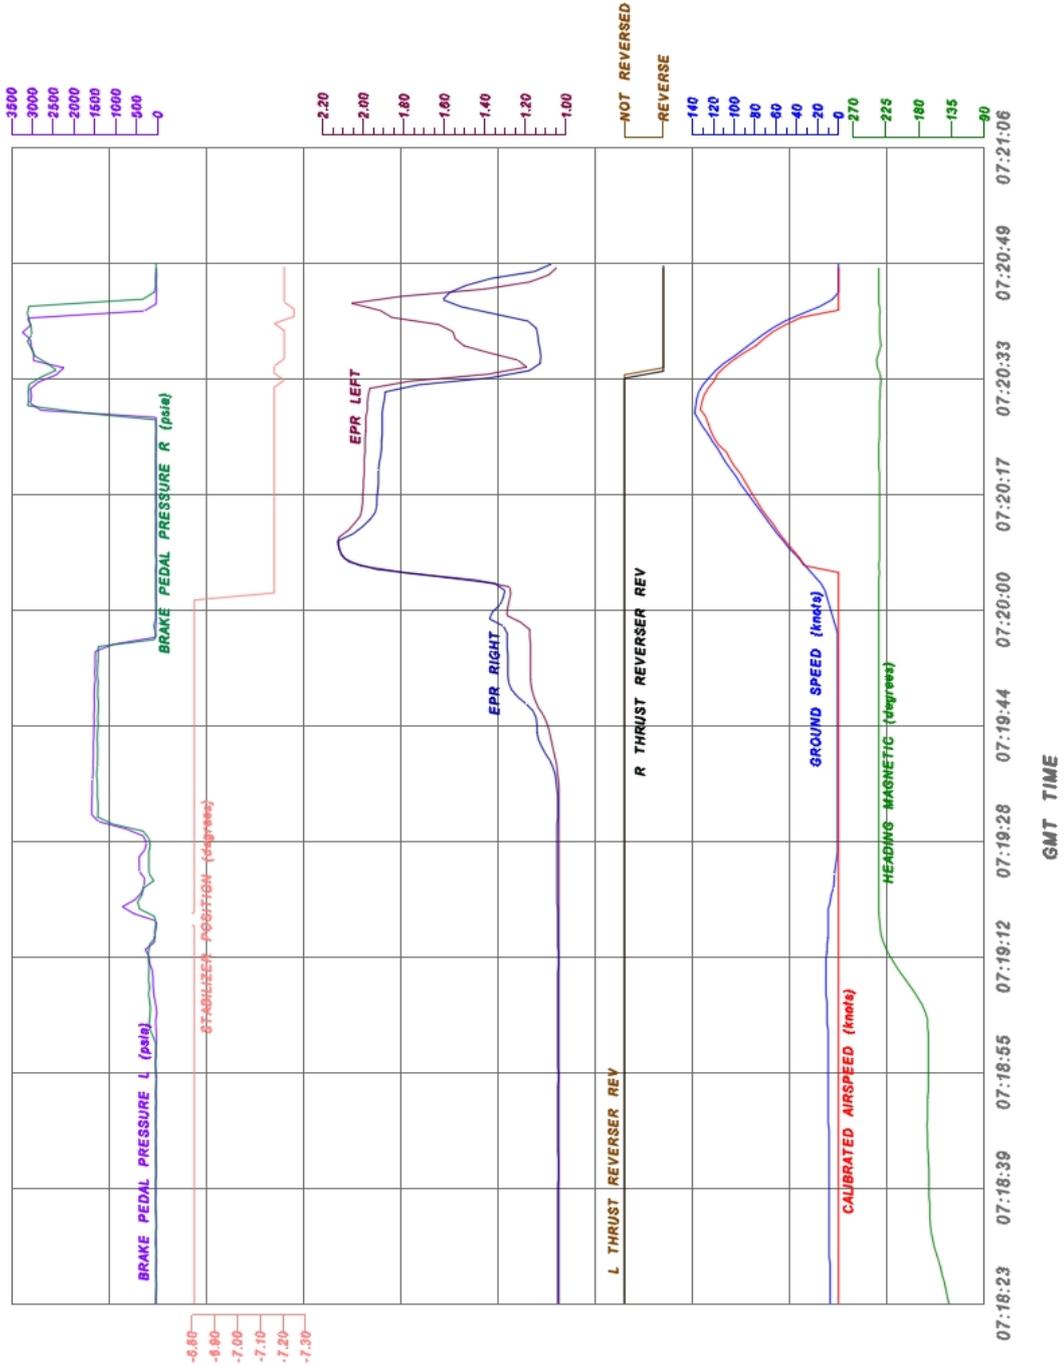
FDR data plot

On the runway checks were performed. FDR data indicated a stabilizer position change from 6.8 to 7.2 degrees aircraft nose up (ANU). Thereafter the crew initiated a static engine spin-up. Again the stabilizer warning sounded. The crew released the brakes and started the take-off roll. From the CVR it is derived that during the entire take-off roll the warning sounded continuously.

The throttle response was used to reconstruct the selected thrust. FDR data indicate that engines did not stabilize at 1.40 EPR, but both initially increased to a maximum of 2.12 EPR (left engine) and 2.16 EPR (right engine). ATS was engaged shortly afterwards. From FDR it was derived that at the time the engines stabilized the thrust values were 2.02 EPR for the left engine and 1.97 EPR for the right engine. The shallow EPR (and also N1) decrease is a common engine output response during the take-off as speed increases and engine inlet conditions change.
