**Aviation Safety Council  
Taipei, Taiwan**

# **GE 791 Occurrence Investigation Report**

**IN-FLIGHT ICING ENCOUNTER AND CRASH INTO THE SEA  
TRANSASIA AIRWAYS FLIGHT 791  
ATR72-200, B-22708  
17 KILOMETERS SOUTHWEST OF MAKUNG CITY,  
PENGHU ISLANDS, TAIWAN  
DECEMBER 21, 2002**

**ASC-AOR-05-04-001**

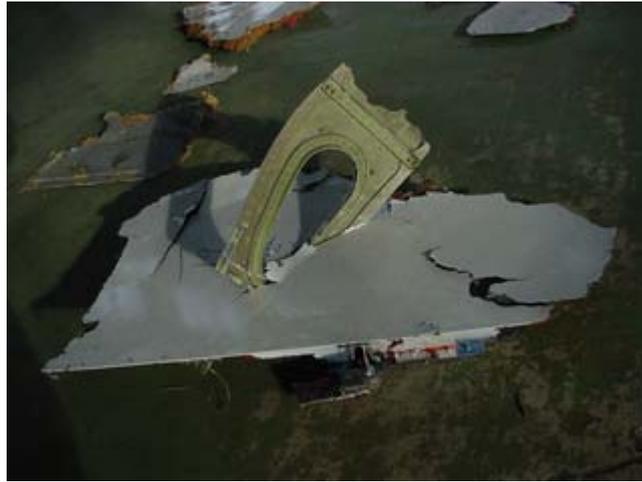
Figure 1.12-15 Window frame stuck into rudder

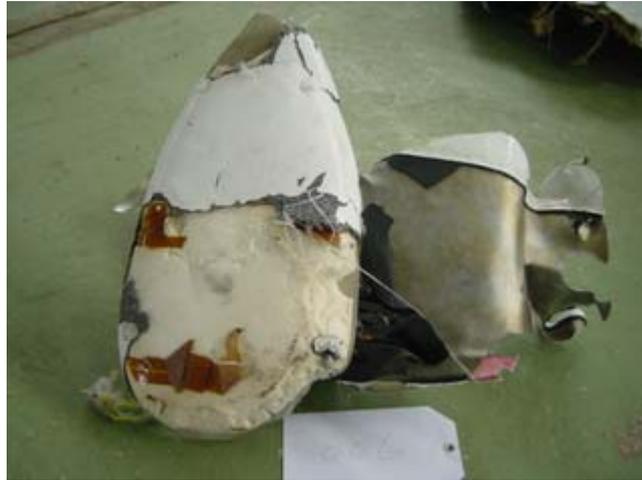
Figure 1.12-25 ADF antenna

- ADF antenna: The antenna was separated from body. The shape is still conserved. The front skin was delaminated (refer to figure 1.12-25).

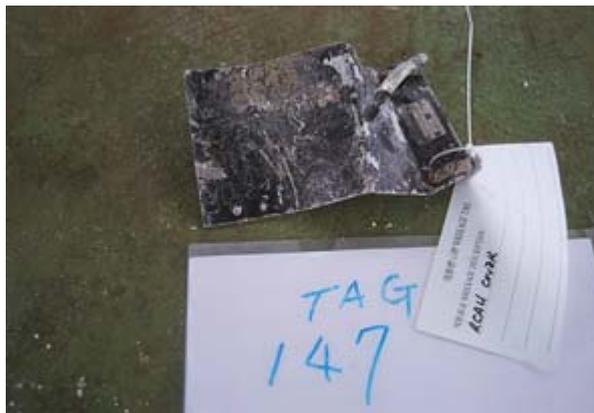
Figure 1.12-29 RCAU case

- Remote Control Audio Unit (RCAU) metal case: The case was separated from the unit. The leading edge of the case was bended and wrinkled (refer to figure 1.12-29).

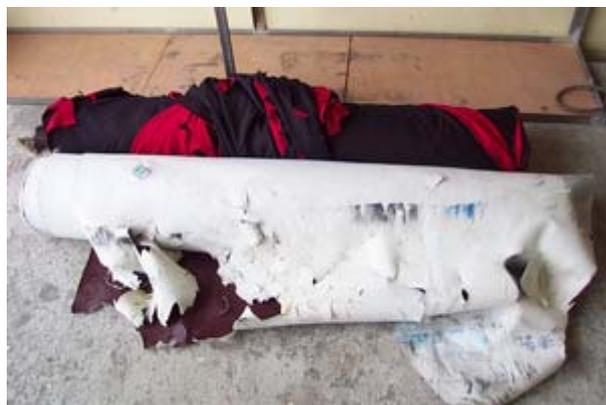
Figure 1.12-30 Cargo (cloth)

- Cargo (cloth) : There is no fire phenomenon on the cloth. One roll of cloth was protruded by floor structure (refer to figure 1.12-30~31).

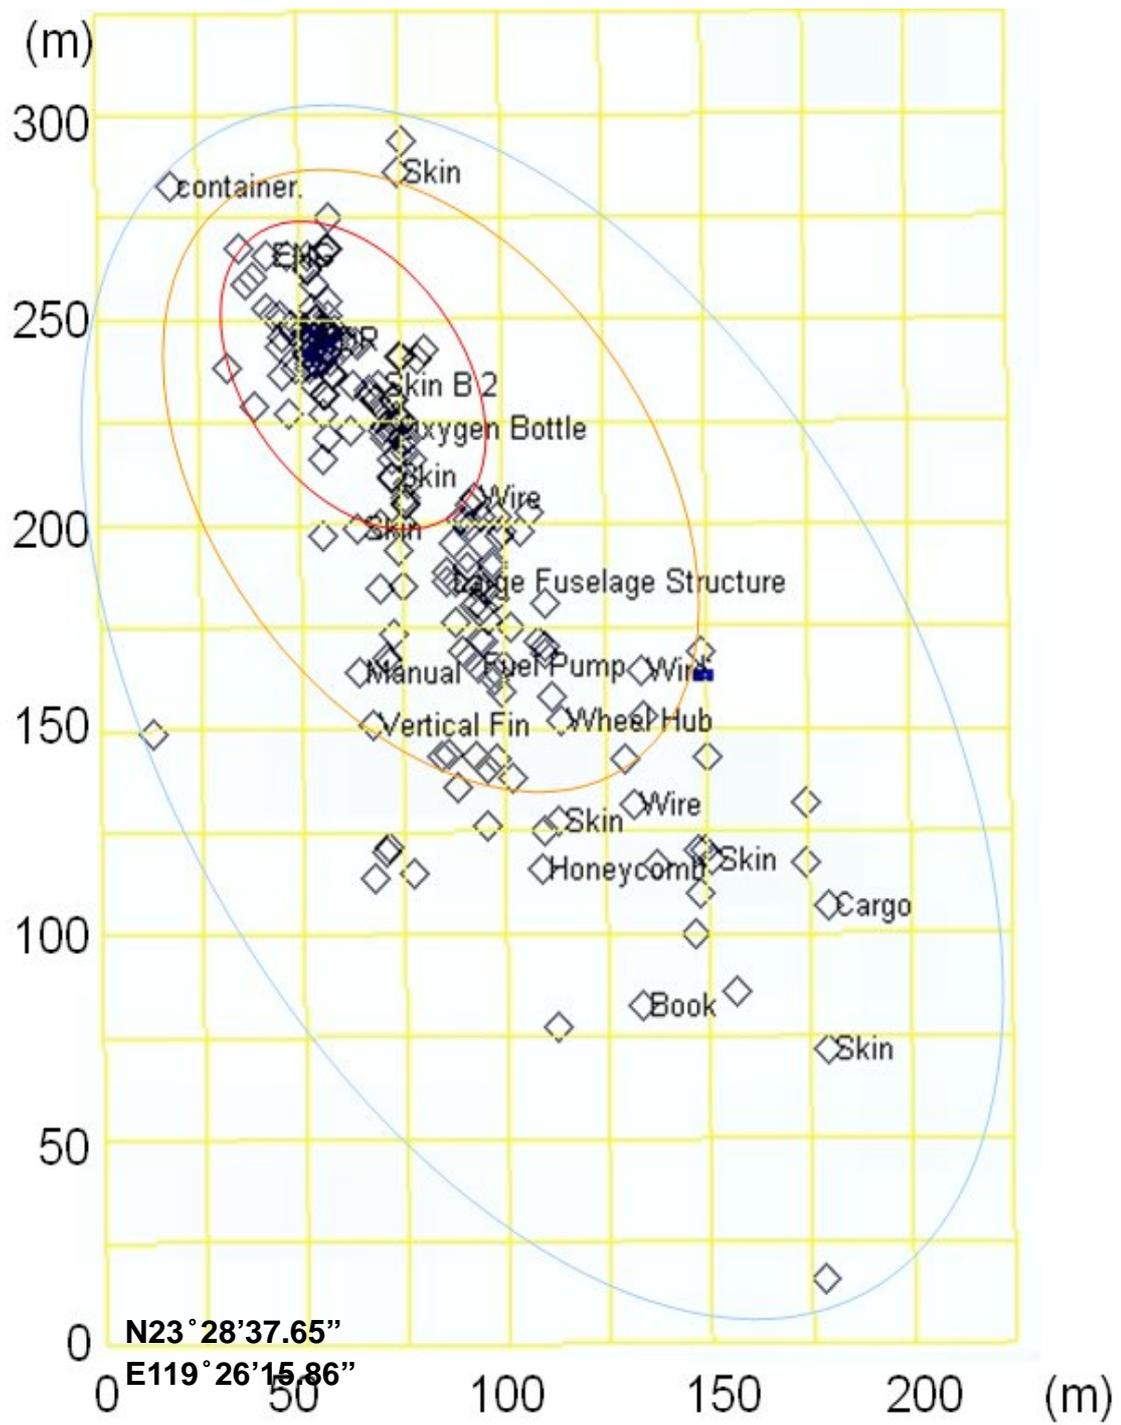
Figure 1.18-7 Wreckage distribution pattern

After the accident occurred, the Coast Guard launched the search and rescue operation and several fishing boats joined the operation as well. The Coast Guard found floating wreckages around 119.26E, 23.25N, 119.35E, 24.55N and 119.26E, 23.25N. The Navy searching vessels used the side scan sonar and acoustic receiver to detect the wreckage and one of the flight recorders. The area of suspected targets detected by Navy shows in Figure 1.18-7 with blue circle. The suspected targets detected by Ocean Research II (OR-II) side scan sonar shows in 1.18-6 with green circle. With these targets, the Ocean Hercules double checked the targets with its video camera that was mounted on remote operating vehicle (ROV). Those wreckage found in area of latitudes from 119° 26'16"E to 119° 26'23"E , longitudes from 23° 28'38"N to 23° 28'47"N about 60 meters of water depth shows in Figure 1.18-6 red circle. The debris field distributed in an area of about 170 meters x 280 meters (see Figure 1.18-7). The Figure also shows the most dense area of wreckage in red circle. Wreckage such as power plants, landing gears and wing tanks were found in this area. Both flight recorders were found in this area as well. The densest distribution of wreckage shows in Figure 1.18-8. Figure 1.18-7 shows the less dense area was between red line and orange line. Small debris and less dense area were between orange line and blue lines.

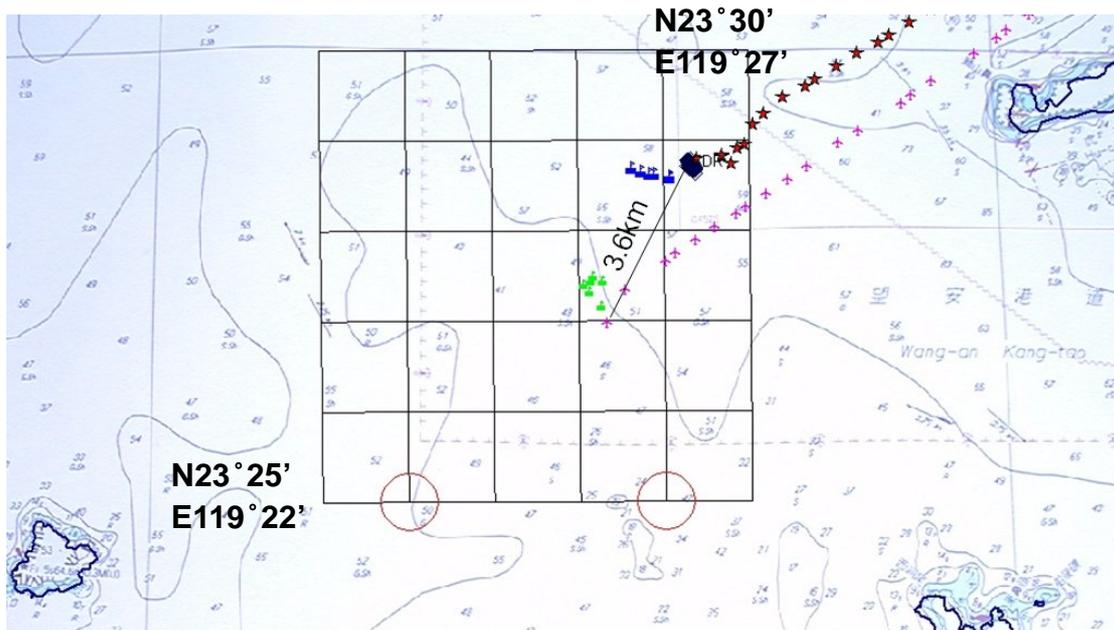
Figure 1.18-9 Comparison between radar tracks and main wreckage site

After finding the main wreckage site, Recovery Group measured the distance between the last transponder data position at the first calculated radar track and other found targets ( see the purple track in Figure1.18-6) which was the reference point for site survey planning. For more precise calculation of the track, Recovery Group considered the local oval globe effect and re-calculated the track (see red track in Figure1.18-9). The distance between the last radar position and main wreckage site was about 186 meters.

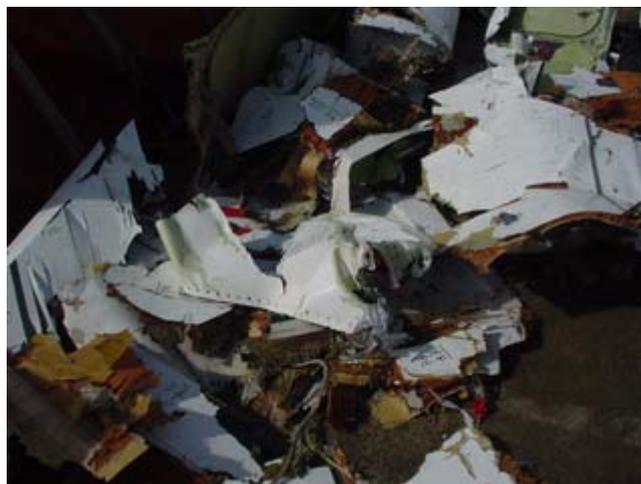
Floating wreckage: The floating wreckages found by Navy and Coast Guard was 87 pieces. Most of them are honeycomb of wing trailing edge, flaps, rudder, and elevators engine cowling and so on (refer to Figure 1.18-10). Some of them are clothing. The biggest one was number 55, which was a roll of clothing (210 cm X 17 cm). The smallest one is a taco meter of engine rpm (10cmX1cm)

Figure 1.18-10 Floating wreckages

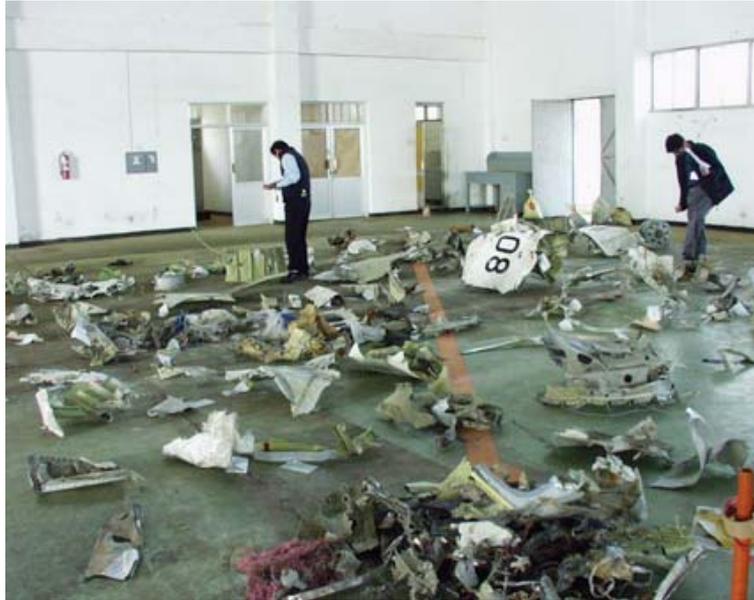
Underwater wreckage : The Ocean Hercules recovered 10 pieces of wreckage and trawling operation recovered 102 pieces. Most of them are from of wing structure, fuselage skin, landing gears, wheel, stringer and frame (refer to Figure 1.18-11). The biggest piece is a cargo floor (no.198 with size of 205cmX135cmX6cm). The smallest one was fuselage skin (no.152 with size 24cmX8cmX0.2cm).

Figure 1.18-11 Underwater wreckage recovered by trawling operation

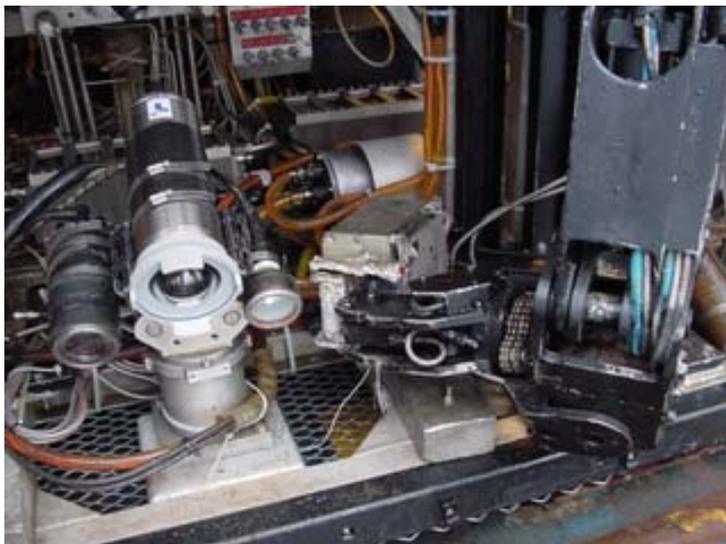
At 0626 on January 12, 2003, ROV discovered the FDR fore part and pinger, its orange casing came off. At 0800, ROV mechanical arm salvaged the FDR (Figure 1.18-25,26), and subsequently discovered wreckage such as: Brake disk, Engine mounting, Engine casing, Landing gear#2, Large engine part, Generator, etc. Work continued until 1630 when current became strong. The FDR was ferried to shore by Coast Guard vessel, and taken to ASC Lab by IIC.

Figure 1.18-25 FDR recovered by ROV

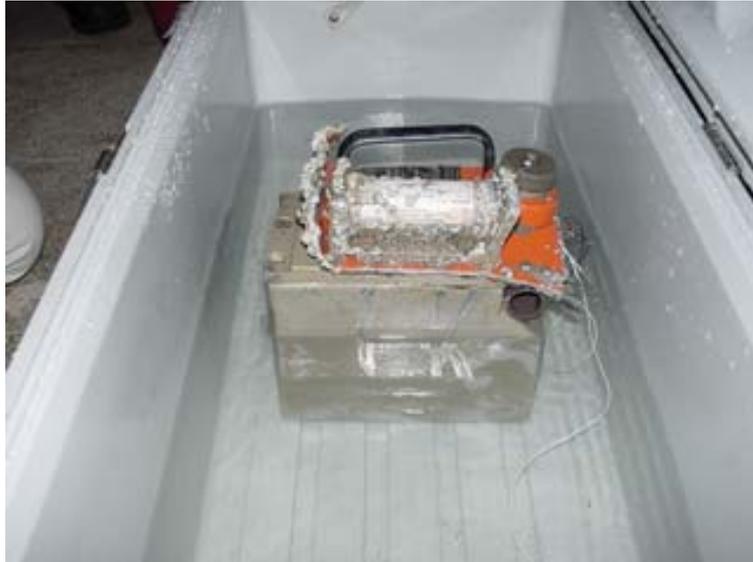
Figure 1.18-26 FDR close view while recovered

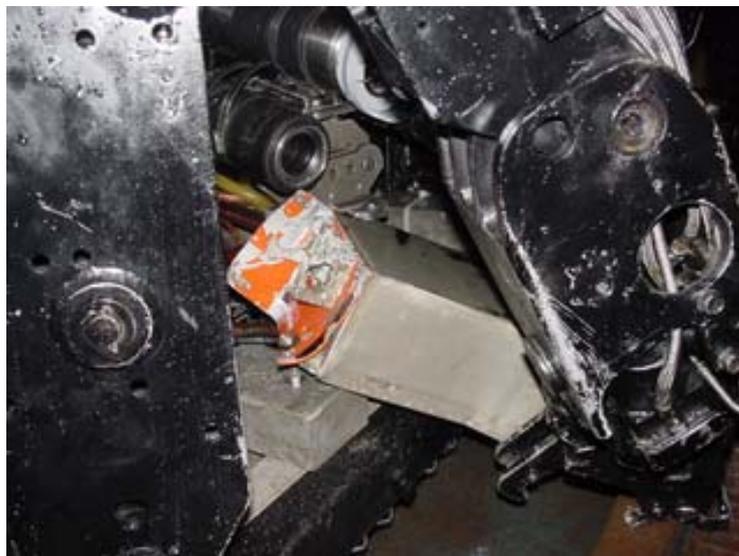
At 0140 on January 14, 2003, ROV discovered CVR fore part ( Crash Survivable Unit, CSU ) , its pinger being lost, and without the orange casing. At 1900 ROV mechanical arm salvaged CVR (Figure 1.18-27,28), and subsequently discovered wreckage.

Figure 1.18-27 CVR recovered by ROV

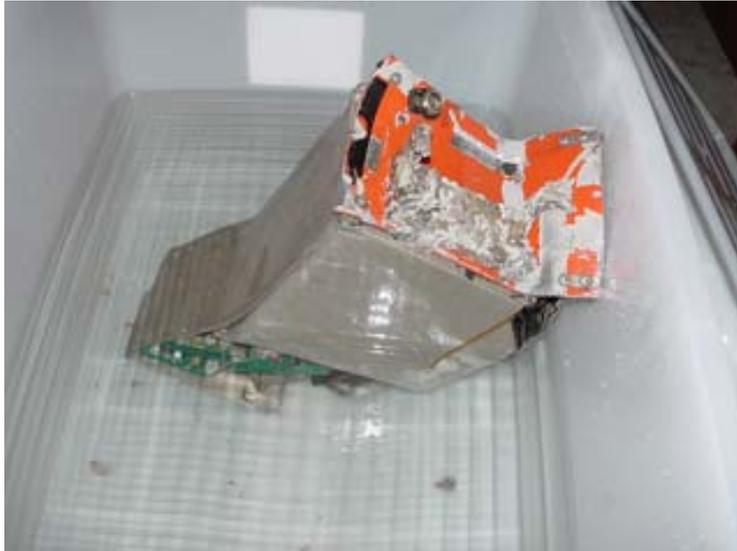
Figure 1.18-28 CVR closed view while recovered

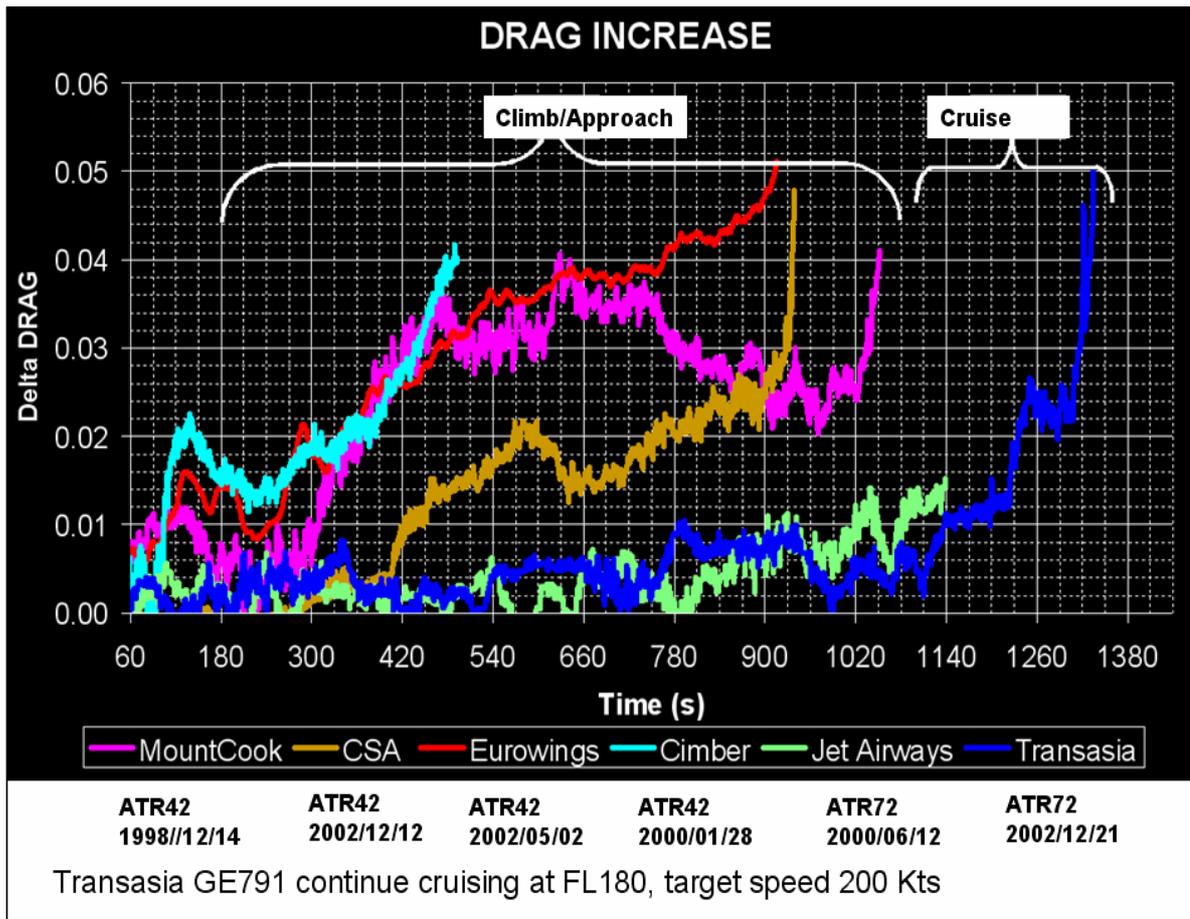
The Roselawn accident is not included into Figure 2.4-1, because of the very small amount of drag created by severe ice, in fact the ice accumulated was only in front of aileron and the roll upset was created by the influence of this ridge on the aileron hinge moment variation. All the other events presented a very high drag increase with large speed penalties.

Figure 2.4-1 Aircraft extra drag due to ice versus time after Roselawn (1998~2002)

The Safety Council believes that ATR 42 /72 after prolonged exposure to severe icing conditions and continuously activated the airframe de-icing, icing accretion may caused drag increased to 500 counts, and caused the aircraft upset or stall.

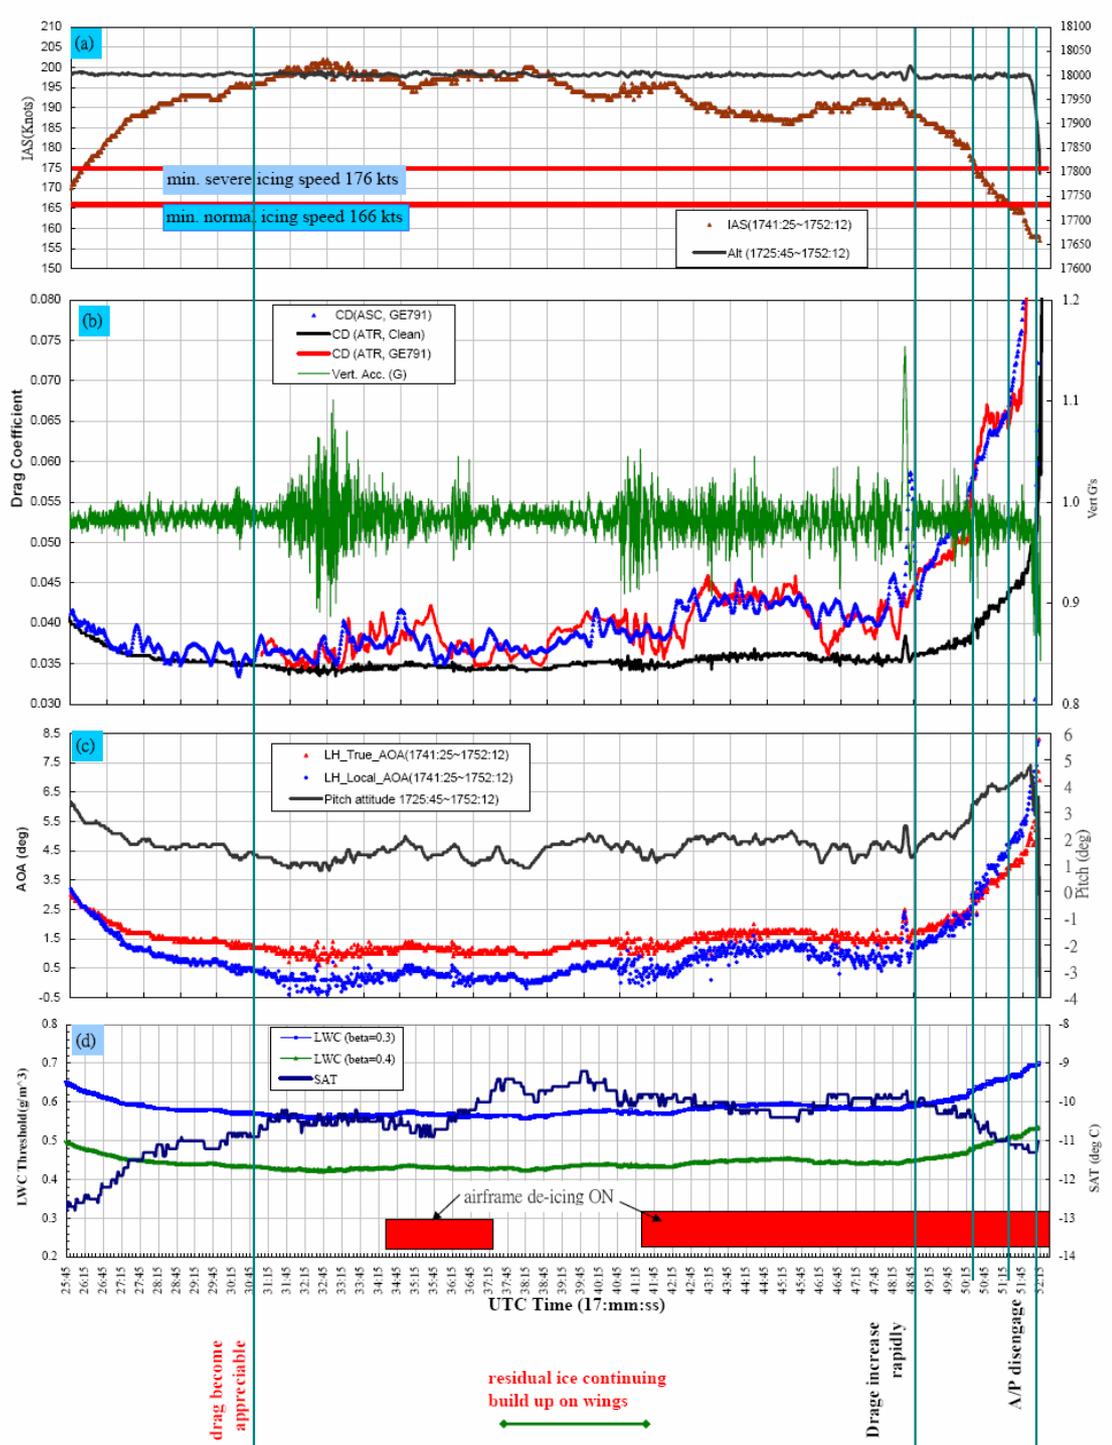
The effect of ice accretion increased the drag of about 500 counts, lift-drag ratio loss was about 64% and the indicated airspeed decayed in about 1 min and 50 sec. from 176 knots (Minimum severe icing speed) to 158 knots.

The Safety Council, after analysis of FDR and CVR data, believes that the GE791 probably encountered a severe icing condition, which was worse than icing certification requirements of FAR/JAR 25 Appendix C.

Figure 2.4-3 GE791 performance data plot due to ice accretion versus time (airspeed, altitude, OAT, drag, and severe icing threshold value of LWC)

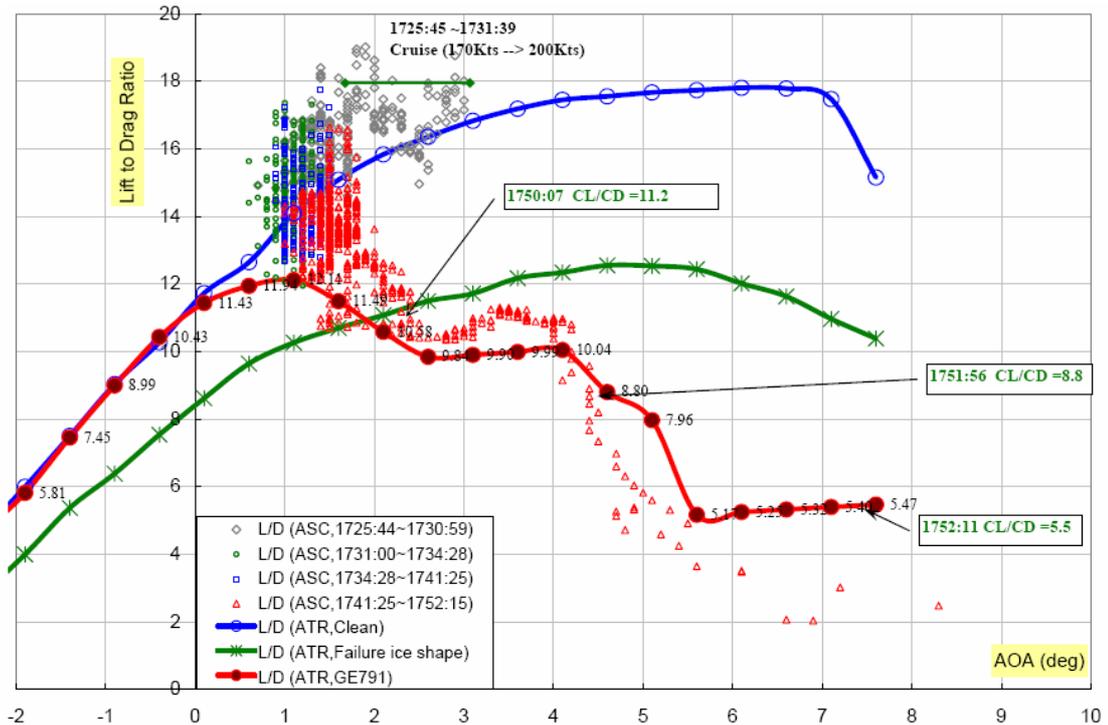
Figure 2.4-4 The lift-drag ratio of the GE791 due to ice accretion versus true AOA

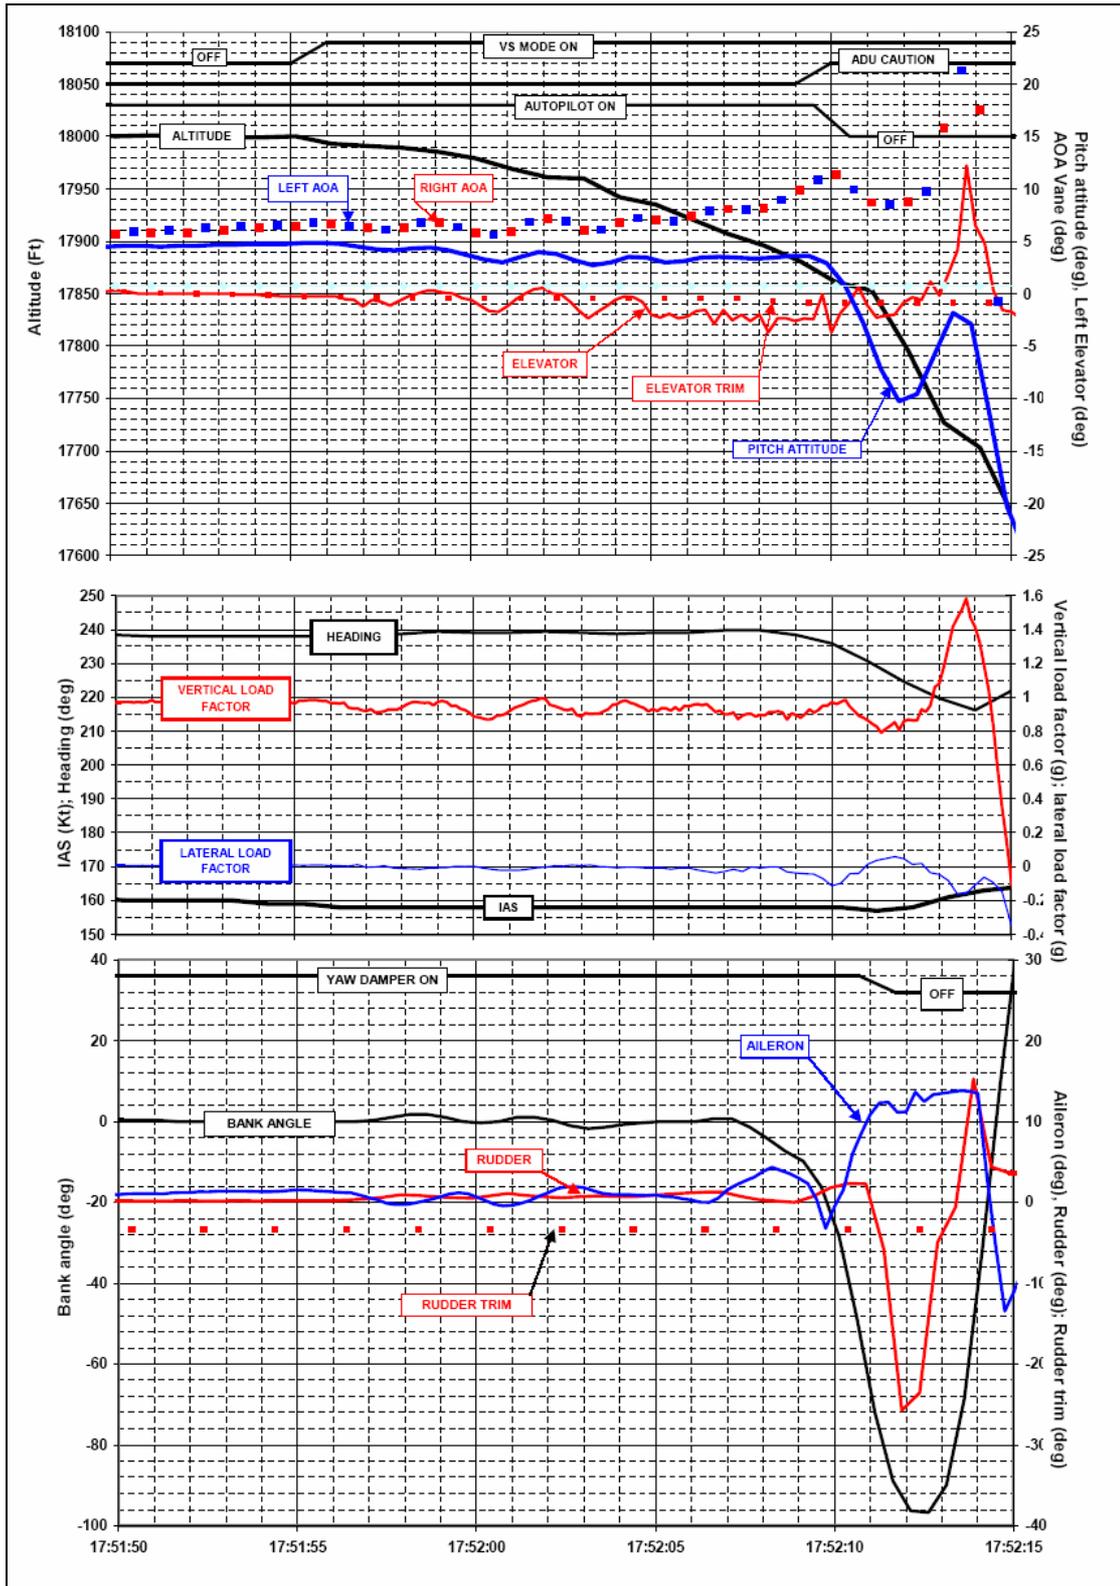
At about 5.5° of true AOA and few seconds before the autopilot disconnection, the loss of lift and the increase of drag clearly indicate that the left wing of the GE791 is entering the stall. After the autopilot disconnection the drag and the loss of lift continued to increase up to the maximum AOA (at 0152:14, 22.5° vane; 15.07° true AOA). Since the activation of stick pusher (at 0152:13.75, 12.83° true AOA) until maximum AOA, then the AOA decreased rapidly due to time delay to recover from lift the flow remained separated on the wing inducing a further additive drag of 600 counts.

Figure 2.4-5 GE791 FDR data plot during the roll upset

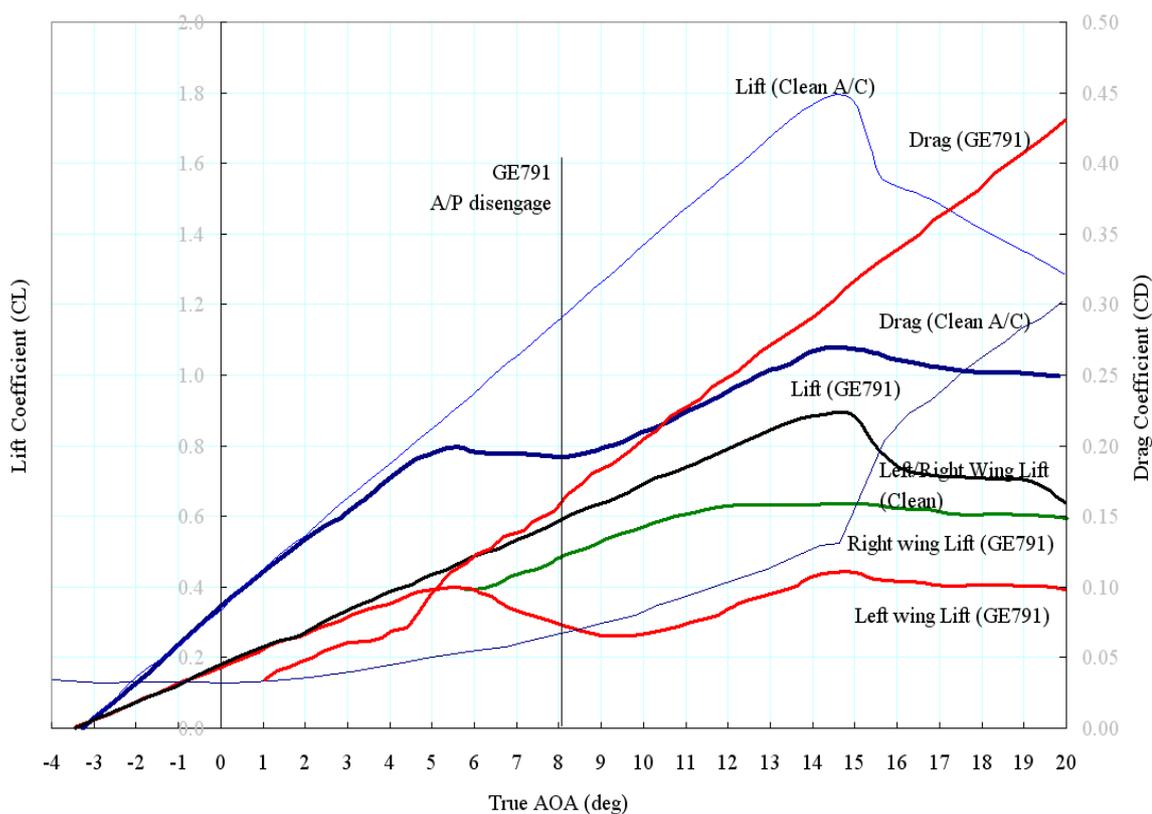
The Figure 2.4-6 shows the drag and lift versus true AOA computed during the speed decay and the roll excursion. It can be observed that at about 4.5° of true AOA, the severity of the ice produced a flow separation on the wing, which induced a loss of lift and a drag increase.

Figure 2.4-6 The lift and drag coefficients versus true AOA (ATR72 clean and GE791 ice polluted)

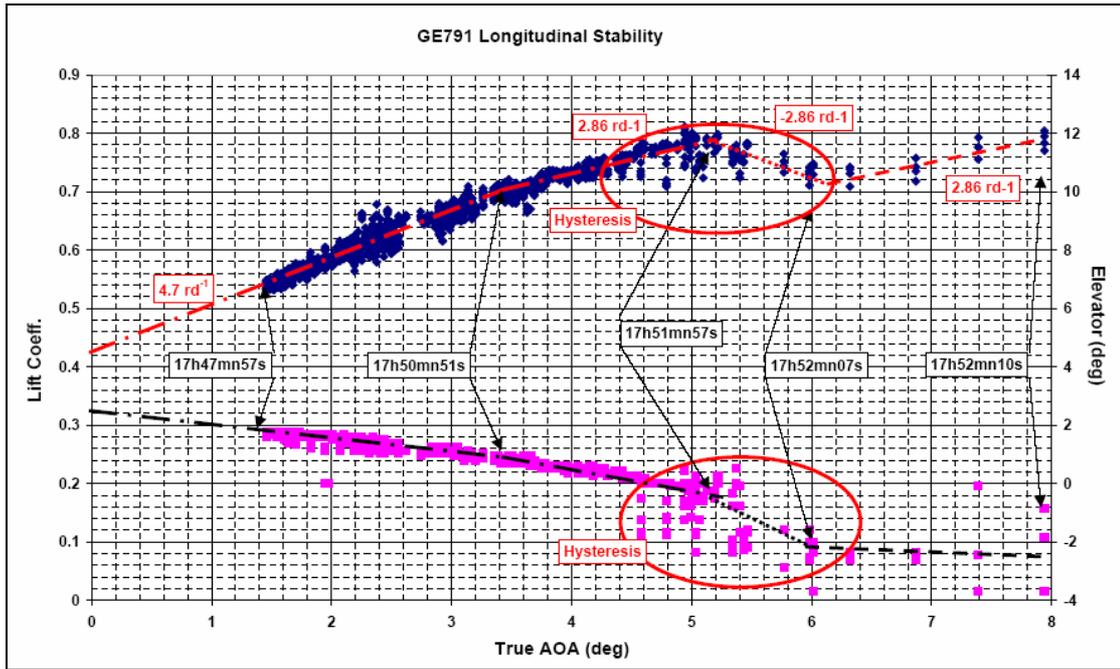
During the 10s before the roll excursion (0151:57 to 0152:07) the longitudinal and lateral stability has been modified by the ice accumulated on the wings producing the flow separation. In particular the application of recovery procedures using a significant reduction of aircraft AOA (3°) by a pitch down elevator input or flaps extension (15) lead the aircraft in a situation where all aerodynamic parameters are nominal.

Figure 2.4-8 GE791 longitudinal stability (derived from FDR data)

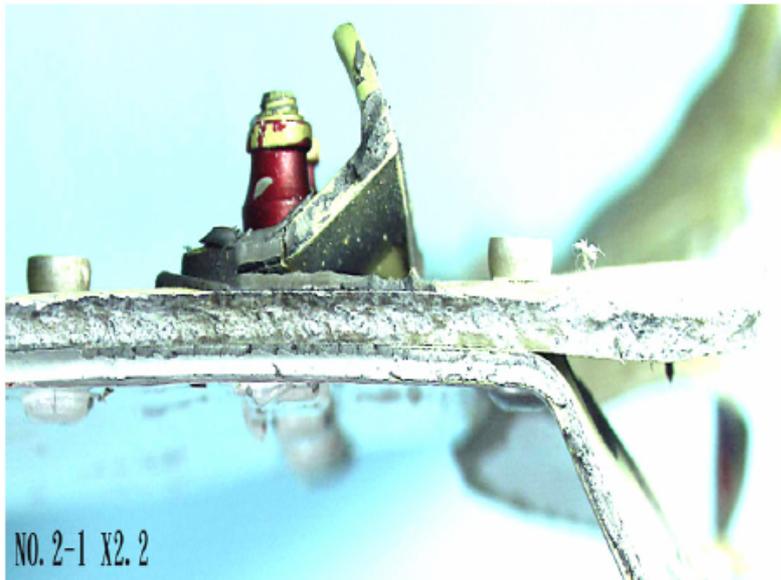
如圖 2~圖 8 分別為斷面編號 1-1、1-2、1-3、1-4、1-5、1-6，及 1-7 之斷面巨觀觀察，斷面從頭到尾均呈現崎嶇不平的斷裂形態。而圖 9~圖 13 則分別為斷面編號 2-1、2-2、2-3、2-4，及 2-5 之斷面巨觀觀察，斷面從頭到尾也是呈現崎嶇不平的斷裂形態。至於破壞模式須由 SEM 確認。

圖 9. 客艙窗戶結構破損件編號 2-1 端斷面的巨觀觀察。(2.2X)

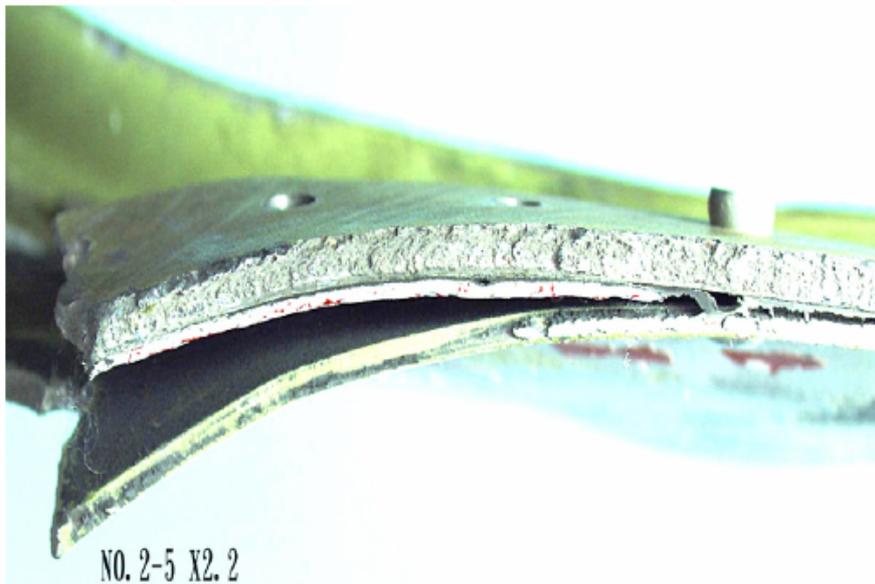
NO. 2-5 X2.2

圖 13. 客艙窗戶結構破損件編號 2-5 端斷面的巨觀觀察。(2.2X)

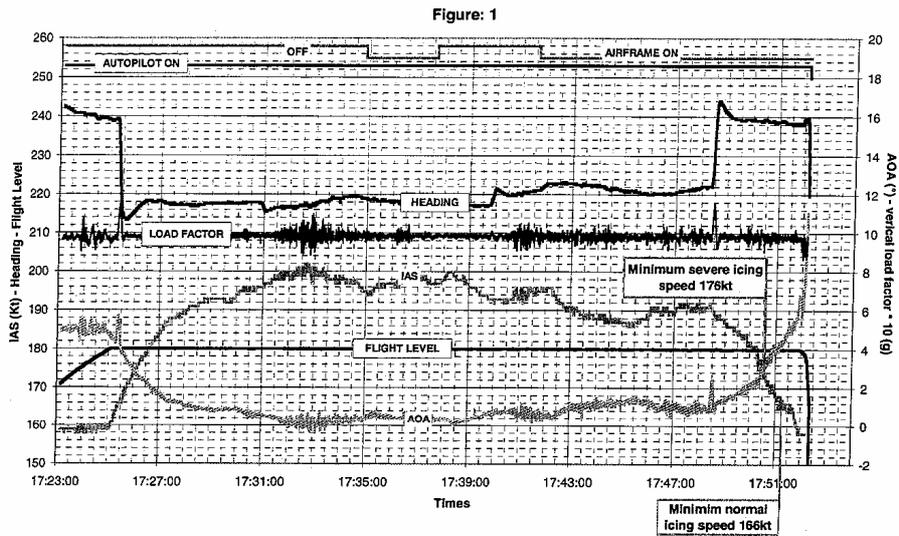
- Flight level 180: Speed decay (see figure 1)

The aircraft decelerated to 194Kt (-8kt) due to ice accretion (see vertical load factor activities). This deceleration has been stopped by the crew intervention to select level 3 of de-icing system (Airframe ON from 17h 34mn 52s to 17h 37mn 38)

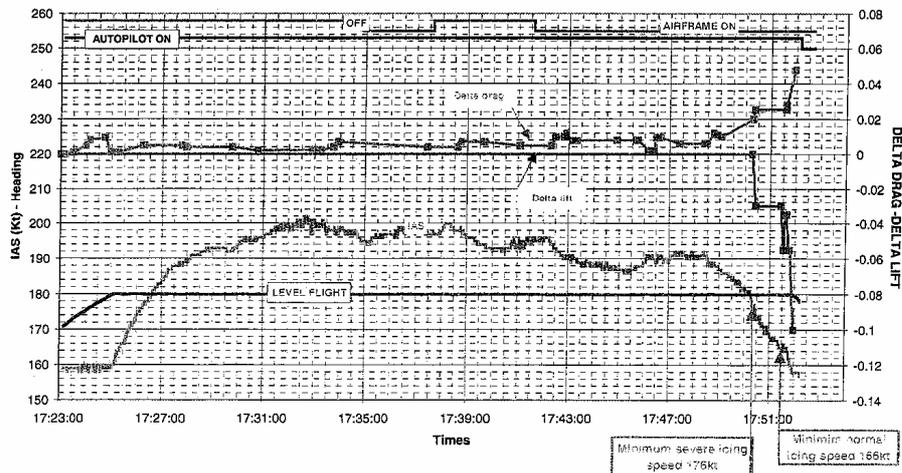
Figure: 4

The figure 4 shows that the aircraft staid exposed to icing conditions during 29mn. During the first 25 minutes the drag increased slowly (within 100 counts) inducing a speed diminishing about 10Kts. After that, the drag increased quickly and the speed dropped to 158 Kts in 4 minutes.

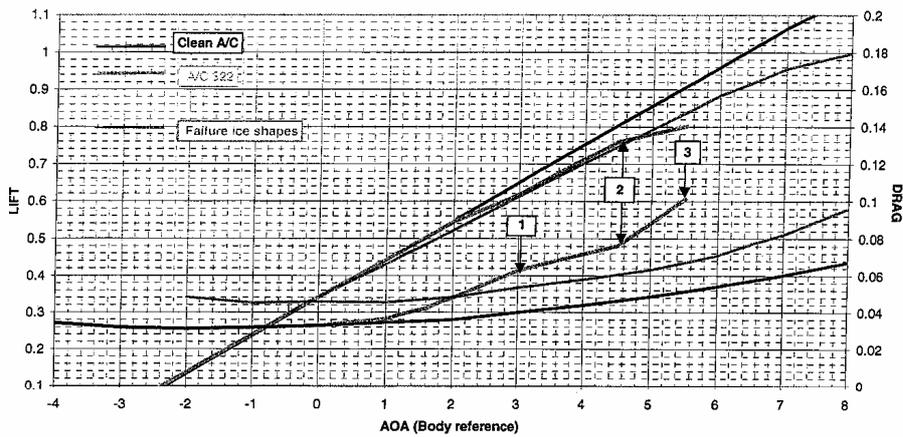
Figure: 5  
Performances comparison

This Figure 5 shows the drag and lift computed during the 30mn before autopilot disconnection compared to the drag and lift obtained in aircraft certification with and without normal icing.

Between points 1 and 2 the aircraft 322 has the lift gradient corresponding to an aircraft polluted with ice shapes due to boots not operating (as per certification requirements Appendix C ). At the same time the drag increase is more important (about the double) for the MSN 322. This difference is a sign that the aircraft faced a severe icing exposure whose effects were even bigger than ice shapes corresponding to inoperative boots.

At the point 2, at about 4.5° of angle of attack, the severe ice produces a flow separation on the wing, which induces a loss of lift and a further drag increase.

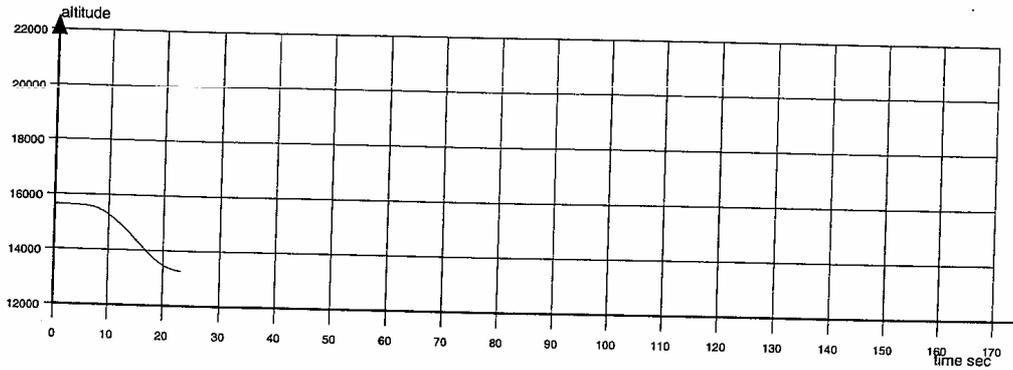
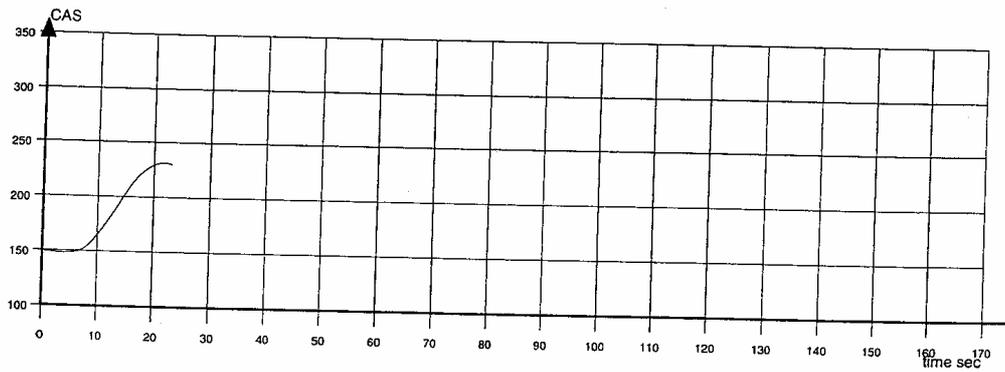
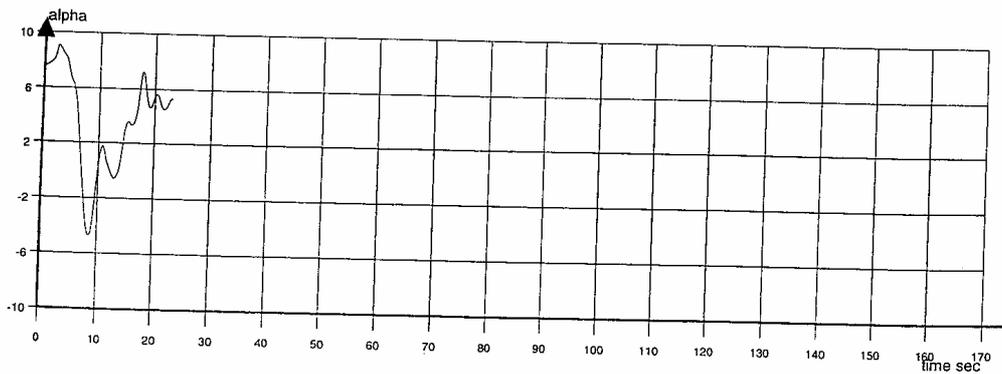
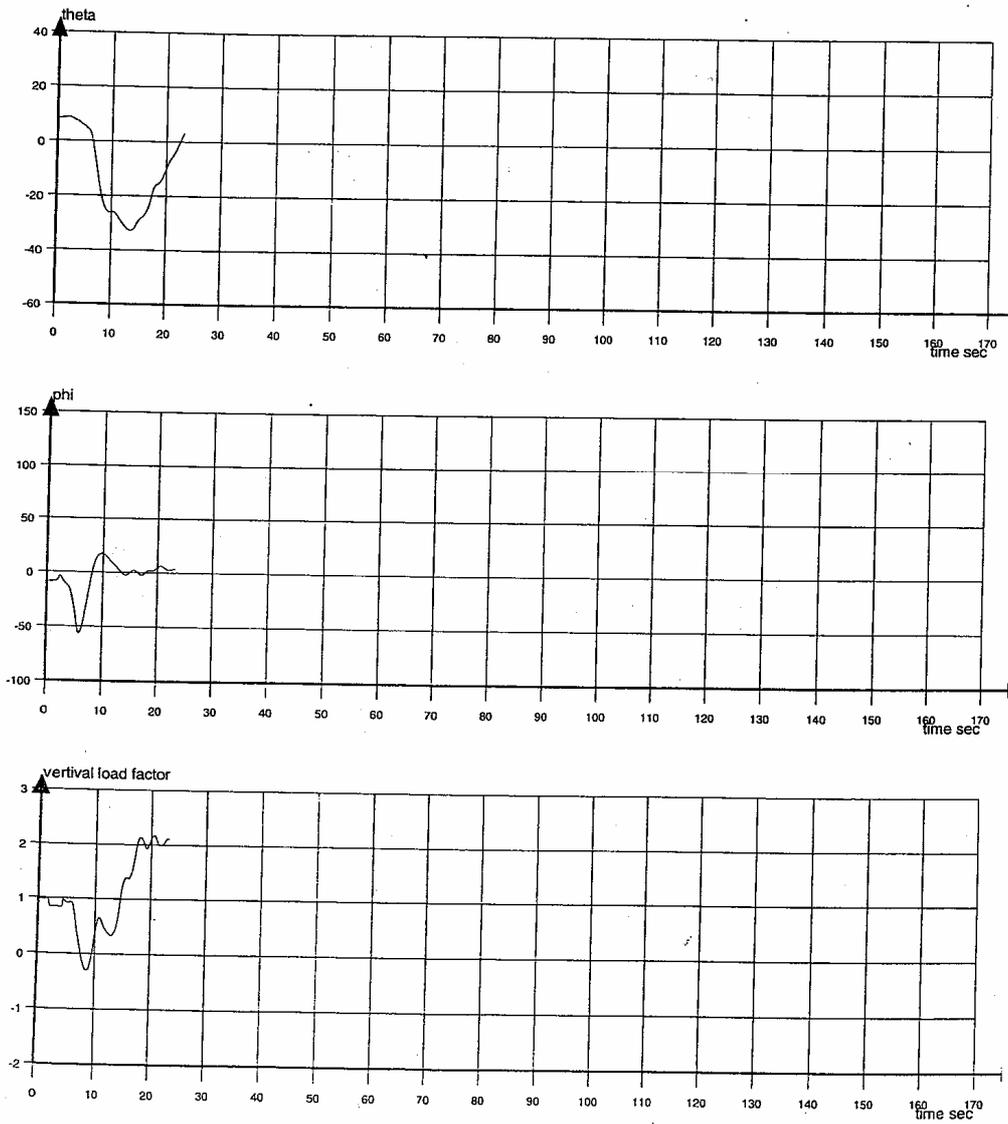
# 1

- ◆ Severe icing conditions induce speed decay;
- ◆ If the pilot does not observe the minimum speed recommended by the procedure, a stall may occur, with unwanted roll motions;
- ◆ The stalling conditions are maintained if the pilot only counteracts the roll motions, keeping the stick around the neutral position;
- ◆ The control of the aircraft is immediately regained when applying either of the recovery techniques recommended by ATR.

THOMSON-CSF - TSS  
RESULTS: 72-200 TNG68 SEVERE ICING

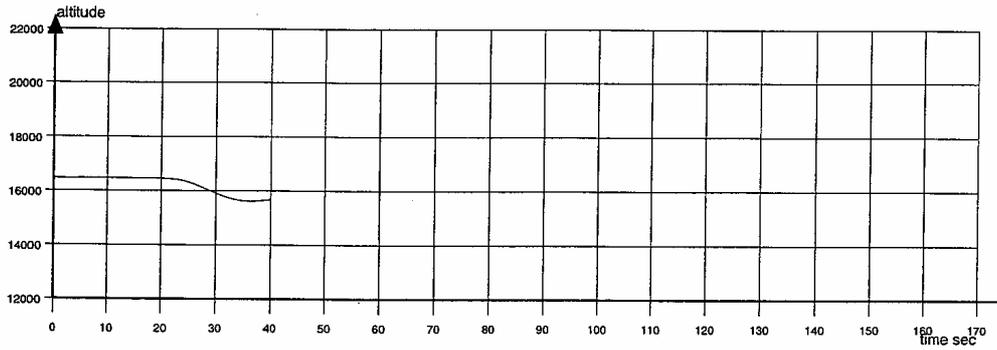
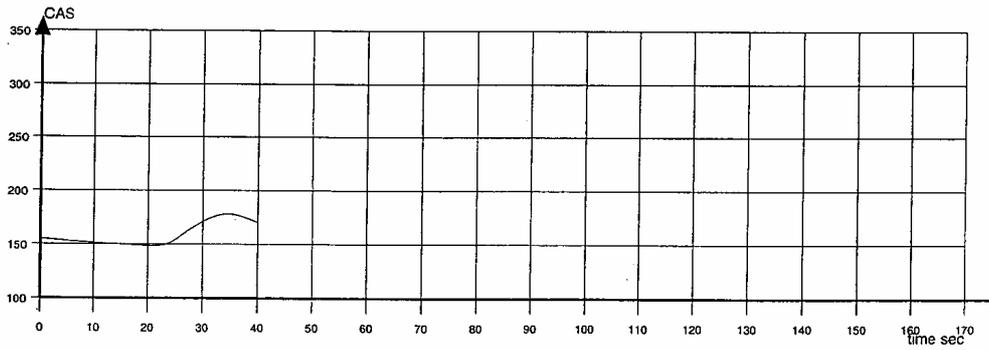
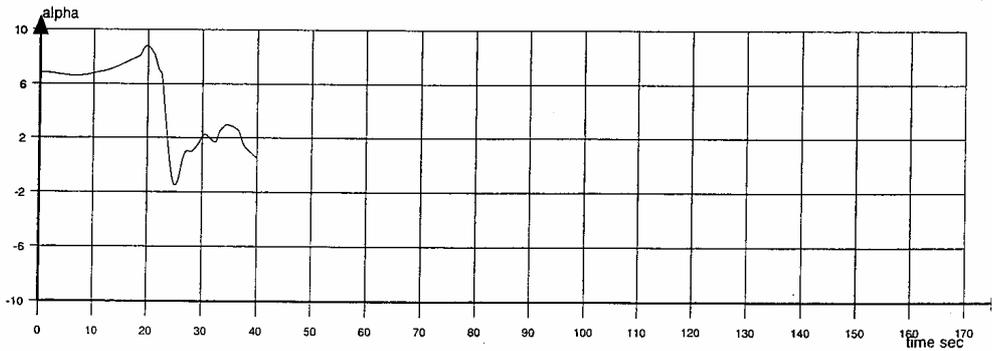
#2

The extension of flaps  $15^\circ$  is another procedure recommended by ATR : as soon as the flaps begin to extend, the AOA immediately

Flaps 15 - (SEVERE ICING)

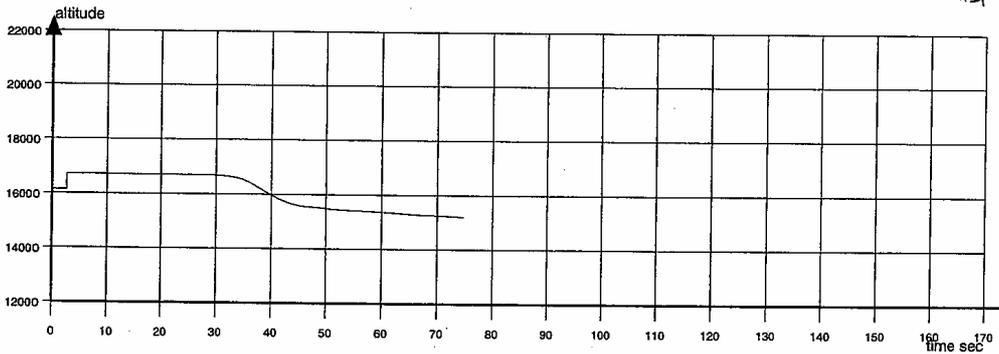
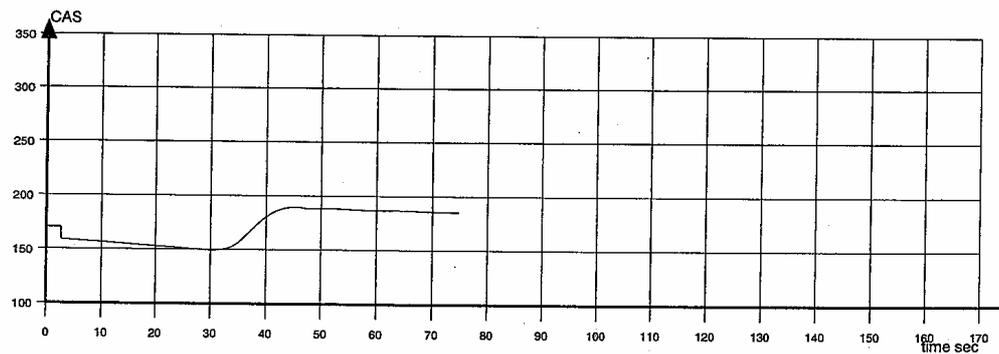
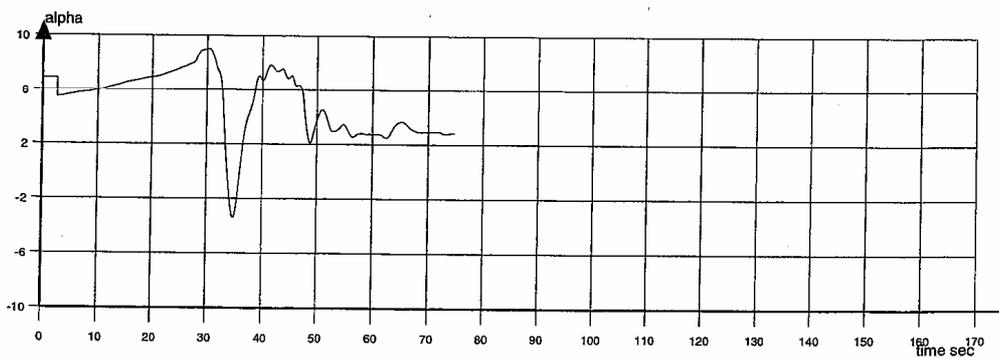
#3

The result is that the aircraft is maintained in stall conditions : by fighting on the roll axis, the bank angle may be kept in reasonable margins, but there are still erratic roll motions, and the full control is never regained.

Flaps 0 (brake release)
