**Aviation Safety Council  
Taipei, Taiwan**

# **GE 791 Occurrence Investigation Report**

**IN-FLIGHT ICING ENCOUNTER AND CRASH INTO THE SEA  
TRANSASIA AIRWAYS FLIGHT 791  
ATR72-200, B-22708  
17 KILOMETERS SOUTHWEST OF MAKUNG CITY,  
PENGHU ISLANDS, TAIWAN  
DECEMBER 21, 2002**

**ASC-AOR-05-04-001**

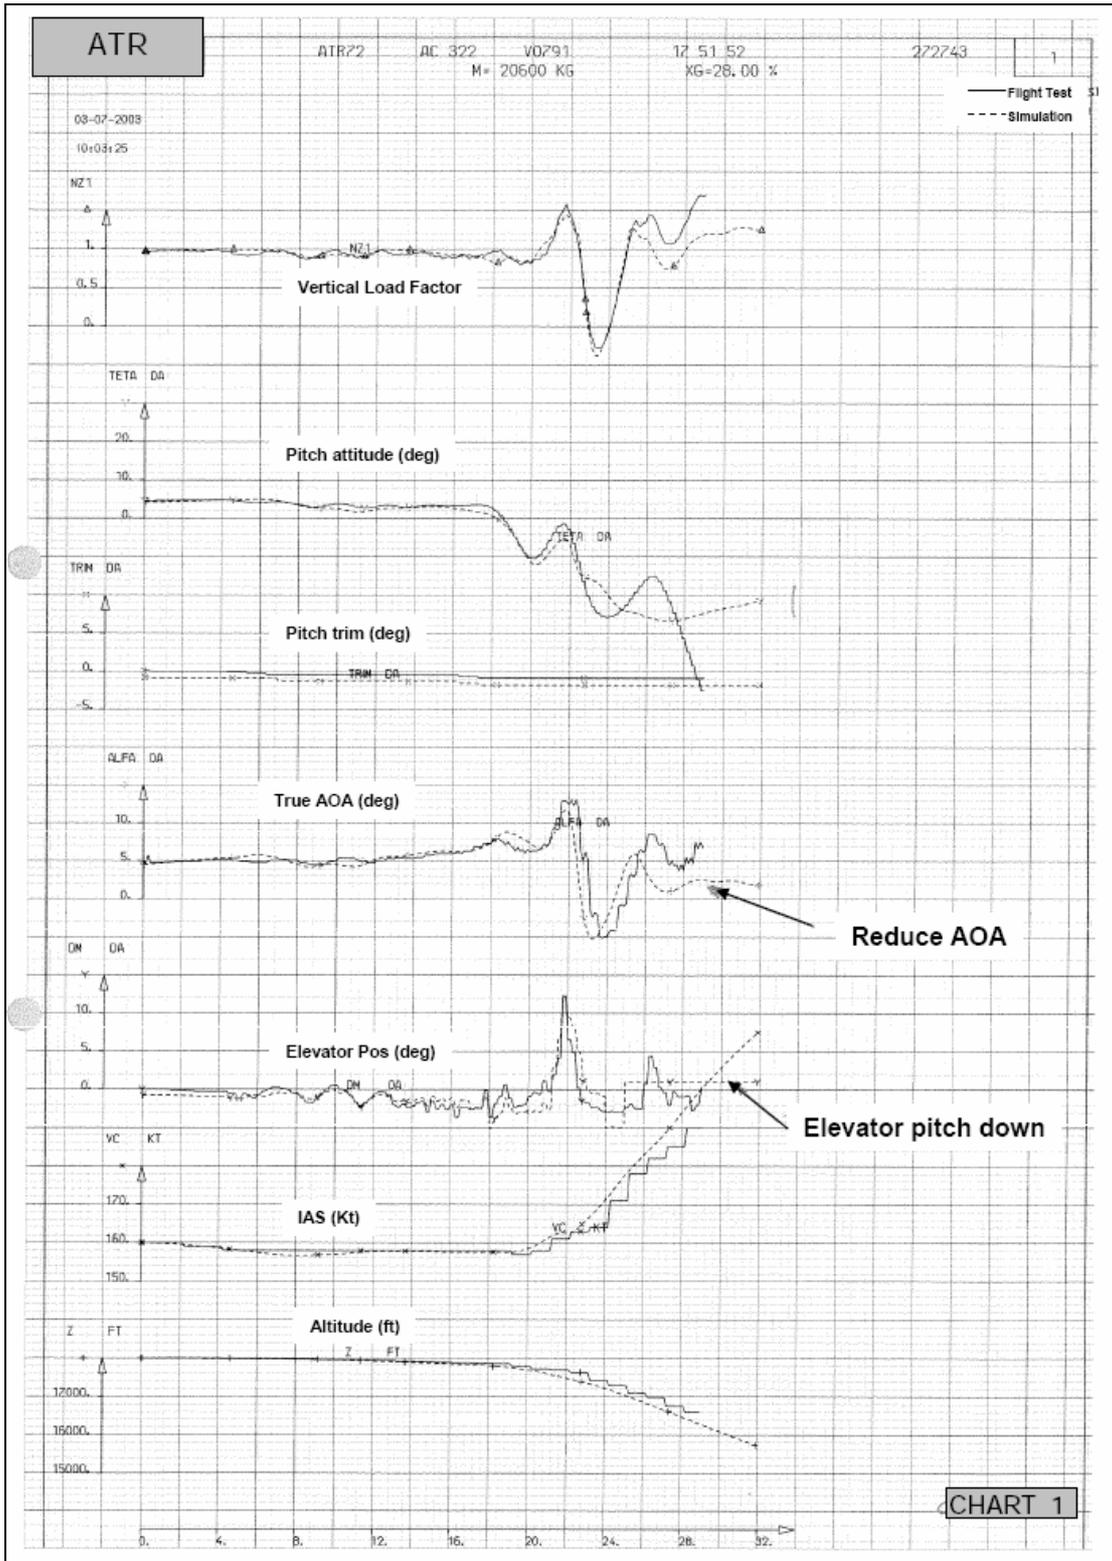
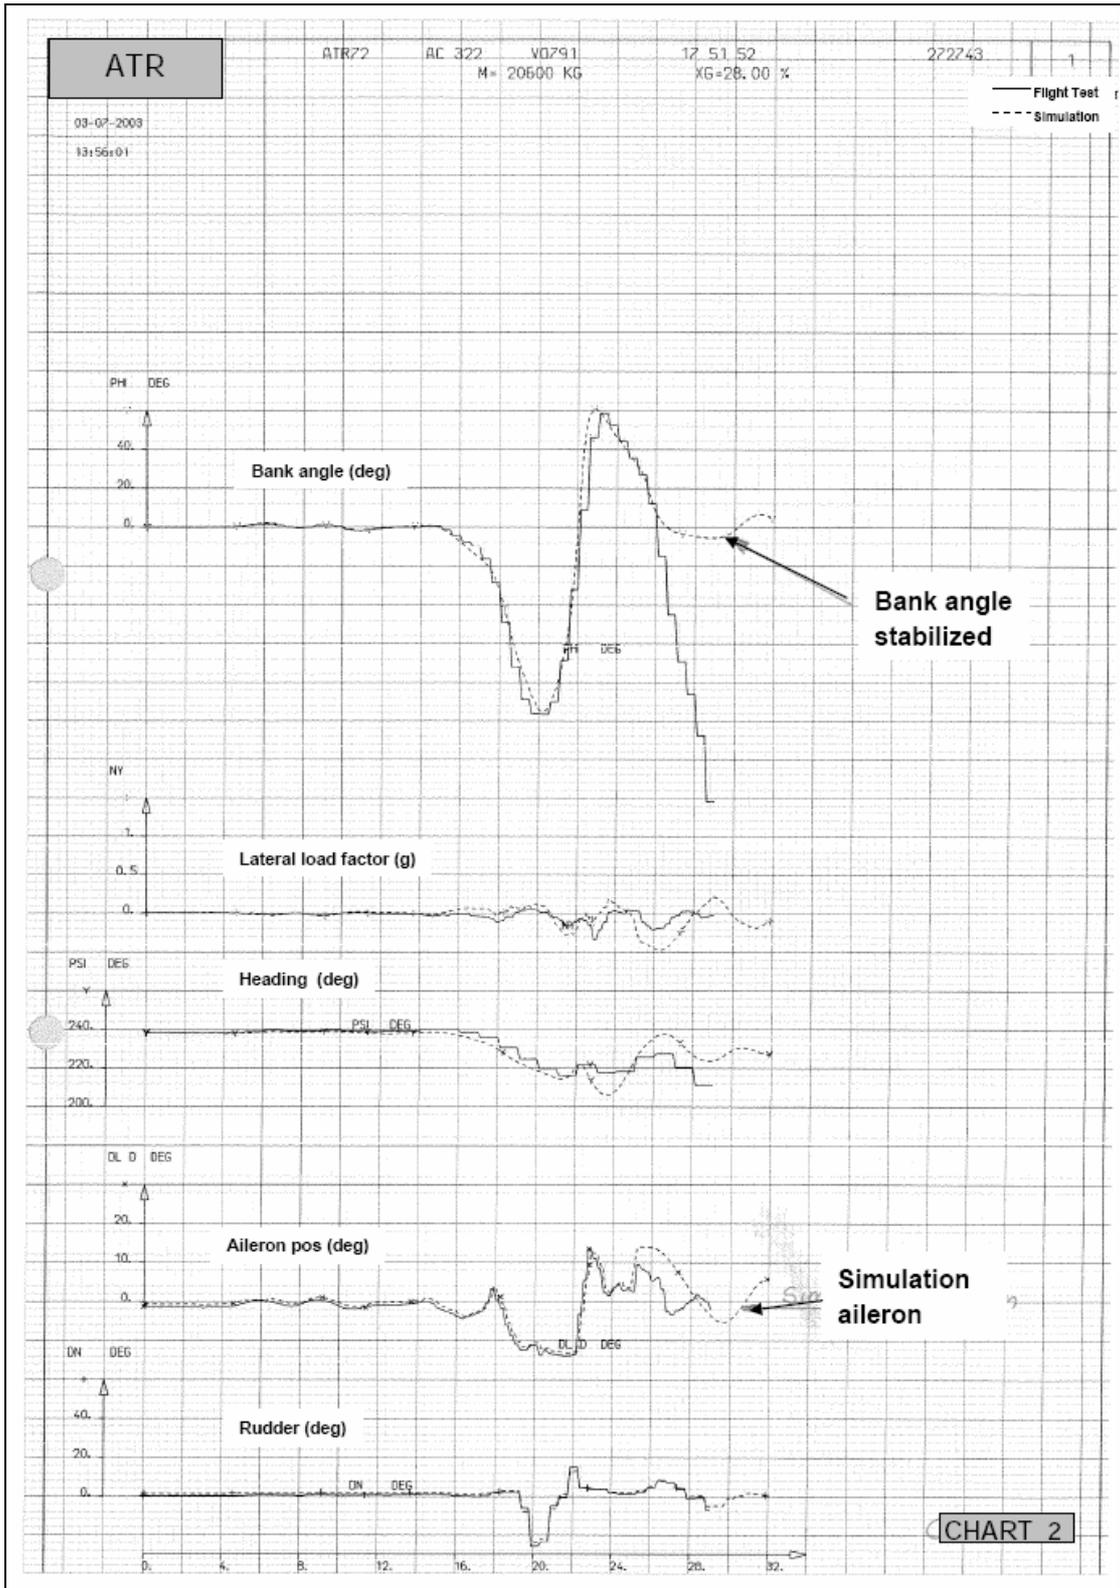
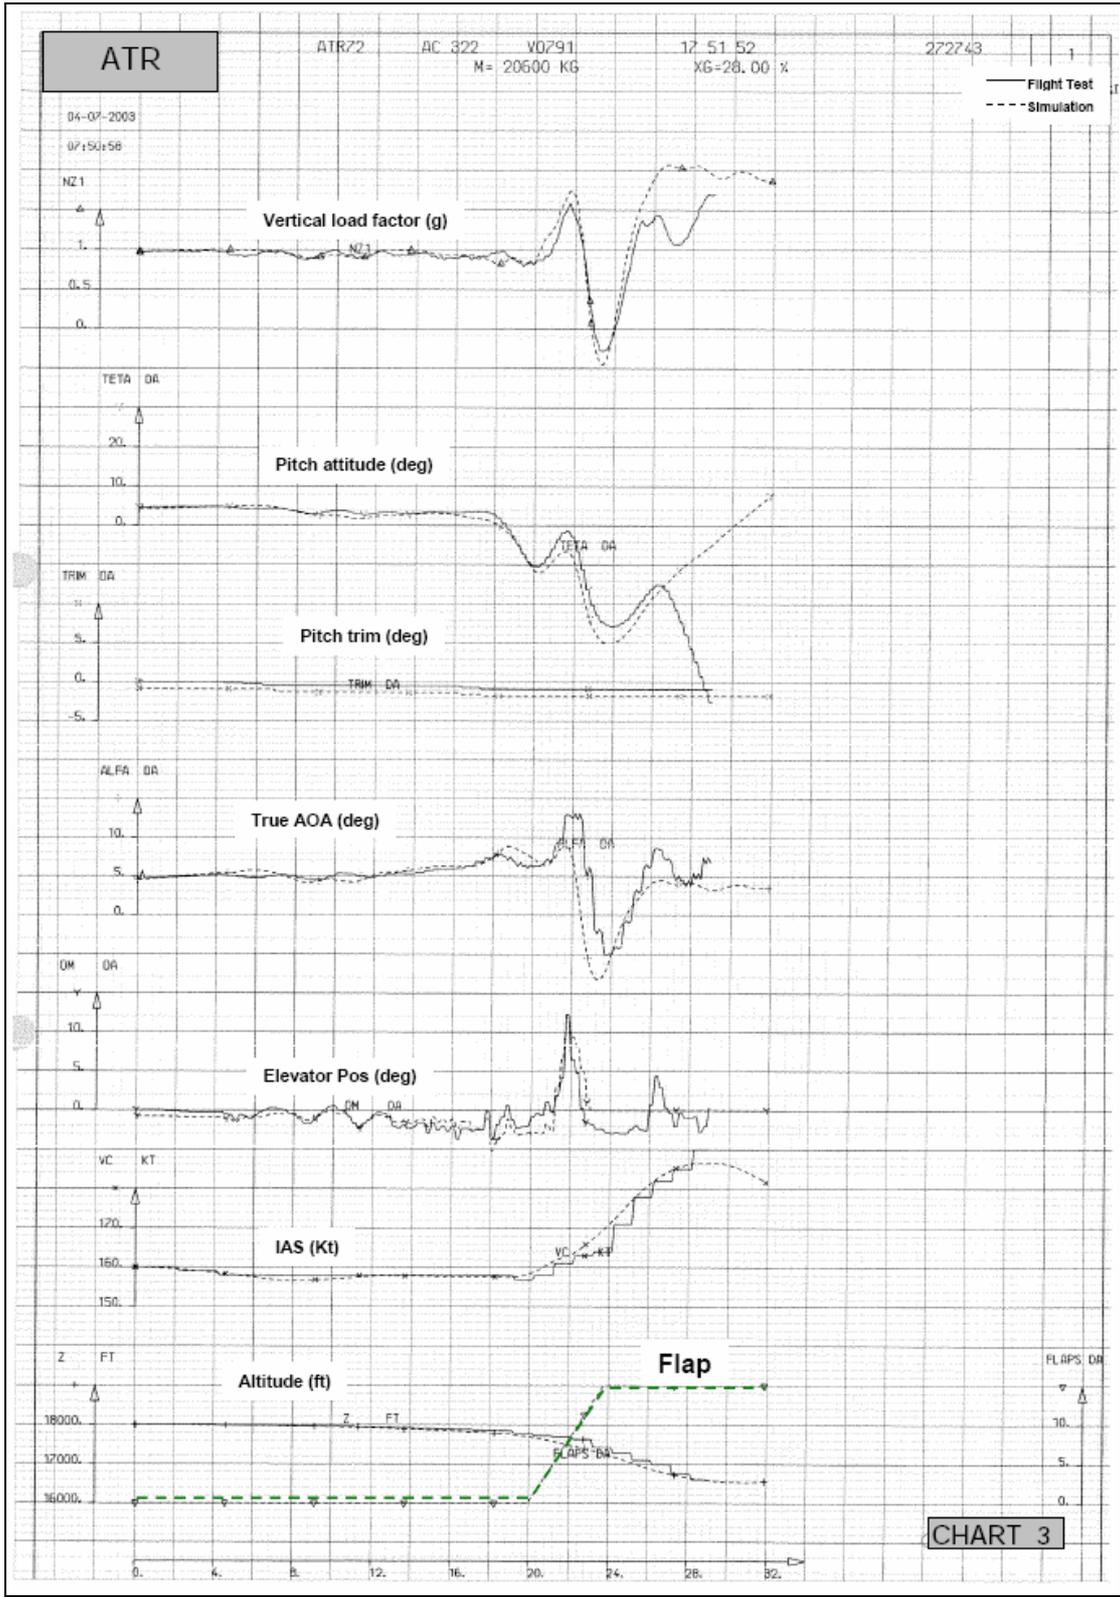
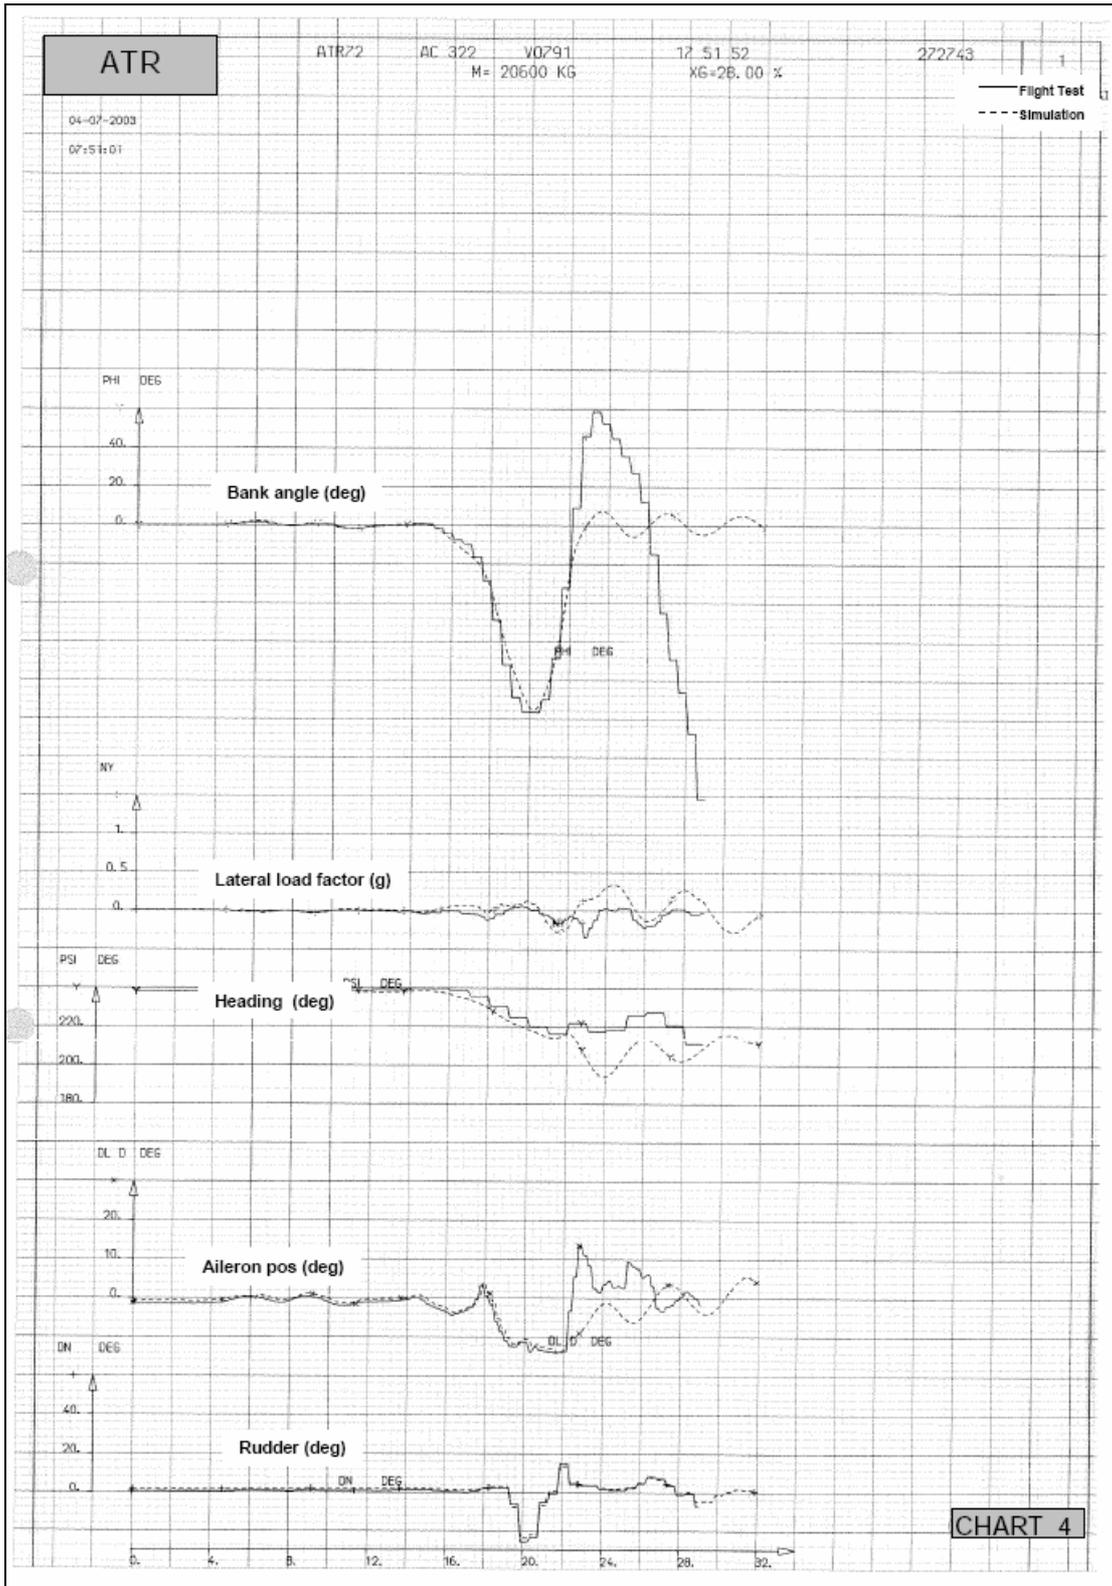
The figures from 1 to 4 show that the simultaneous application of AFM procedure in the same accident flight conditions leads to the recovery of the correct flight attitude.

The figure 2 shows the aileron command and the effect on the bank. The actions on the aileron combined with the angle of attack reduction obtained with elevator push down leads to complete recovery.

The figure 3 shows the effect of flap extension on the recovery. The effect on the pitch angle is immediate.

The Safety Council, after analysis of FDR and CVR data, believes that the GE791 probably encountered a severe icing condition, which was worse than icing certification requirements of FAR/JAR 25 Appendix C.

In fact the continued flight in such conditions caused a drag increase of 500 counts which is 130% greater than the expected drag for this aircraft model in cruise and 100% more the normal ice condition. Both lift-drag ratio and airspeed decayed rapidly and caused the mishap from which the aircraft did not recover for lack of application of the recovery procedure.

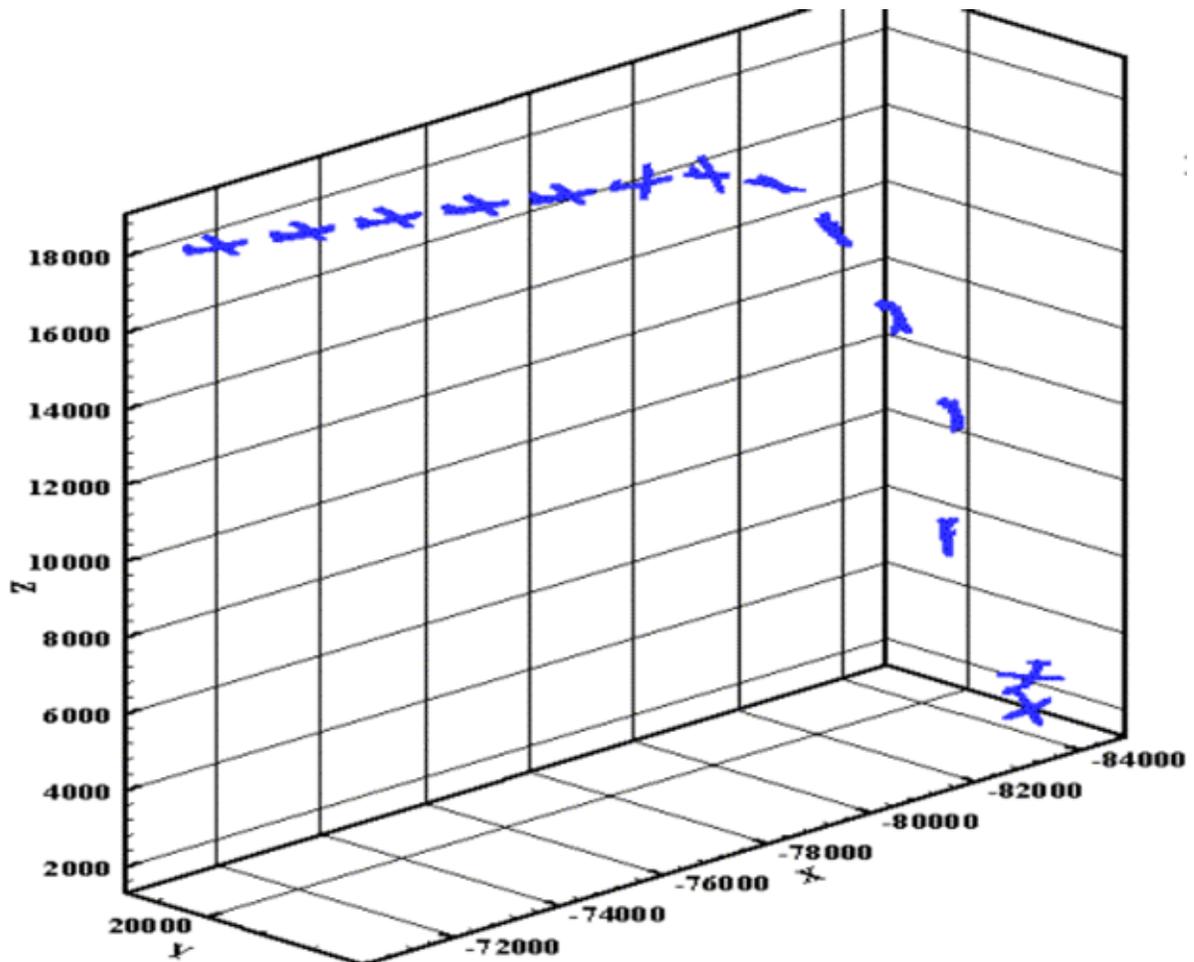
Figure 4 Schematic of GE 791 during the last 288 seconds

The aircraft attitudes and trajectory in the last 283 seconds are re-created in figure 4. As can be seen, the accident scenario started in rolling motion. This will be verified further with engineering plots. Therefore, only three (3) aerodynamic models for the normal force, pitching moment and rolling moment coefficients will be generated.

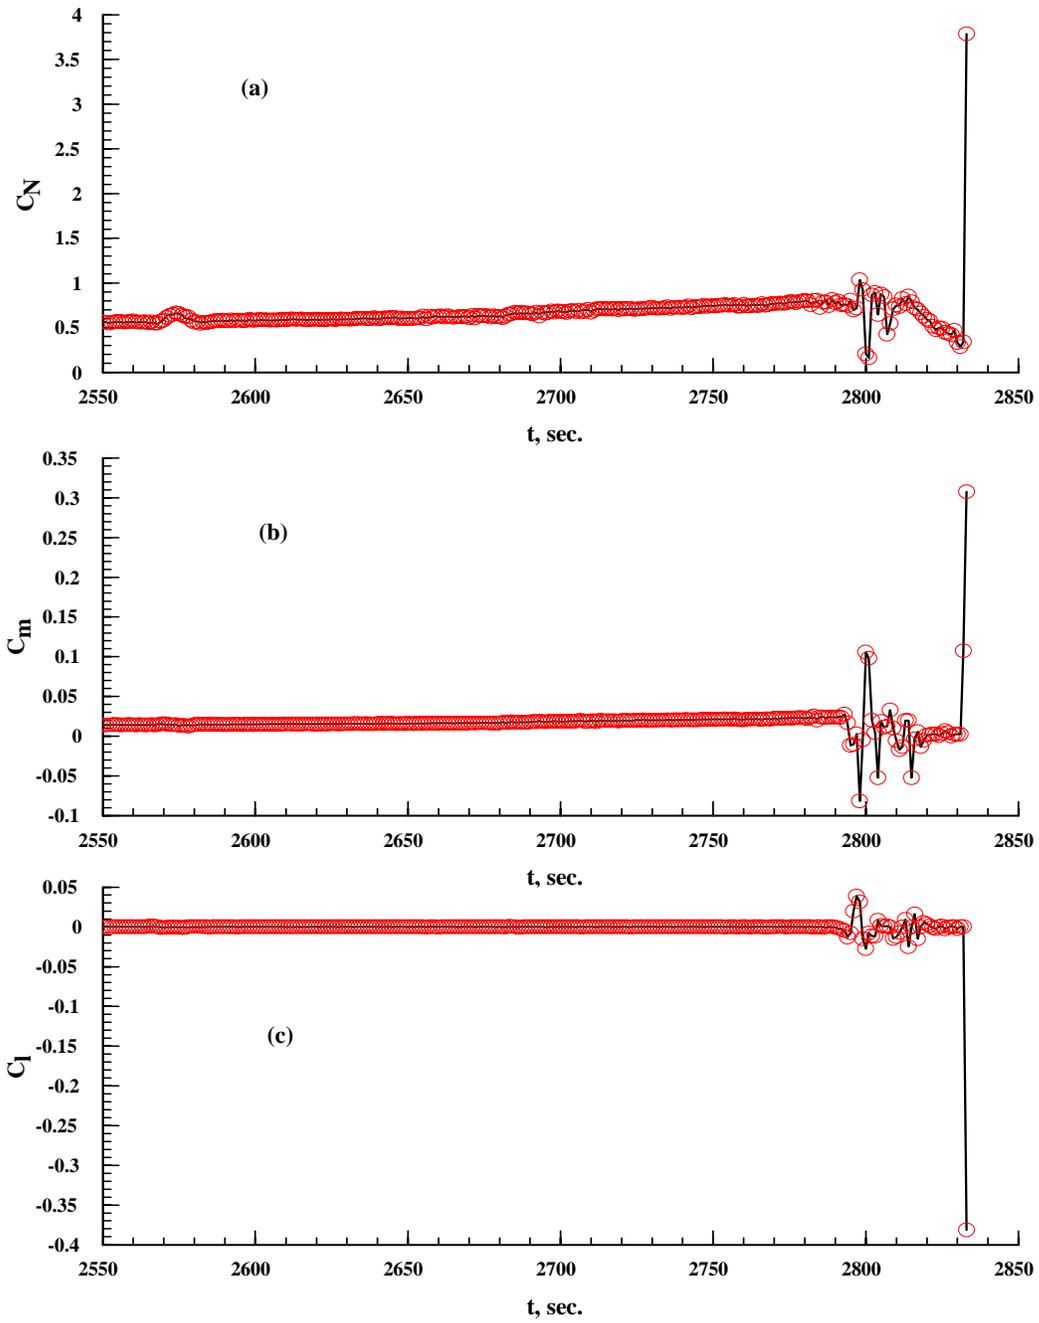
Figure 5 Comparison of predicted aerodynamic coefficients with data along the trajectory

The variation along the flight trajectory for these three coefficients are presented in figure 5. It is seen that the model-predicted results match data very well. In fact, all correlation coefficients exceed 0.999. The yawing moment coefficient model is not established, because the yaw rate and sideslip angle were not significant. And if a specific flight variable is not excited in a motion, flying quality parameter corresponding to that variable cannot be identified or calculated.

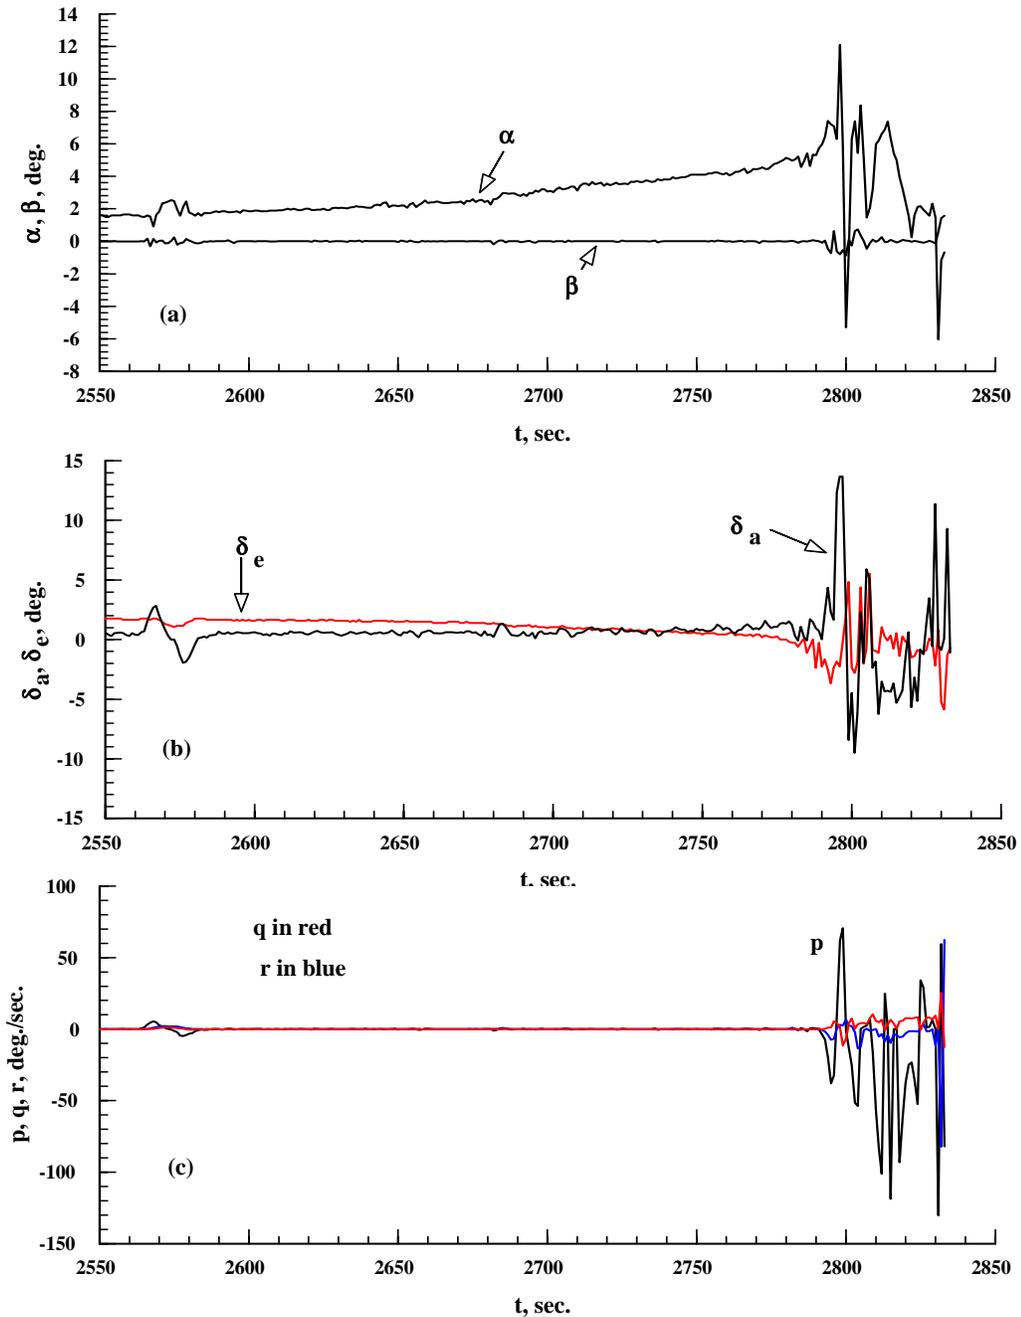
Figure 6 Variation of flight variables of GE 791 along the trajectory

Actually, data of the last 533 seconds are employed in the fuzzy logic modeling technique. In this time period, it was certain that icing on the aircraft would be significant throughout. If the analysis covers a larger time period, an observable flight variable would be needed to distinguish icing level and non-icing conditions. Currently, there is no such variable available in the FDR. Time histories of some primary flight variables are shown in figure 6.

It is seen that large roll rates started at about  $\alpha = 6$  deg. (fig. 6a), and the aileron was active (fig. 6b). In figure 6c, it is shown that roll rate is the primary angular rate affecting the motion. In figure 7, the normal force coefficient slope with  $\alpha$  before roll excursion is estimated to be about 2.2 per radian. Since the effectiveness of both the elevator and stabilizer before the roll excursion appeared to be small (fig. 7b and fig. 8b), tail icing might have started before wing ice accretion.

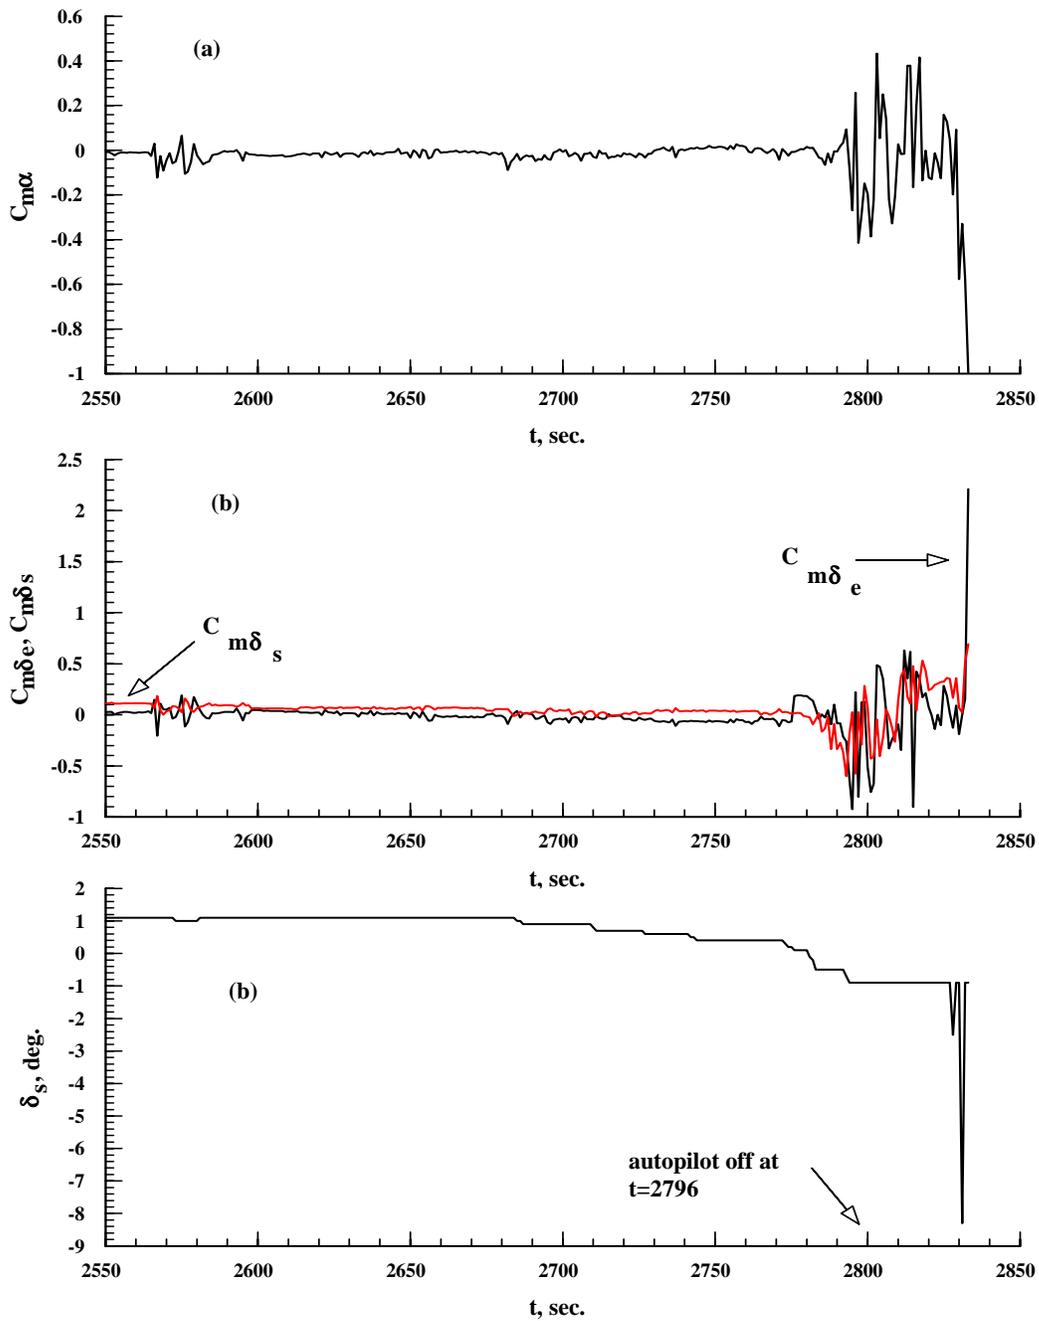
Figure 8 Calculated derivatives for the pitching moment coefficient along the trajectory

The speed decrease at a rate of 0.28 ft./sec per second means that wing ice has increased the aerodynamic drag slightly. In figure 8a, it is seen that longitudinally it was almost neutrally stable (i.e. small negative  $C_{m\alpha}$ ). But the stabilizer angle, although small, moved toward the negative side slowly to produce the nose-up pitching moment probably to counteract the nose-down pitching moment due to ice. Of course, reduced effectiveness of the stabilizer also means it required adjustment continuously.

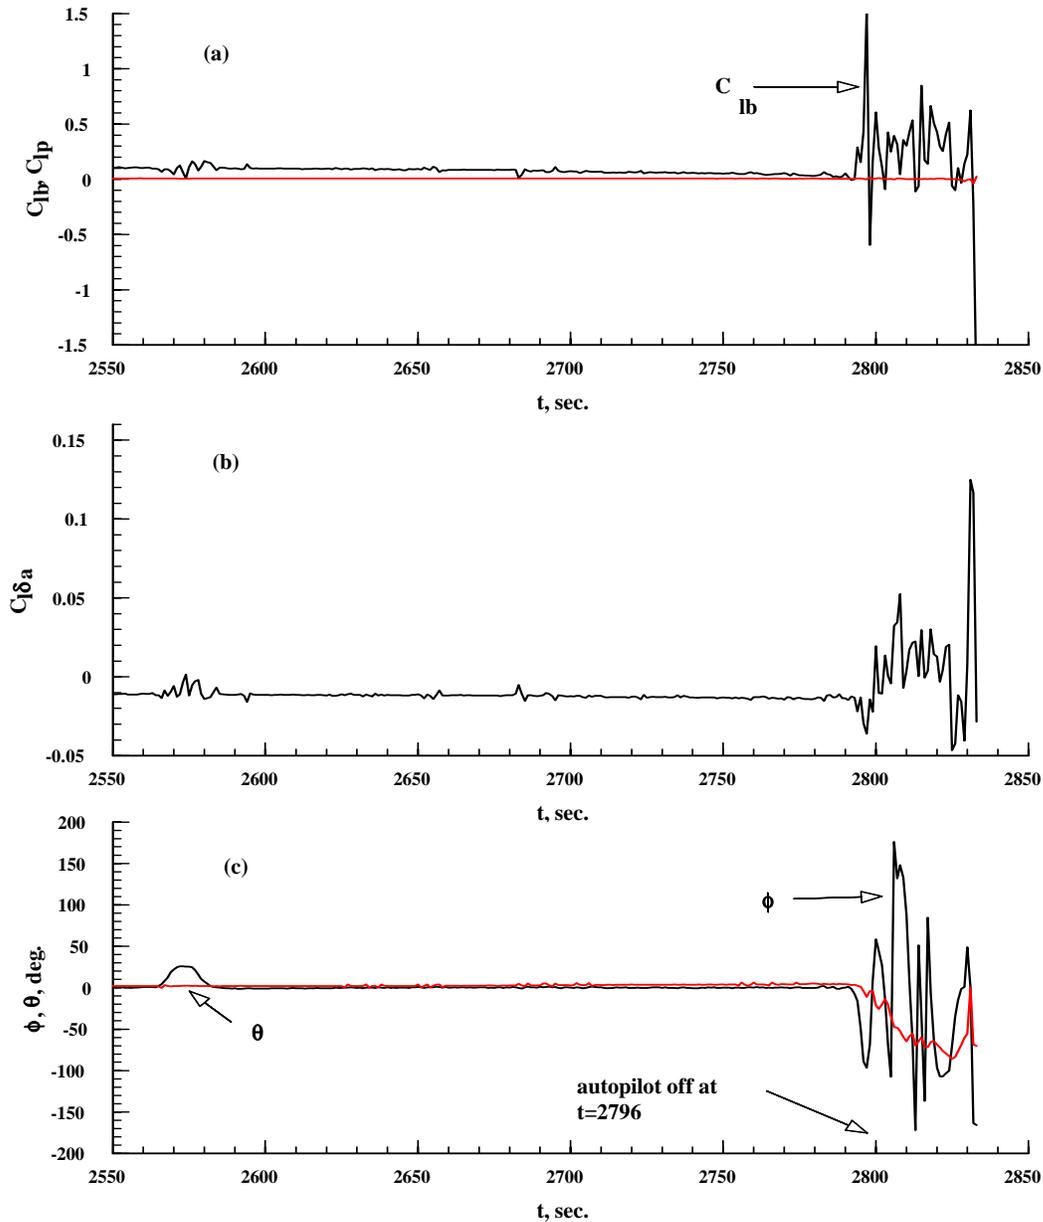
Figure 9 Calculated derivatives for the rolling moment coefficient along the trajectory

The main interest in the present case is in the behavior of rolling moment. Figure 9a shows that the dihedral effect is unstable ( $C_{l\beta} > 0$ ) and the roll damping is also slightly unstable ( $C_{l_p} > 0$ , see fig. 9b).

And the roll control effectiveness is negative ( $C_{l\delta a} < 0$ ) before roll excursion. According to the conventional sign, if the roll control is effective,  $C_{l\delta a}$  should be positive. Before the scale in figure 6a for  $C_{lp}$  is too small, it is re-plotted in figure 7b to show that it is positive.

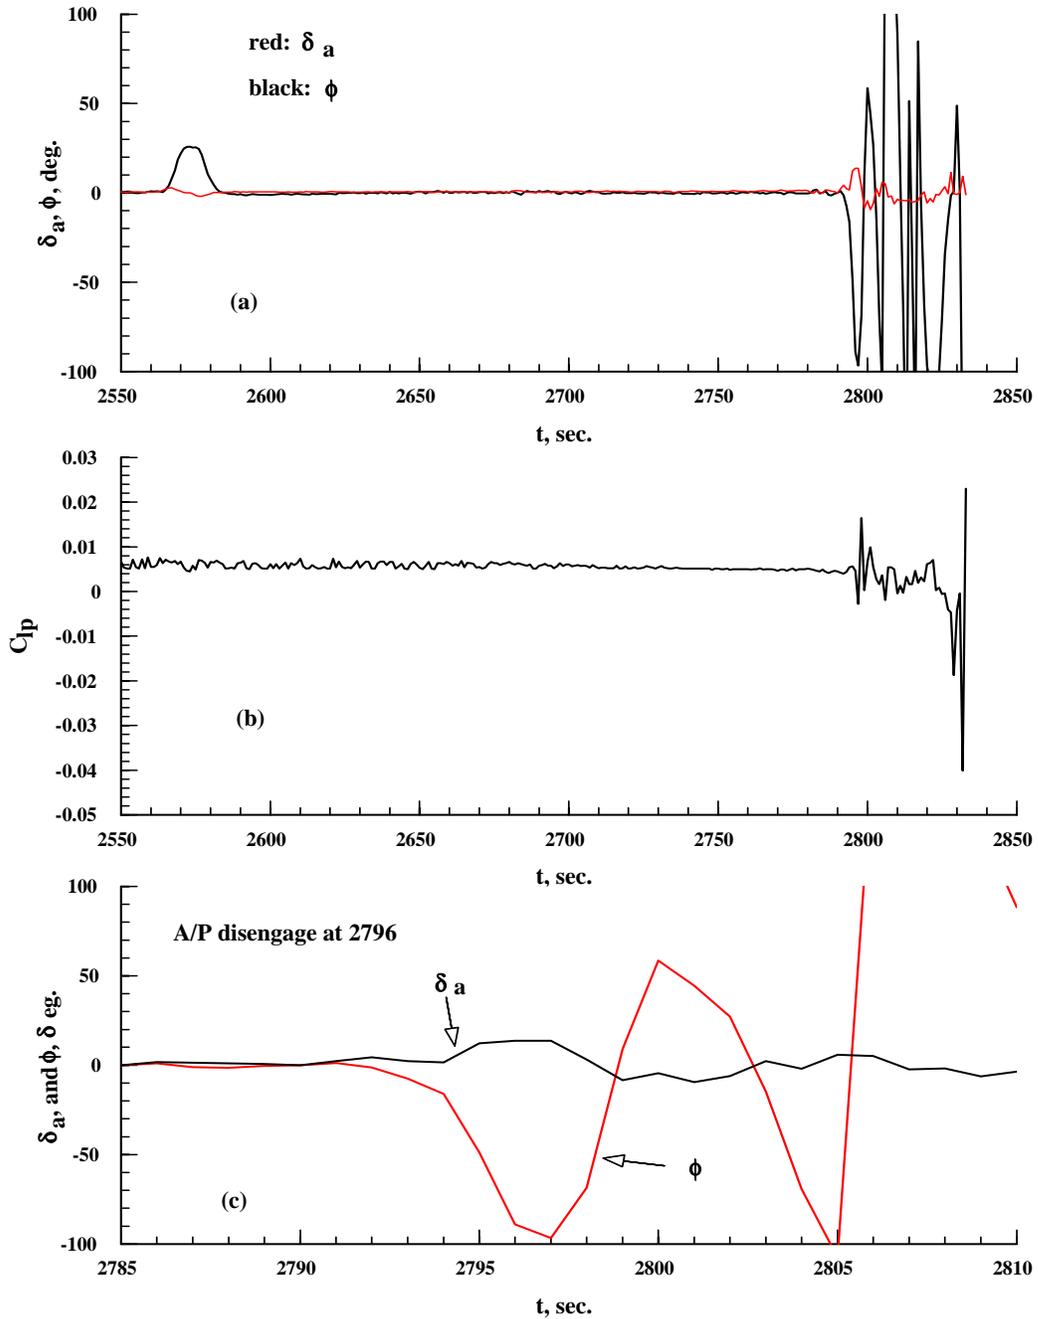
Figure 10 Enlarged plotting of rolling characteristics along the trajectory

In figure 10a with the roll angle and aileron deflection superposed, it is seen that initially the aileron deflection is opposite that of the bank angle before the autopilot disengage. This plot (fig. 10a) is further enlarged in figure 10c. Furthermore, during the roll excursion, there was a divergent roll oscillation. In the first 10 seconds, the rolling motion looks like a wing rock that is a limit-cycle oscillation. But because of increasing angle of attack and the dihedral effect being unstable, the rolling motion became divergent.

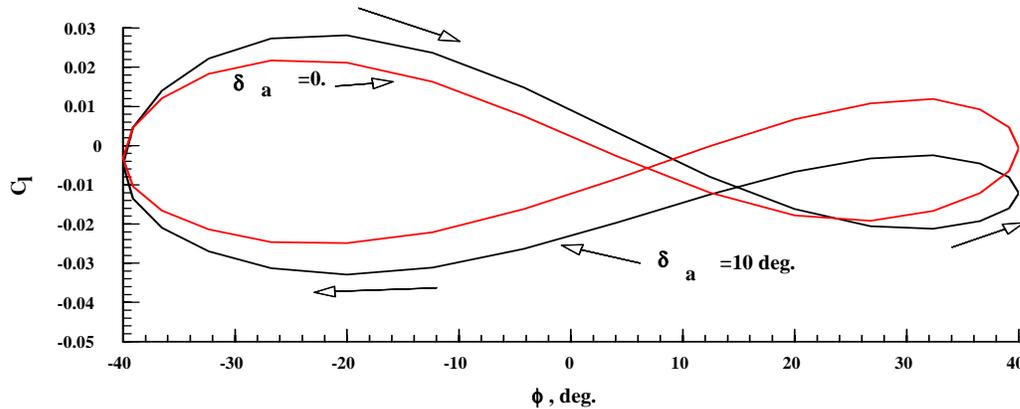
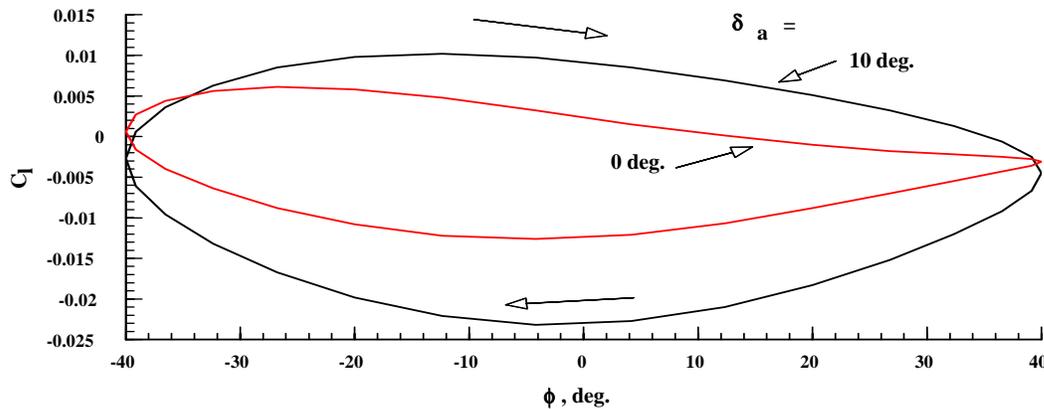
Figure 11a Response in rolling moment with  $\beta$  effect to a rolling oscillation input at  $k=0.03$ ,  $M = 0.4$ ,  $V=400$  ft./sec.,  $\alpha = 6$  deg.

Figure 11b Response in rolling moment without  $\beta$  effect

The  $\beta$  effect is present when rolling about the body axis at an angle of attack is performed. On the other hand, if the rolling is about the stability axis, no  $\beta$  would be generated. Figure 6a indicates that  $\beta$  is small; but not zero. Both figures show interesting hysteretic characteristics. It is well known that if hysteretic loop is clockwise, the oscillatory roll damping derivative  $(C_{lp})_{osc}$  is positive, implying dynamic instability. On the other hand, a counterclockwise hysteretic loop implies a negative  $(C_{lp})_{osc}$ , and hence, dynamic stability. Figure 11a shows that left roll is unstable, so that the aircraft will roll to the left under any disturbance, not necessarily due to aileron deflection. Besides, the aileron has lost its effectiveness already (fig. 9b). As the left roll angle became large,  $C_{l\beta}$  changed its sign to negative (stable), and the aircraft would roll back. Note that all rolling moment derivatives are primarily contributed from the wing. If wing rock was the cause, it would not be possible to control the aircraft and recover from the disaster, not only because of the issue of control effectiveness, but also a human pilot just can not provide timely roll control input for stability augmentation. To damp wing rock, the only way is to generate artificial damping moment (ref. 6).

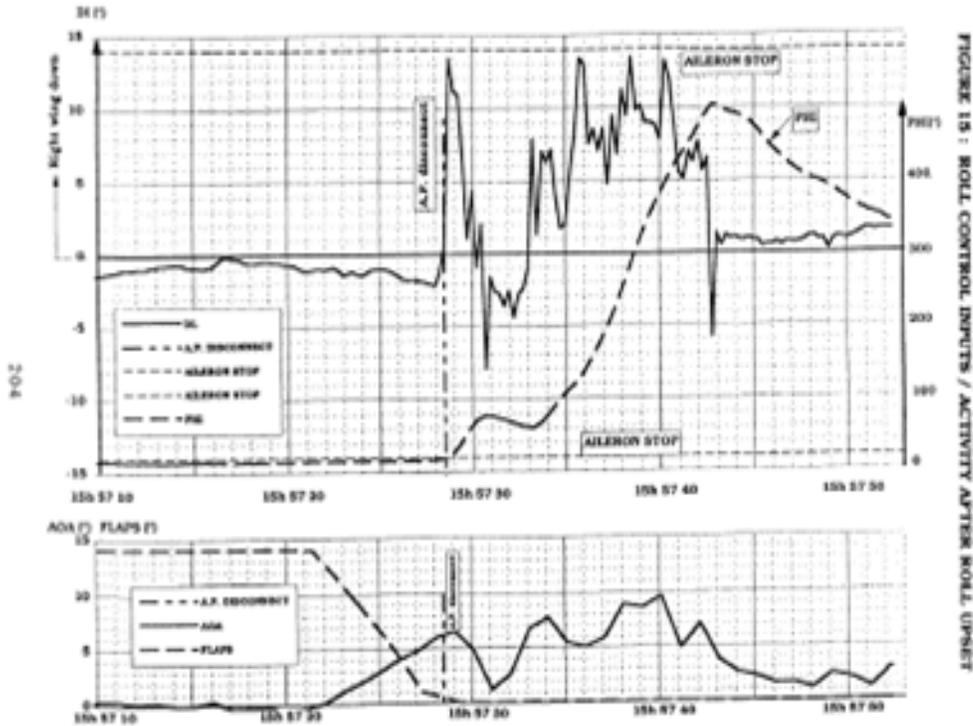
Figure 12 Roll characteristics of an ATR-72 in Roselawn, IN accident

Based on these results, we can now compare the roll excursion scenario between the Roselawn case (fig. 12) and GE 791:

<u>Roselawn case</u>	<u>GE 791</u>
No roll oscillation	roll oscillation
In descent and holding pattern	in cruise
No stall warning sounded	stall warning sounded
Propeller RPM=77%	Propeller RPM=86%
Speed decreased faster	speed decrease was slight and eventually it was increased fast
autopilot disengaged	autopilot disengaged
$\alpha \cong 6$ deg.	$\alpha \cong 6$ deg.

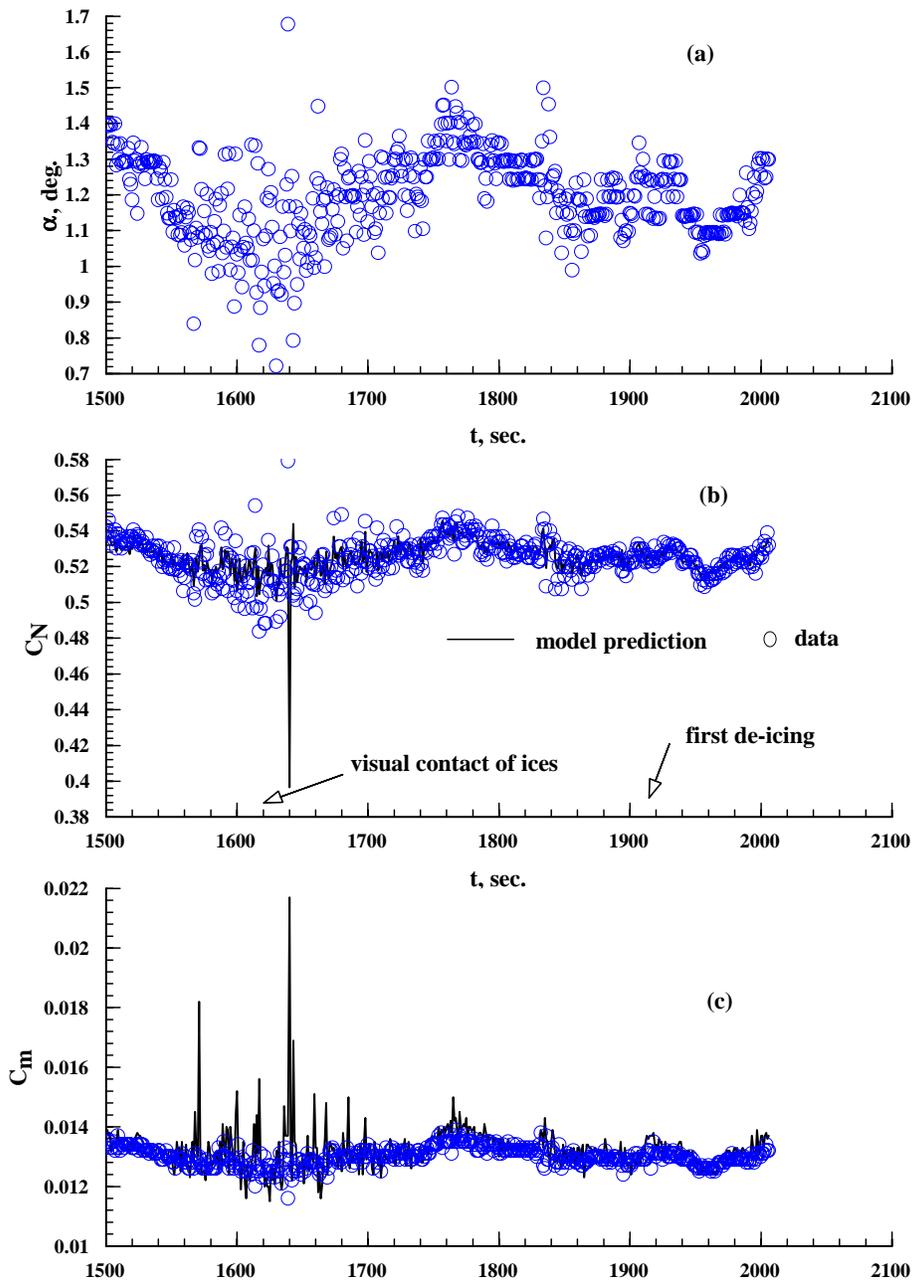
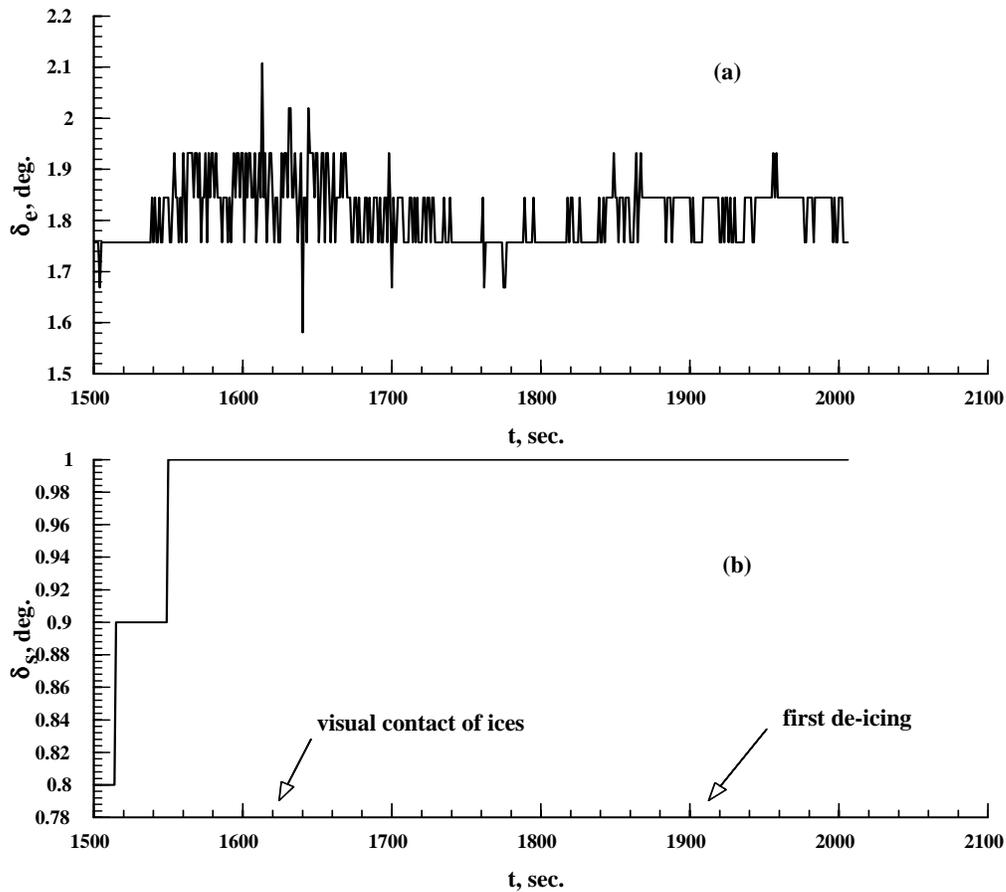
Figure 13 Normal force and pitching moment coefficients for GE 791 in the period of ice built-up

Based on these results, it may be concluded that significant icing occurred after 1480 (UTC 17:30:15) and it can be detected by using data correlation.

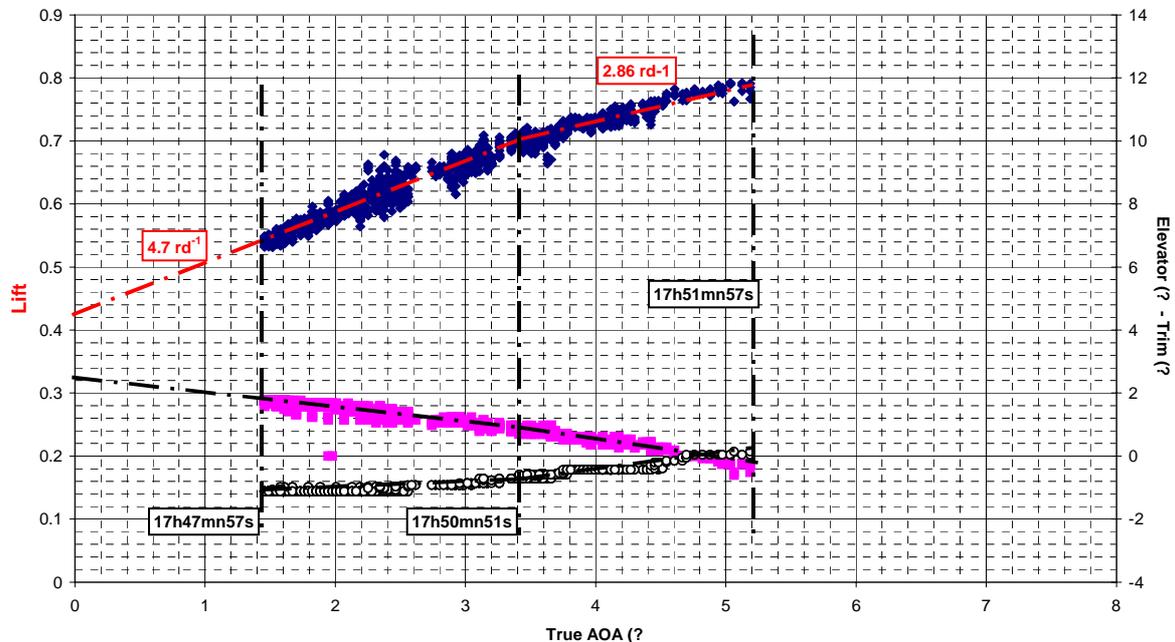
Figure: 1 - AC 322 LONGITUDINAL STABILITY

The figure 1 shows that between 17h 47mn 57s to 17h 50mn 51s the lift coefficient is  $4.7^{\text{rd-1}}$  and not  $2.2^{\text{rd-1}}$ .

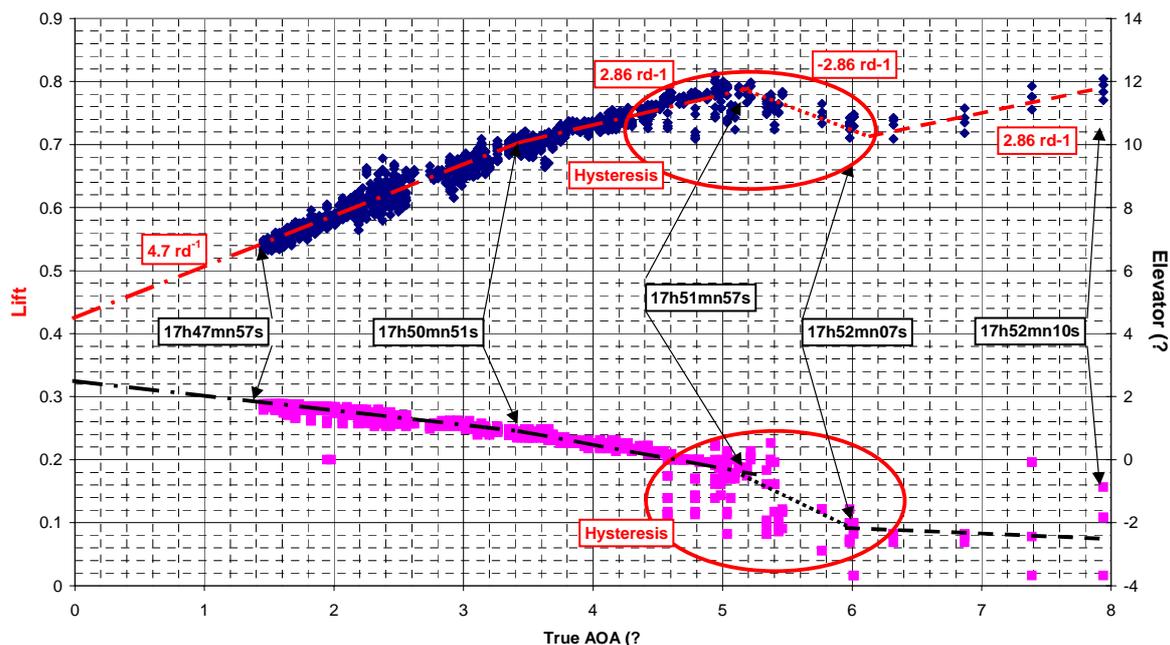
Figure: 3 - AC 322 LONGITUDINAL STABILITY

When the autopilot initiated the descent a flow separation occurs simultaneous on the two wings (no roll) up to AOA=6°, then an asymmetrical left roll appears.

During this period it is difficult to check correctly the longitudinal stability due to the aerodynamic hysteresis phenomenon on the lift (See figure:3). However the elevator efficiency is not affected and after the roll departure (17h52mn07s). The longitudinal

According to the figure:1  $Cz_{\alpha} = 4.7^{rd-1}$  then  $Cz_{\alpha} = 2.86^{rd-1}$  and according to the figure:3  $Cz_{\alpha} = -2.86$  few seconds before the roll departure and  $Cz_{\alpha} = 2.86$  between roll departure and stall warning.
