**Aviation Safety Council  
Taipei, Taiwan**

# **GE 791 Occurrence Investigation Report**

**IN-FLIGHT ICING ENCOUNTER AND CRASH INTO THE SEA  
TRANSASIA AIRWAYS FLIGHT 791  
ATR72-200, B-22708  
17 KILOMETERS SOUTHWEST OF MAKUNG CITY,  
PENGHU ISLANDS, TAIWAN  
DECEMBER 21, 2002**

**ASC-AOR-05-04-001**

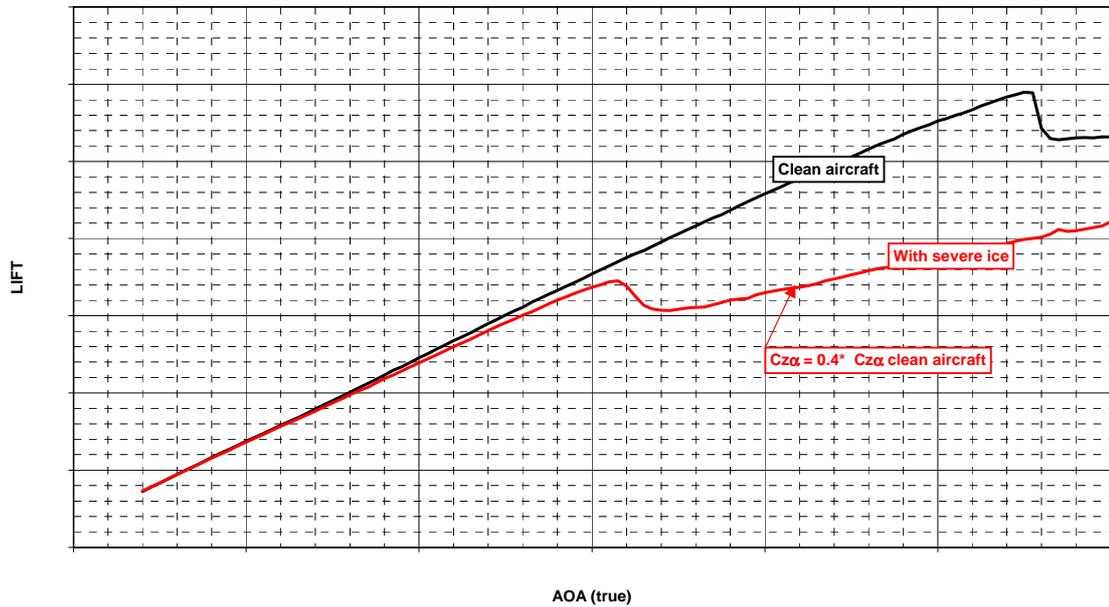
Figure 4 : ATR 72 - WIND TUNNEL TEST

Wind tunnel tests conducted on a mockup ( 1/2 span; Scale: 1/8) with and without Severe Ice on the airframe show a same result on lift coefficient (See Figure 4)

When a flow separation occurs, the figures 3 et 4 show that a significant reduction of angle of attack (about  $3^\circ$ ) during few seconds, leads the aircraft in a situation where all aerodynamic parameters are nominal.
