Landing Aircraft Collides During Rollout with Aircraft Taking Off on Intersecting Runway

—
FSF Editorial Staff

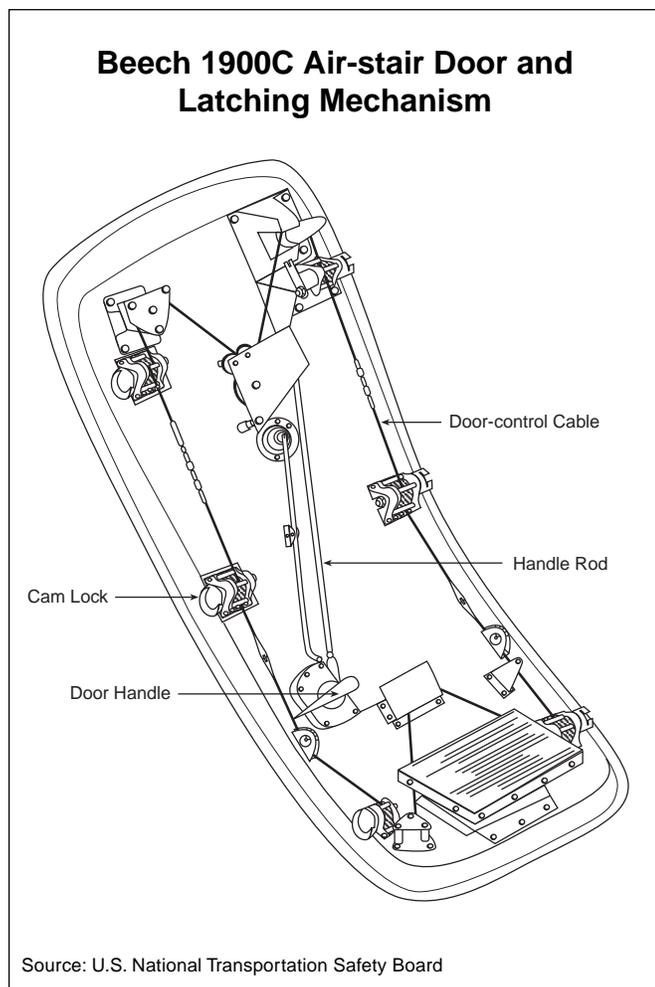
Figure 2 (page 12) shows a drawing of the Beech 1900C air-stair door and latching mechanism, viewed from inside the aircraft.

"The air-stair door parts from the accident airplane were examined at the [NTSB] Materials Laboratory on Jan. 30, 1997. The findings of the examination were as follows:

- "1. All cams were either fully or partially latched;
- "2. The exterior door handle was frozen in the latched position with aluminum melted around it;

"3. The position of the interior door handle assembly could not be determined because there was no frame of reference to compare to surrounding structure;

"4. The door-control cable was attached at both handle assemblies and was fractured at both turnbuckles. The metallurgical examination of the turnbuckle surfaces revealed a topography typical of copper alloys subject to static failure influenced by high temperatures and steady-state strain rates."

The report said, "If the impact caused deformation of the door and/or the fuselage that prevented one or more of the cam locks from moving, it would not have been possible for the exterior door control handle to be moved from the closed position to the open position as easily as it was described to have been done by the United Express pilot who tried to open the air-stair door from the outside.

"However, if the impact caused deformation of the door/frame system that introduced slack into the cable system, the exterior handle could have been moved from the closed to the open position, but the cable would not necessarily simultaneously rotate all the cam locks to the completely open position. This would explain why the FBO pilot found the door handle in the unlocked position when he first arrived but could not open the door."
