Preventing HARD Nosegear Touchdowns

JEFF BLAND
MANAGER
DYNAMIC LOADS
BOEING COMMERCIAL AIRPLANES

DAVID CARBAUGH
CHIEF PILOT
FLIGHT OPERATIONS SAFETY
BOEING COMMERCIAL AIRPLANES

FLIGHT OPERATIONS

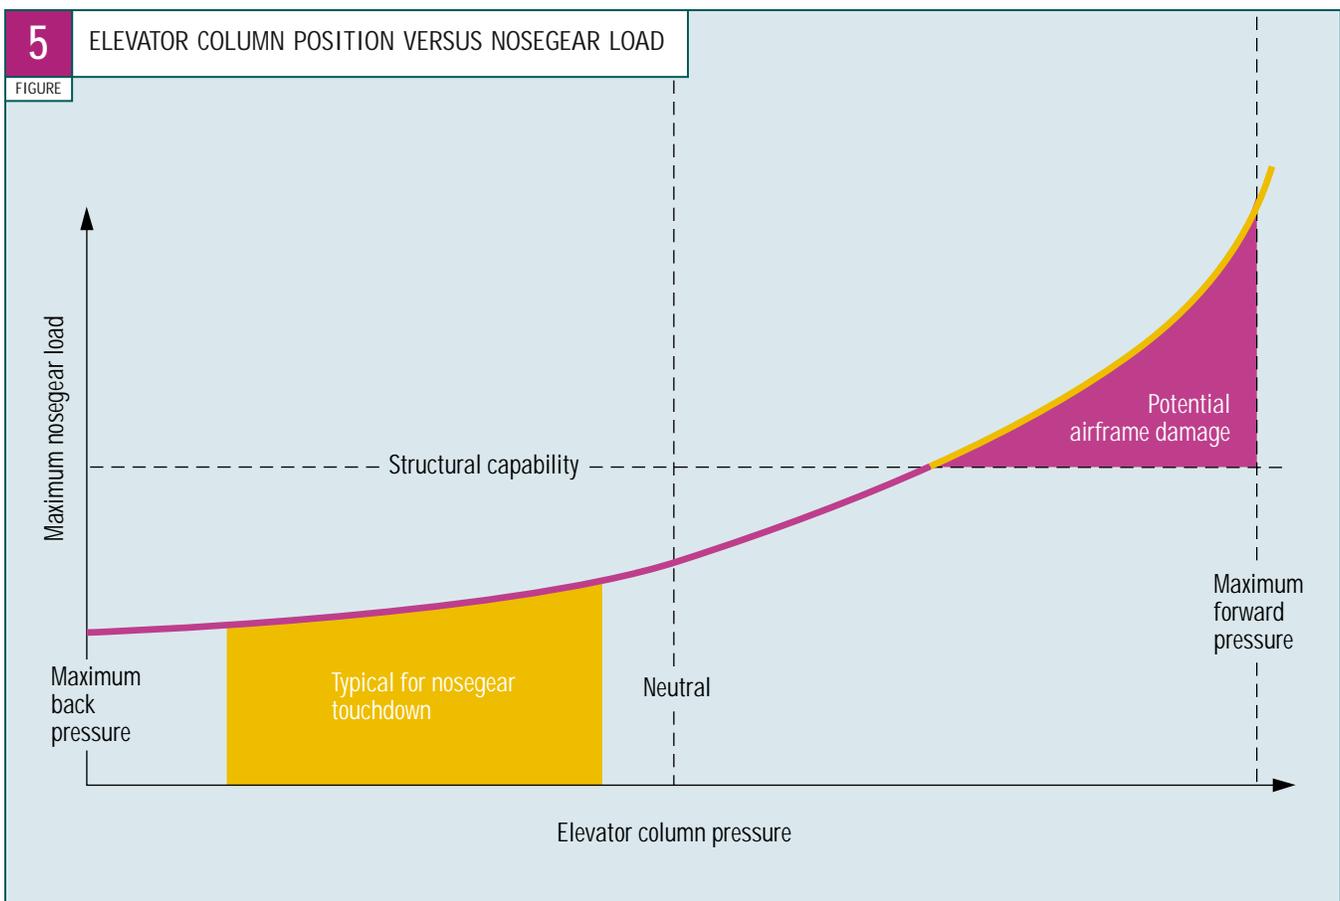
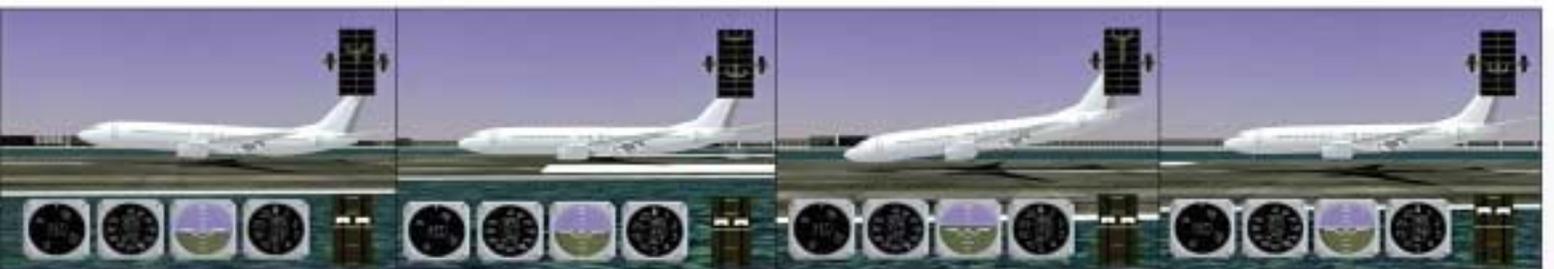
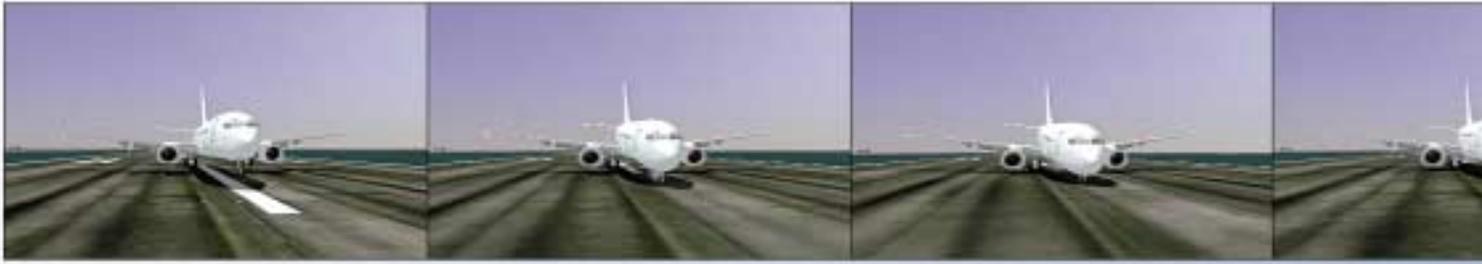
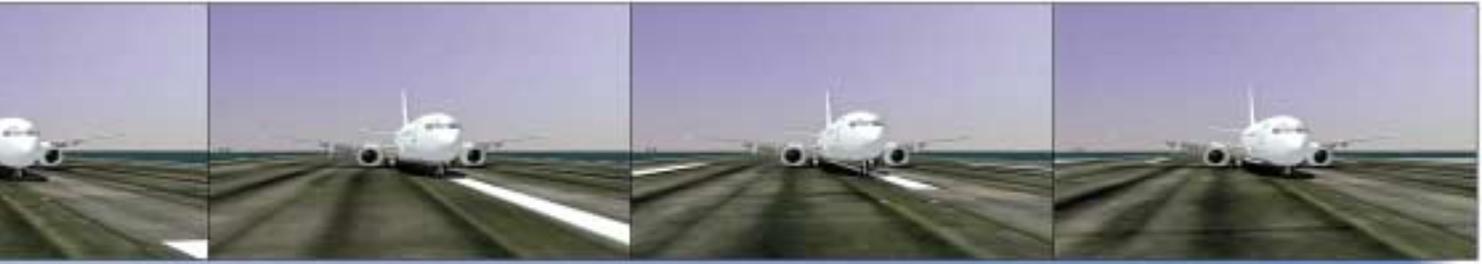
6 RADIO ALTITUDE, PITCH ANGLE, AND CONTROL COLUMN FORCES—NORMAL AND HARD LANDINGS

relaxing aft column pressure. When heavy brake applications are needed, with and without autobrakes, increased aft column pressure may be required to slow the derotation rate. Flight crews should not hold the nose up in the touchdown attitude or allow the nose to rise because either could result in a tail strike. Control column movement forward of the neutral position should not be needed. Figure 6 illustrates this smooth relaxation of column force as the nose is lowered. The figure compares the radio altitude, pitch angle, and control column forces for both normal landings and landings during which airframe damage occurred.

derotation should be performed so that the flight crew immediately starts flying the nosewheels smoothly onto the run-

way when the main wheels touch down. Flight crews can accomplish this by controlling the airplane pitch rate while
