Final Report

of AFRIQIYAH Airways Aircraft
Airbus A330-202, 5A-ONG Crash
Occurred at Tripoli (LIBYA)
on 12/05/2010

Published February 2013

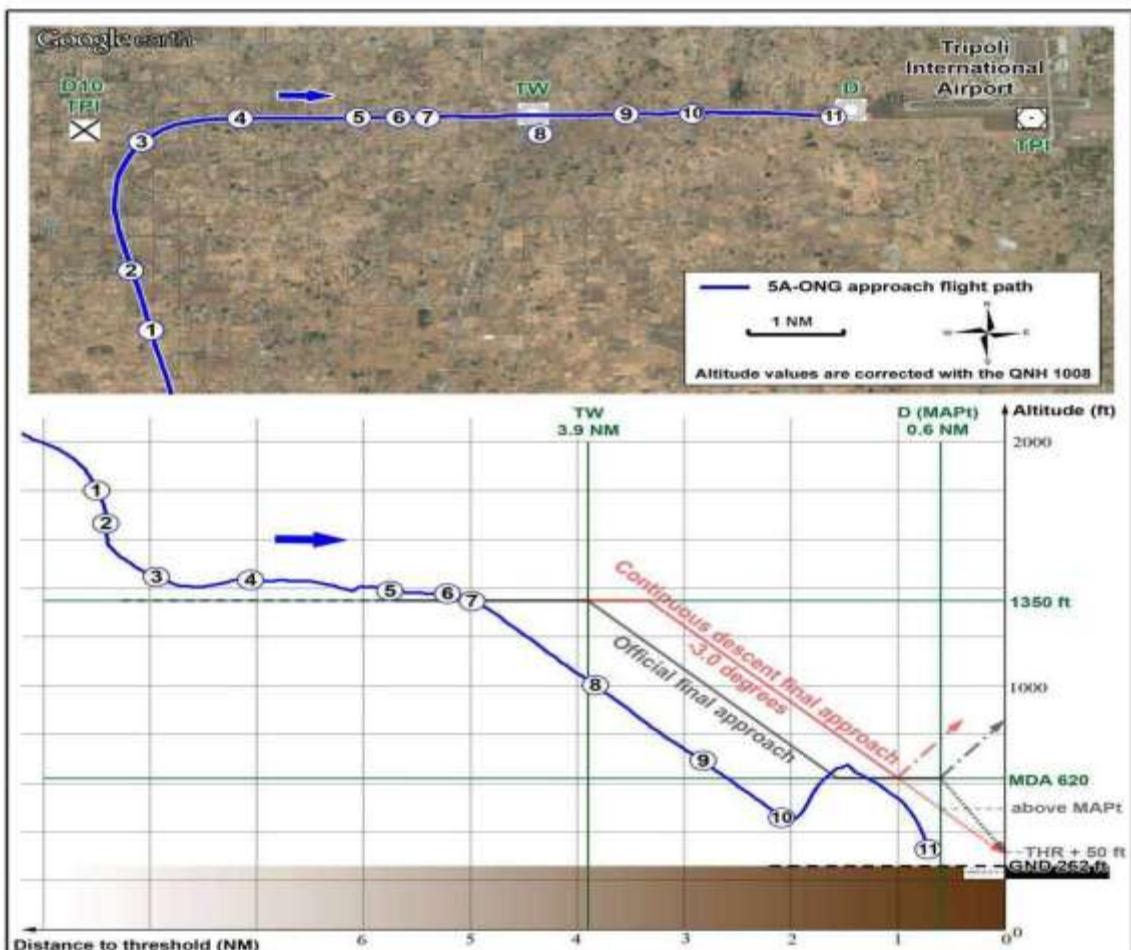
End of the flight path of 5A-ONG

From 04 h 01 min 07 onward, the TAWS “DON’T SINK”, “TOO LOW TERRAIN” and “PULL UP” warnings respectively were recorded by the SSCVR.

The SSFDR recording ended at 04 h 01 min 13 (11). Chronology of end of accident flight is shown in APPENDIX 11.

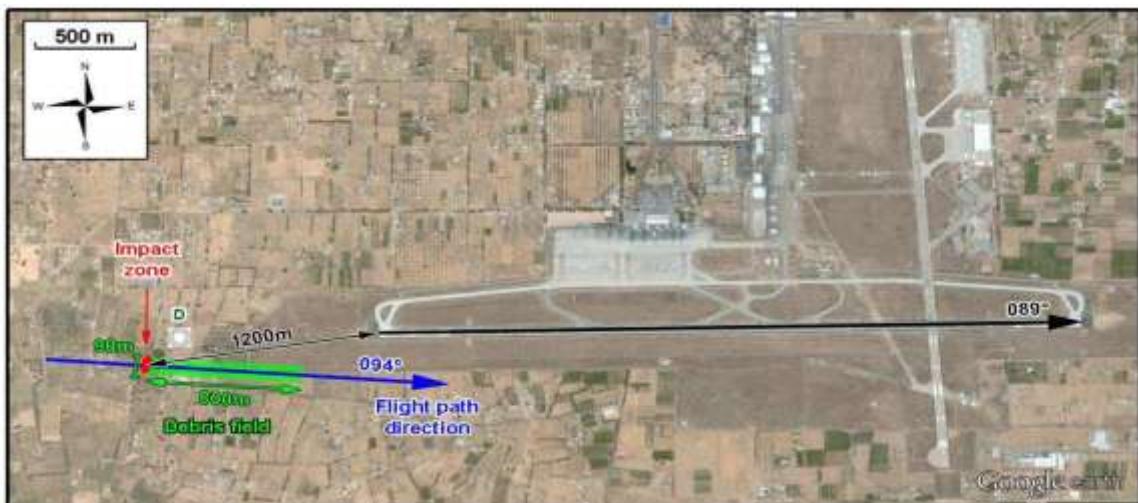
Location of crash site

The impact site was located on a sandy plain dotted with trees, 1,200 m from the threshold of runway 09, at an altitude of about 260 feet, outside the airport. The wreckage was spread over a rectangular area of 800 m long and 90 m wide, oriented 94 degrees, and some debris was found within the airport.

Initial observations show that the aircraft struck the ground with high energy and high longitudinal velocity.

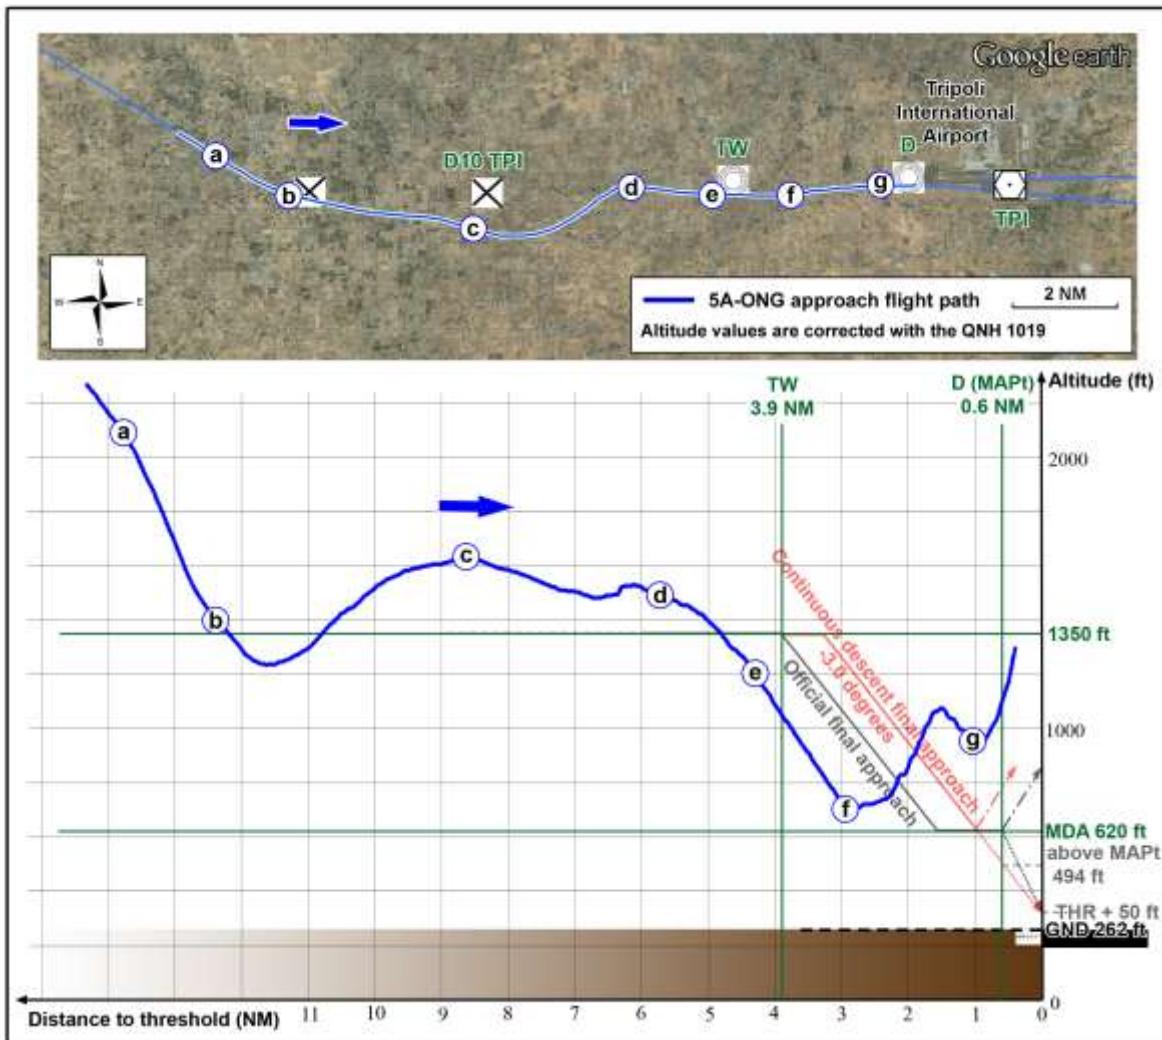
Overall, the approach was never stabilized, from the intermediate approach segment to the

missed approach. Parameters from the 28 April 2010 flight are presented in Appendix 12.

A comparison with the information on the accident flight highlights certain similarities:

- Final approach carried out in FPA vertical guidance mode before flying over TW;
- TW over flown at an altitude lower than specified in Locator approach procedure to runway 09;
- Lack of control and stabilization of pitch attitude during go around;
- Lack of adjustment of the thrust during go-around.
