Investigation Report

Type of Occurrence:	Serious incident
Date:	15 August 2011
Location:	Düsseldorf
Aircraft:	Airplane
Manufacturer / Model:	Airbus Industrie / A330-322
Injuries to Persons:	None
Damage:	Minor damage to aircraft
Other Damage:	None
Information Source:	Investigation by BFU
State File Number:	BFU 5X007-11

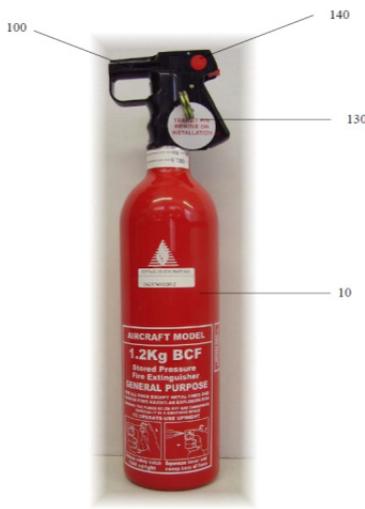
Fire extinguisher (example)

The cabin crew members used a fire extinguisher (P/N BA21741GSR-2) to fight the fire. The fire extinguisher was filled with 1.2 kg BCF (Halon 1211).
