Report

Serious incident on **22 July 2011**
in cruise at FL350, north Atlantic Ocean
to the **Airbus A340-313**
registered **F-GLZU**
operated by **Air France**

BEA

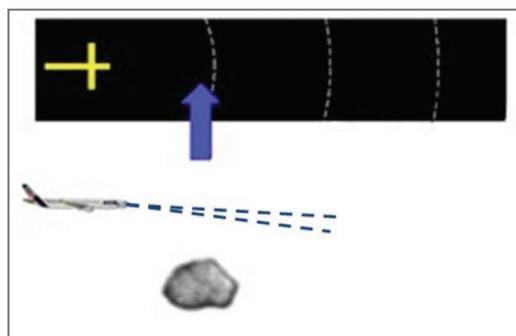
Figure 3 - Example of radar image

The tilt adjustment determines the zone scanned by the radar beam and consequently the echoes that are detected and displayed on the ND. Adjustment of the gain then enables the reflectivity of the precipitation encountered to be adapted. It should be noted that clouds situated in front of the aeroplane but not swept by the beam are not visible on the radar:

The adjustment of the weather radar was not the most suitable for detecting the convective zone crossed. Indeed, the ranges selected remained at 320 NM for a considerable time, whereas the airline's FCOM manual recommends 160 NM or 80 NM. This probably contributed to the crew's failure to detect the convective cell close to point 18N 060W.

It should be noted that choosing the 320 NM range on the ND may come from the practice of adapting the range to see the next waypoint on the ND. In the zones where the waypoints are distant from each other, this practice goes against optimal utilisation of the weather radar.

The tilt is adapted to the range of the ND. The manufacturer's Flight Crew Training Manual and the Air France FCOM A330/A340 manual recommend setting the range in cruise to 160 NM or 80 NM.

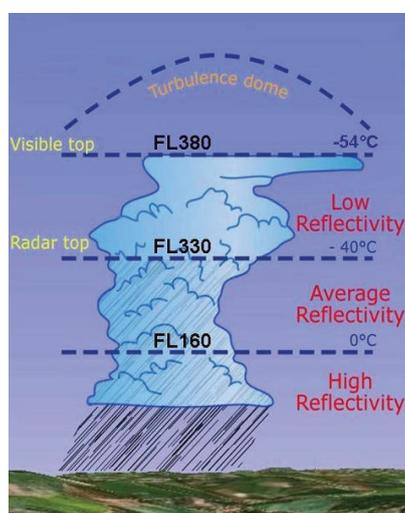
Figure 4 - Cumulonimbus radar reflectivity

In addition, the structure of cumulonimbus requires an adjustment of the tilt and range as the aeroplane approaches a convective cell. Indeed the reflectivity of precipitation inside a cumulonimbus depends on the temperature.

The most reflective zones (liquid precipitation) are located under ISO 0°C. The reflectivity is higher there.
