FINAL REPORT

AIRBUS A380-800, REGISTRATION 9V-SKD

SMOKE IN LAVATORY

31 JANUARY 2011

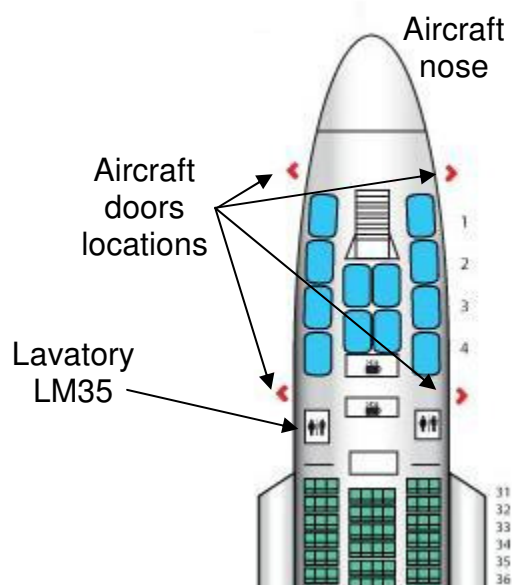
Figure 1: Location of lavatory LM35 on A380 main deck (Top view)

- 1.1.4 About 45 minutes before arriving Singapore (the aircraft was then about three hours into the flight), an ECAM message indicating smoke in lavatory LM35 on the main deck of the aircraft (see **Figure 1**) appeared.
- 1.1.5 At this time, the Cabin Crew-In-Charge (CIC) was in lavatory LM35 and he heard a loud bang. The lights in the lavatory went out and the CIC noticed an electrical burning smell.

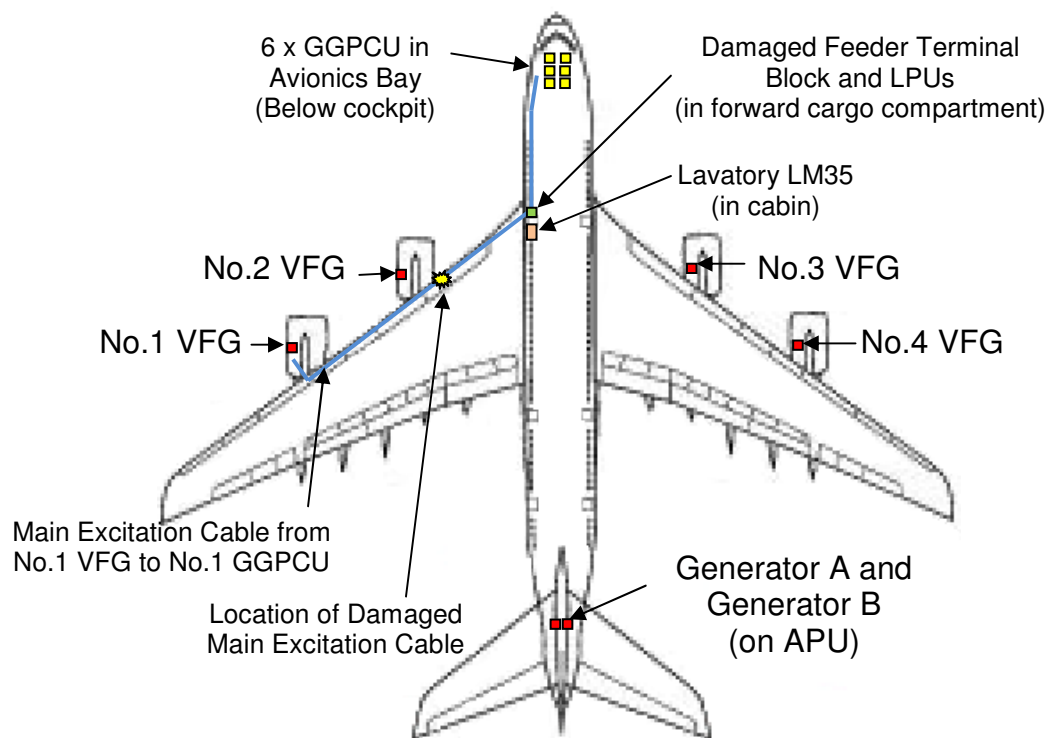
Figure 7: Locations of affected components

- 1.2.6 There was no heat or stress damage found in the proximity of the Main Excitation Cable damage. There was no maintenance work performed on the Main Excitation Cable since the aircraft was delivered to the operator. Figure 7 illustrates the locations of the various components.

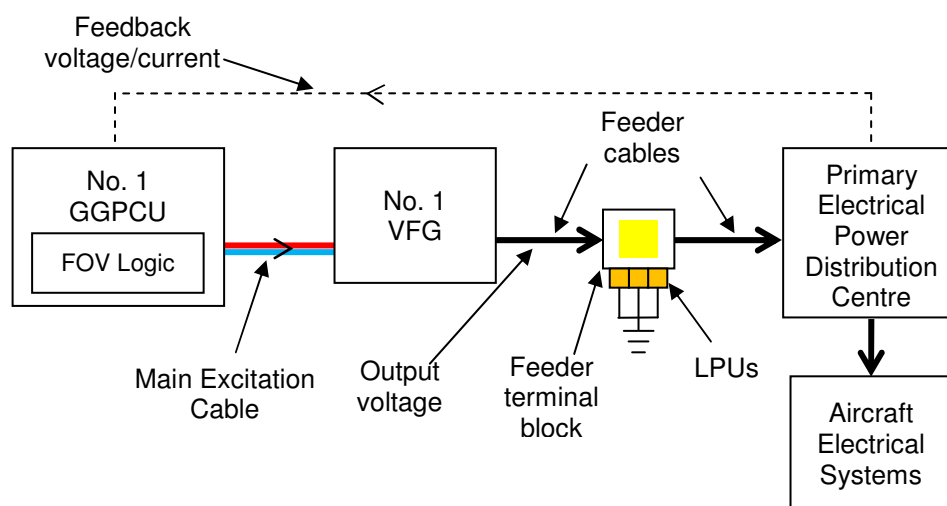
Figure 8: No. 1 electrical system

1.4.1.1 **Figure 8** shows a schematic diagram of the No.1 electrical system. The No.1 GGPCU controls the output voltage of the No.1 VFG by varying the current flowing in the Main Excitation Cable which comprises a positive (red) excitation wire and a negative (blue) excitation wire. The output voltage and current of the VFG are monitored by the GGPCU through the Primary Electrical Power Distribution Centre.

1.4.1.2 Each GGPCU has a Fast Over-Voltage (FOV) protection logic and an Over-Current protection logic. The FOV protection logic would inhibit the output of the VFG (i.e. zero VFG output) if the VFG output voltage is greater than 143Vac and the negative Main Excitation Wire voltage is less than 19Vdc. The Over-Current protection logic would inhibit the VFG output when any phase current of the VFG output is greater than 435A.

- 1.4.1.4 Failure analysis of the Main Excitation Cable revealed that the negative Main Excitation Wire was damaged by electrical arcing between the negative Main Excitation Wire and the cable shielding that enveloped the positive and negative Main Excitation Wires.
