AIRCRAFT ACCIDENT REPORT 3/2005

**Report on the serious incident to
Boeing 757-236, G-CPER
on 7 September 2003**

Air Accidents Investigation Branch

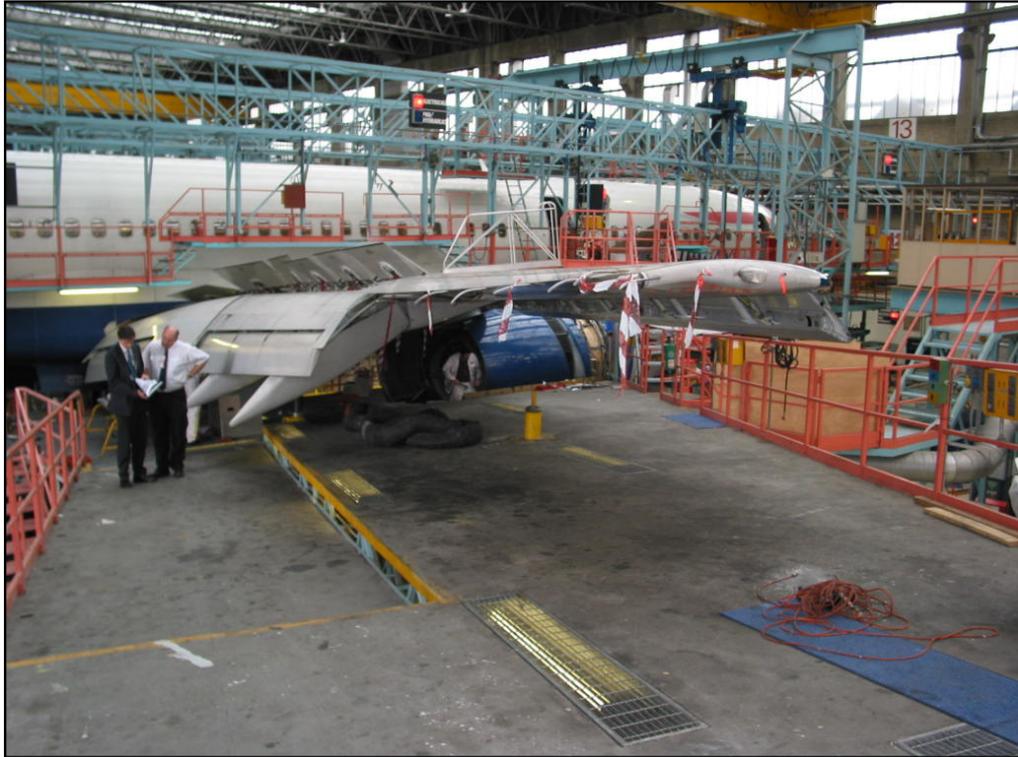
Figure 5

The incident flight was the first flight following the completion of an 'Inter 4' heavy maintenance check. The maintenance was performed by the Airline's JAR-145 approved Maintenance Organisation and commenced on 11 August 2003 and was completed on schedule, on 7 September 2003. The work was carried out in the Airline's Boeing 757/767 heavy maintenance facility in Technical Block 'D' ('TBD') at London Heathrow Airport. The aircraft was parked in Bay 13 of this hangar for the duration of the maintenance and was surrounded by purpose-built movable, multi-level staging, permitting safe and convenient access to different parts of the aircraft (Figure 5).

Boeing 757 docked in staging - Hangar Bay 13, Technical Block 'D'

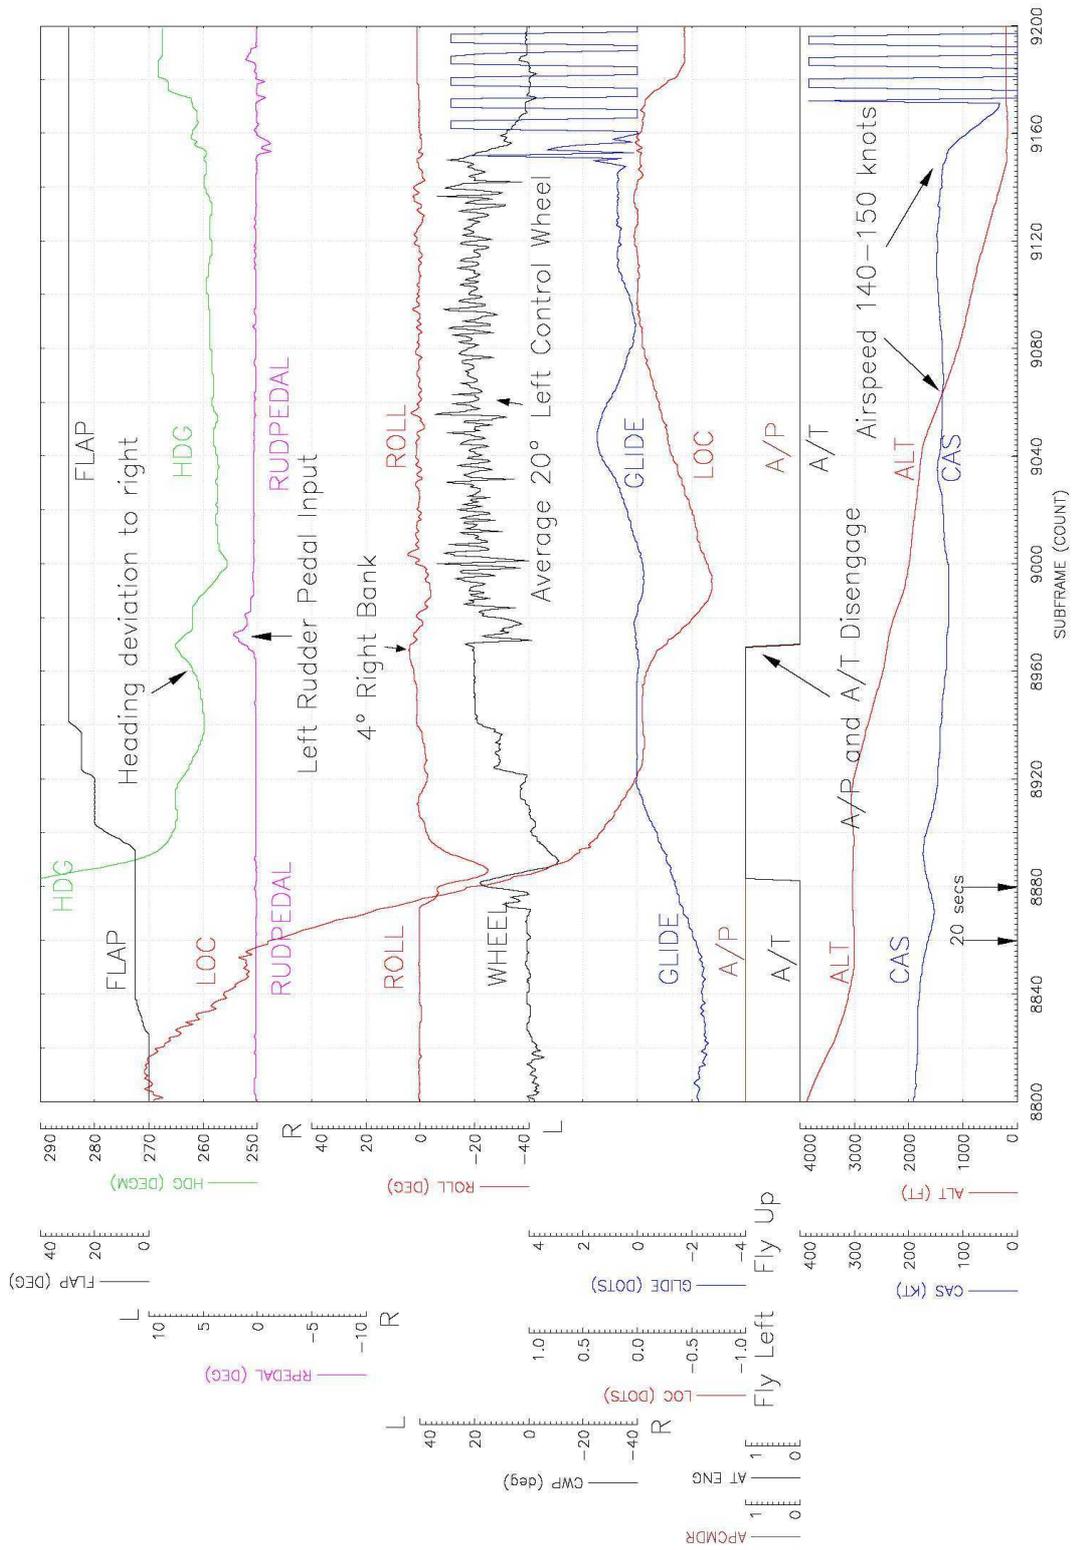
Figure 7
 Relevant Flight Recorder Parameters for Approach and Landing
 at London Gatwick

A time history of the relevant flight parameters during the approach to Gatwick is shown in Figure 7. This shows that the approach was normal until the final stages of flap were lowered. When 25° and 30° of flap were selected the autopilot applied about 12° and 20° of left control wheel respectively. The latter control input was insufficient to stop a slight bank angle of approximately 4° to

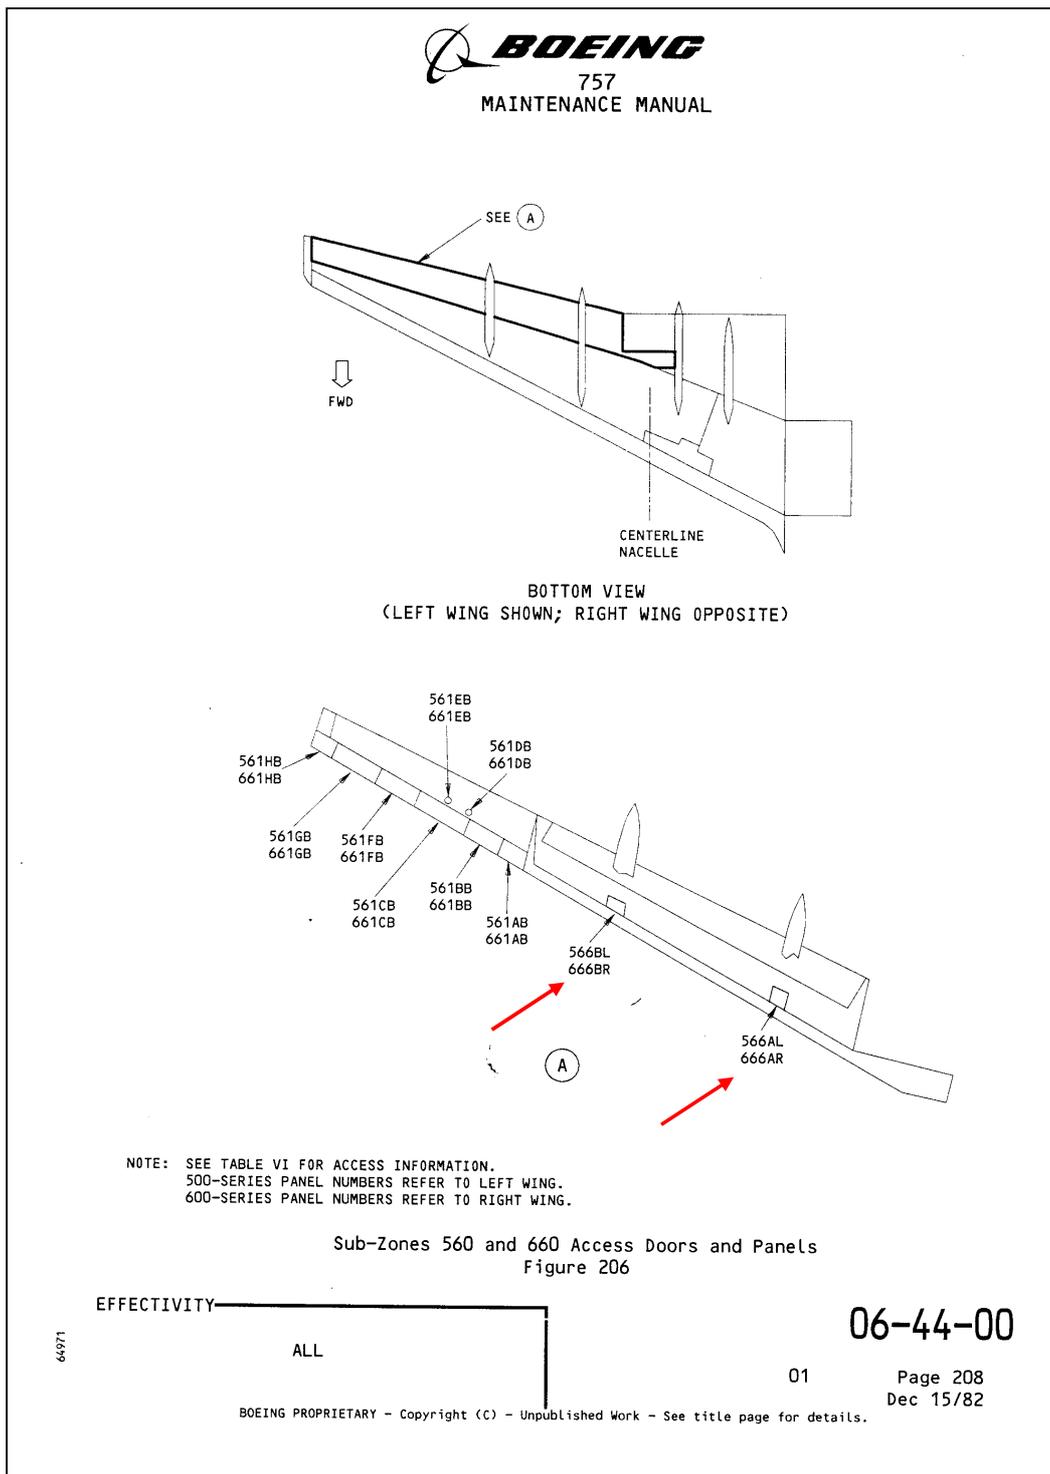
On examining the aircraft with the flaps down, access panels 666AR and 666BR were found to be missing from the outboard flap on the right wing (Figure 1). The panels are approximately 300 mm x 200 mm in size and are installed at the forward attachments for the main flap. Their purpose is to maintain the aerodynamic profile of the flap leading edge.

Boeing 757 AMM Panel Chart showing location of Panels 666AR and 666BR
