**INCIDENT**

<b>Aircraft Type and Registration:</b>	Boeing 777-200ER, AP-BGL	
<b>No &amp; Type of Engines:</b>	2 GE 90 turbofan engines	
<b>Category:</b>	1.1	
<b>Year of Manufacture:</b>	2004	
<b>Date &amp; Time (UTC):</b>	1 March 2005 at 0910 hrs	
<b>Location:</b>	Manchester Airport, Manchester	
<b>Type of Flight:</b>	Public Transport (Passenger)	
<b>Persons on Board:</b>	Crew - 12	Passengers - 332
<b>Injuries:</b>	Crew - 0	Passengers - 31 (Minor)
<b>Nature of Damage:</b>	Slight damage to fuselage skin adjacent to door 3R, heat damage to the No 10 tyre and hydraulic hoses on the left main landing gear	
<b>Commander's Licence:</b>	Airline Transport Pilot's Licence	
<b>Commander's Age:</b>	54 years	
<b>Commander's Flying Experience:</b>	13,000 hours (of which 600 were on type) Last 90 days - 176 hours Last 28 days - 36 hours	
<b>Information Source:</b>	AAIB Field Investigation

**Synopsis**

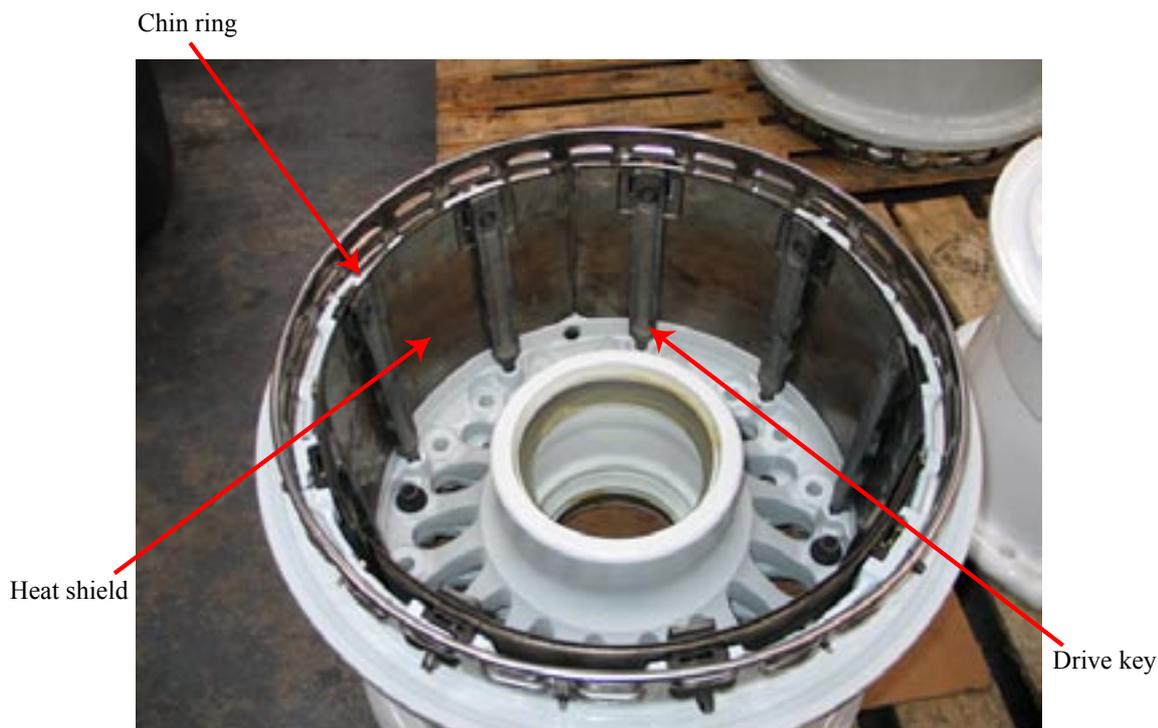
**Figure 4**  
Construction of main wheel

aluminium hub from the high temperatures generated by the carbon brake pack. The heat shields are constructed from two thin sheets of stainless steel, spot welded around their edges, and which contain an absorbent ceramic insulation material. They have a hole on the outer edge to allow the brake pack drive keys to be secured to the hub, and rubber bumpers fitted along the outside surface to prevent fretting against the wheel hub.
