# False Expectations

The pilots were looking out the windshield, anticipating visual contact with the runway, when the A300 descended below minimums at Birmingham.

Inadequate monitoring of the flight instruments and misuse of the 777's autoflight system led to a collision with a seawall at San Francisco.

# Mismanaged Descent

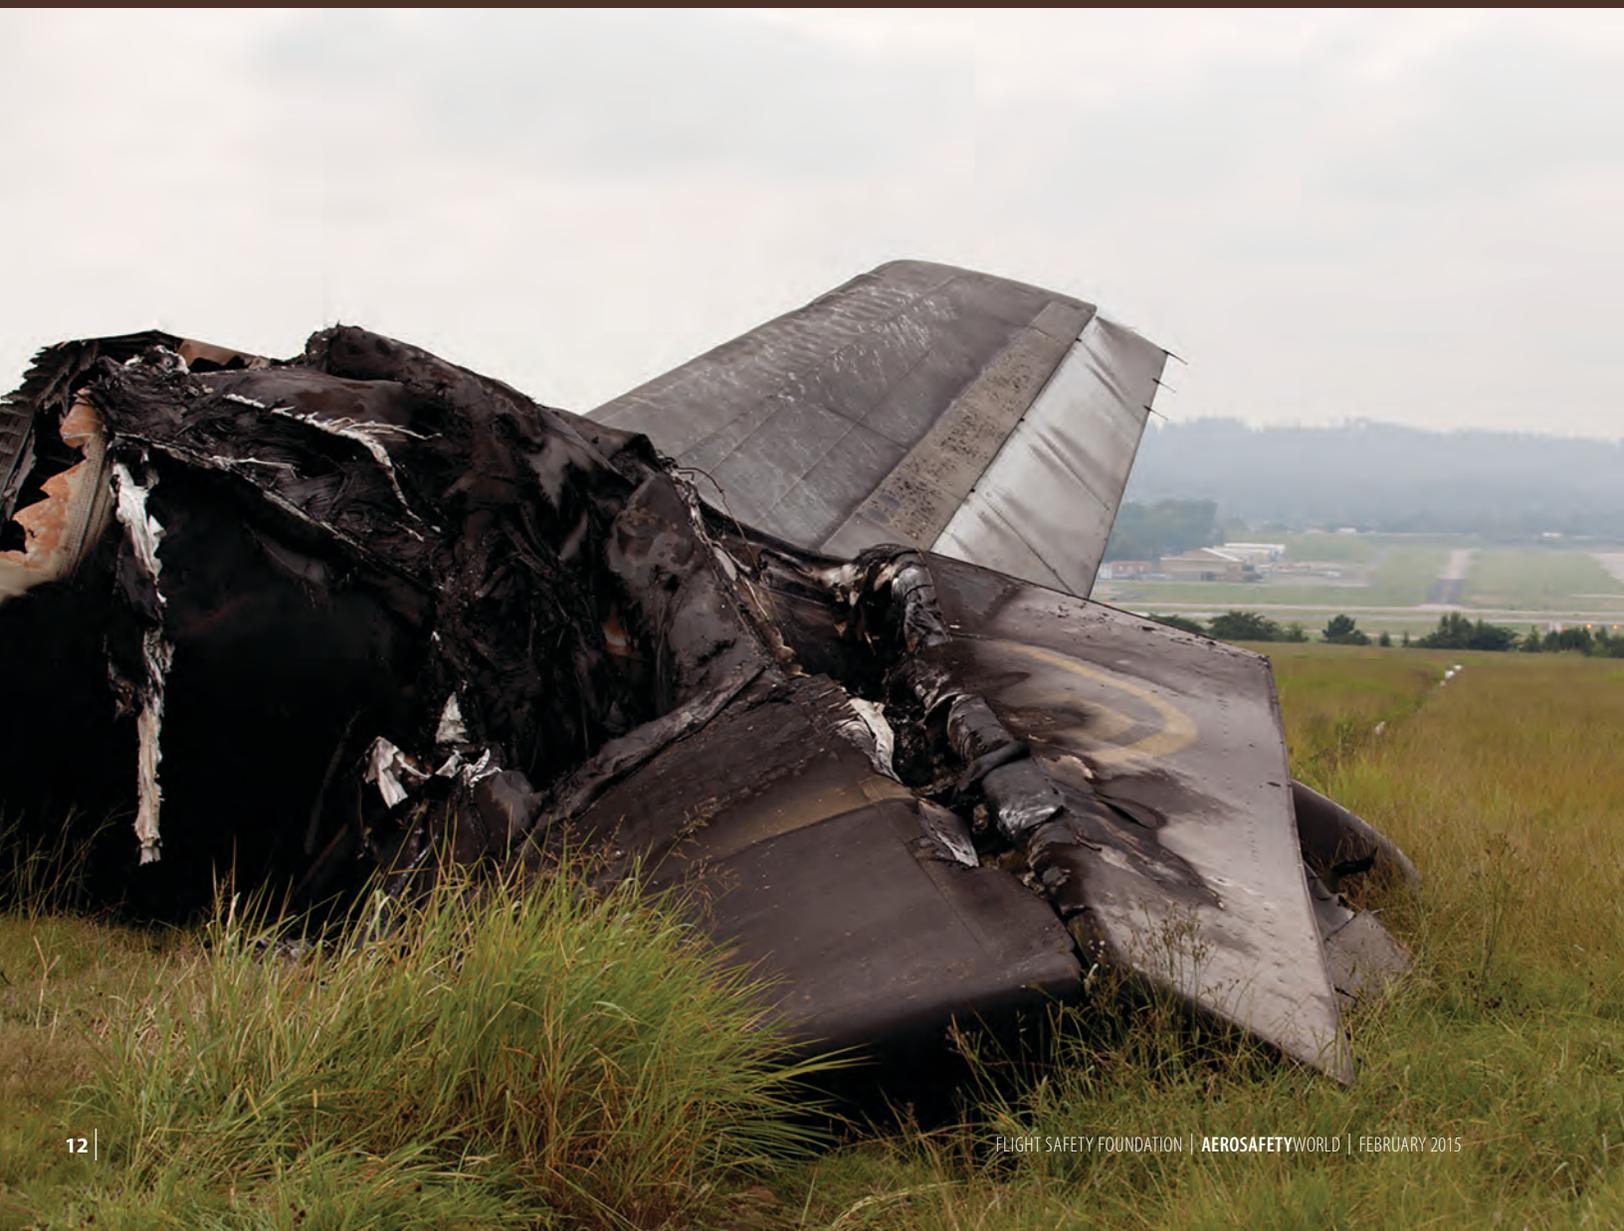
Concentrating on gaining sight of the runway, the pilots allowed the Airbus A300-600 freighter to descend below the minimum descent altitude for the approach. They finally caught sight of the runway about two seconds before the airplane struck the ground near Birmingham (Alabama, U.S.)–Shuttlesworth International Airport at 0447 local time on Aug. 14, 2013. Both pilots were killed, and the airplane was destroyed by the impact and subsequent fire.

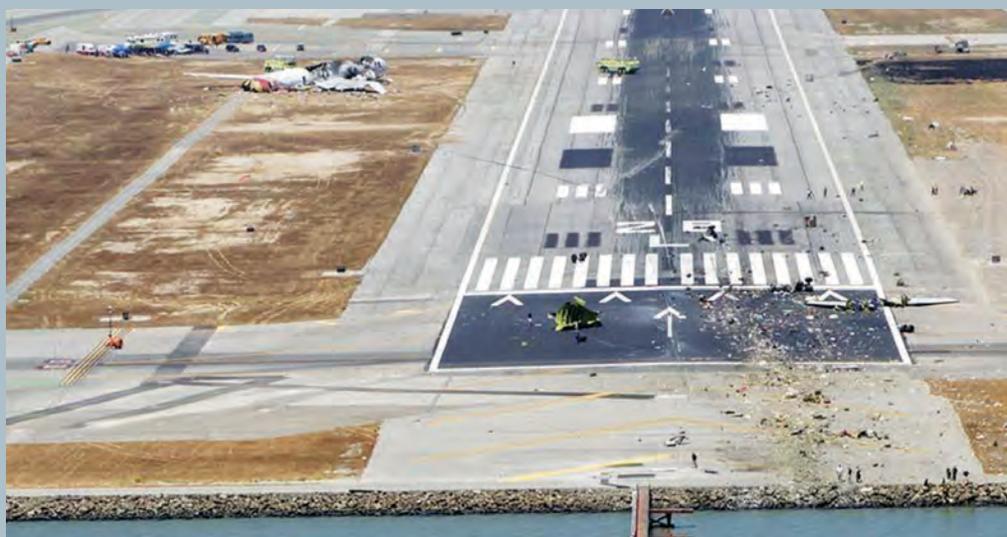
## Profile View of the Last 40 Seconds of Asiana Airlines Flight 214

Instead, however, selection of the flight change speed mode at this point caused the autopilot to command an increase in pitch to slow the airplane to the selected airspeed, 150 kt. Simultaneously, the autothrottle system responded, as designed, by entering the thrust mode and moving the thrust levers forward to attain the selected altitude, 3,000 ft.

The PF reacted to the unexpected pitch-up by disengaging the autopilot,

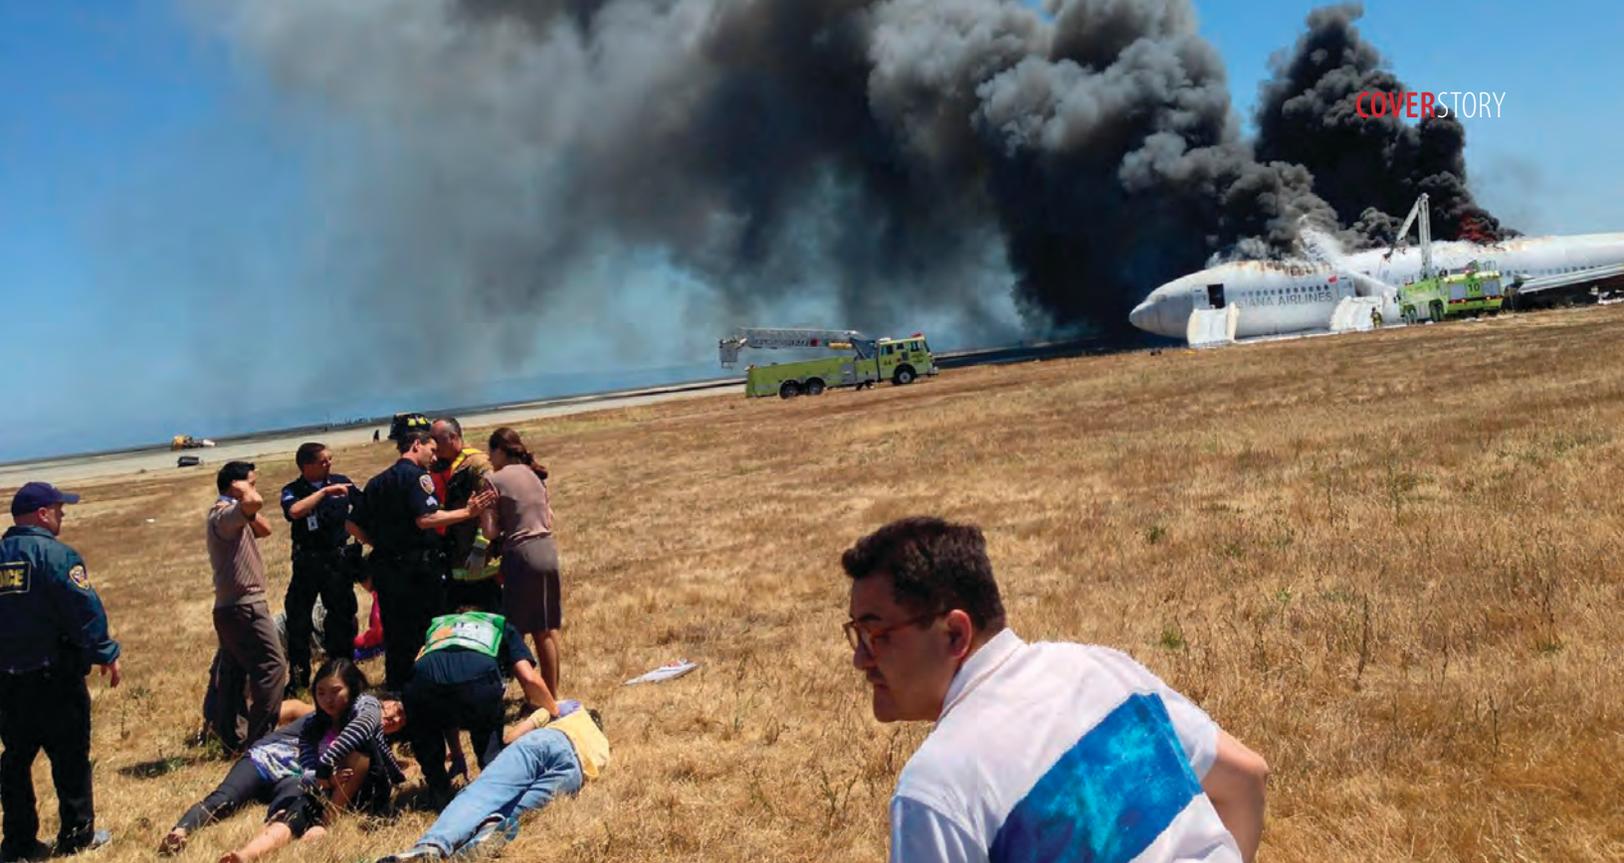
Video images recorded by airport surveillance cameras helped investigators to document the order of the airplane’s momentary lifting and pivoting motions, then a sliding deceleration — all resulting in complex patterns of injuries or absence of injury. “When the main landing gear and the aft fuselage struck the seawall, the tail of the airplane broke off at the aft pressure bulkhead,” the report said. “The airplane

slid along the runway, lifted partially into the air [tilting the airplane into about a 30-degree nose-down angle], spun about 330 degrees, and impacted the ground a final time [coming to rest off the left side of the runway, about 2,400 ft (732 m) from the initial seawall impact point ... about 1128:06.26 local time].

“The impact forces, which exceeded certification limits, resulted in the inflation of two slide/rafts within the cabin, injuring and temporarily trapping two flight attendants. Six occupants were ejected from the airplane during the impact sequence: two of the three fatally injured passengers and four of the seriously injured flight attendants. The four flight attendants were wearing their restraints but were ejected due to the destruction of the aft galley where they were seated. The two ejected passengers (one of whom was later rolled over by two firefighting vehicles) were not wearing their seatbelts and would likely have remained in the cabin and survived if they had been wearing their seatbelts.”
