Pitch Oscillations, High Descent Rate Precede B-727 Runway Undershoot

The flight crew was conducting a Category II ILS approach in instrument meteorological conditions. The airplane pitched down after crossing the middle marker, and the autopilot disconnected. The captain increased power and pulled back the control column to arrest the sink rate. The airplane struck terrain, bounced onto the runway and then veered off the runway.

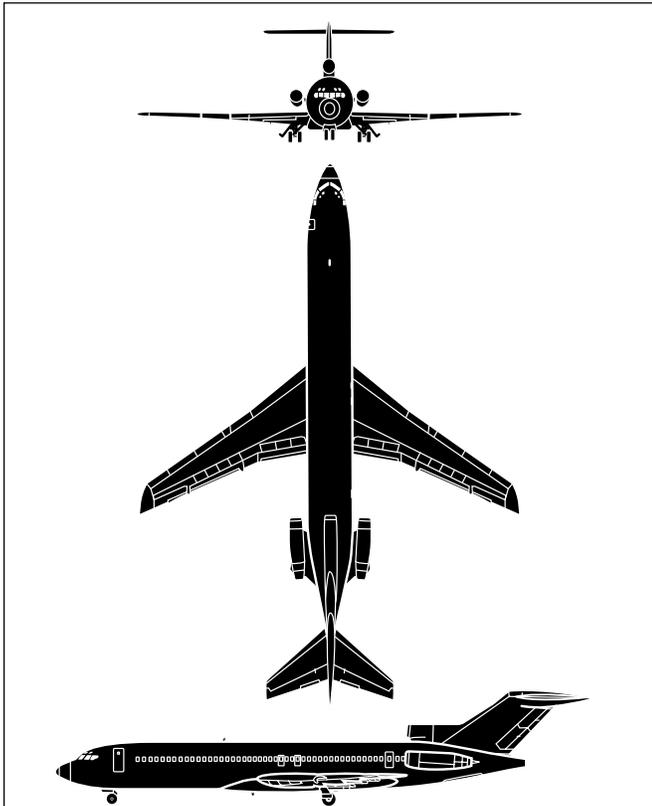
Boeing 727-200

The three-engine, short/medium-range B-727 was introduced into service in 1960. The B-737-200, introduced in 1967, is a “stretched” version, with 10-foot (three-meter) fuselage extensions both forward and aft of the main-landing-gear wheel wells.
