DC-10 Overruns Runway in Tahiti While Being Landed in a Storm

The flight crew encountered showers, turbulence and a strong, gusting crosswind on final approach. The airplane touched down about midpoint on the wet runway, overran the runway, struck localizer antennas and came to a stop with the forward section of the fuselage in a lagoon.

—
FSF Editorial Staff

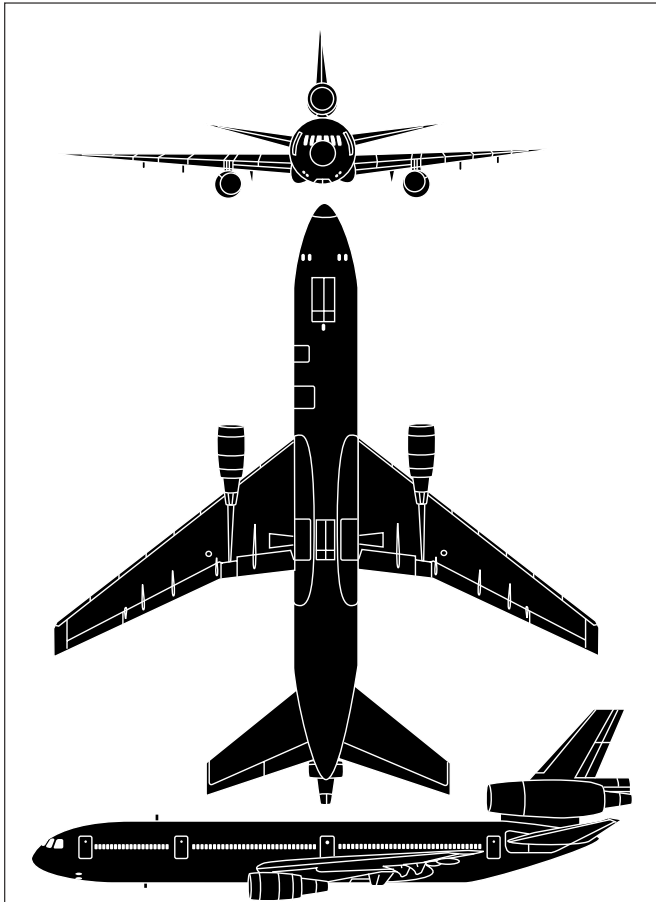
The McDonnell Douglas DC-10-10 was the first model in the DC-10 series, a long-range, high-capacity transport airplane. It first flew in August 1970.
